MACADAM
Renault Arkana '21

Vehicle information

Damages

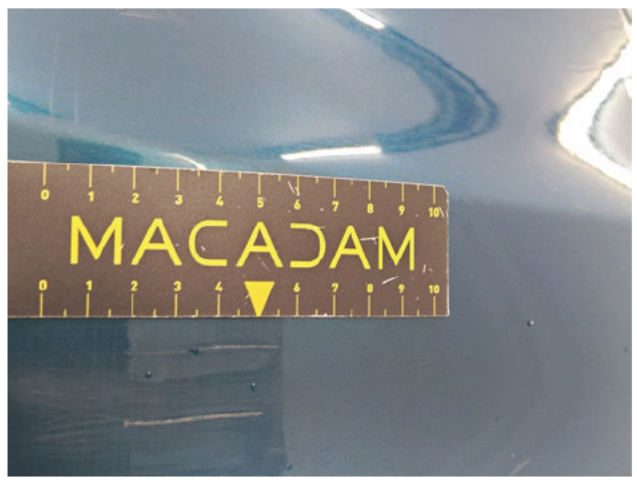
Bumper corner RL
Scratch(es)
Repair and paint (complete)
Rear

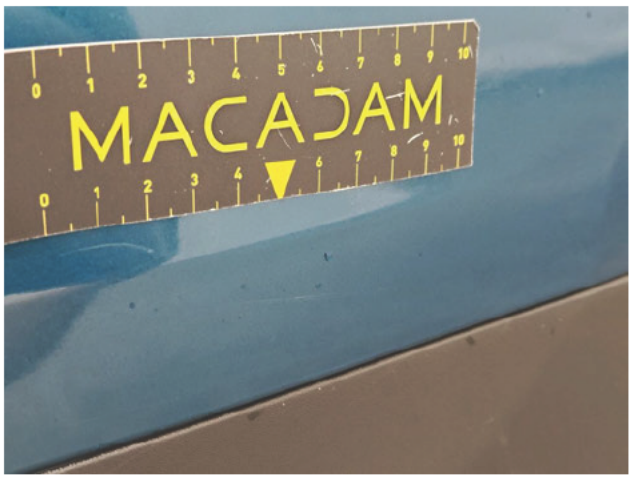
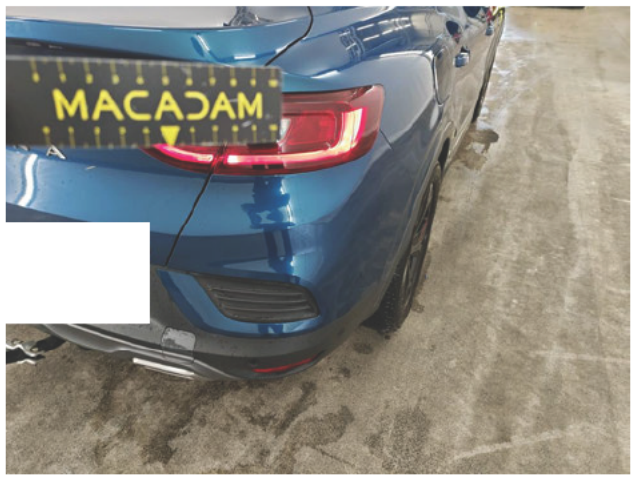
Bumper corner RR

Scratch(es)

Repair and paint (complete)

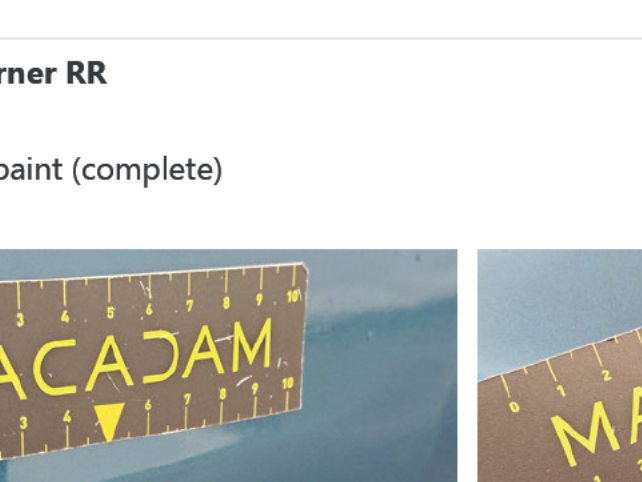
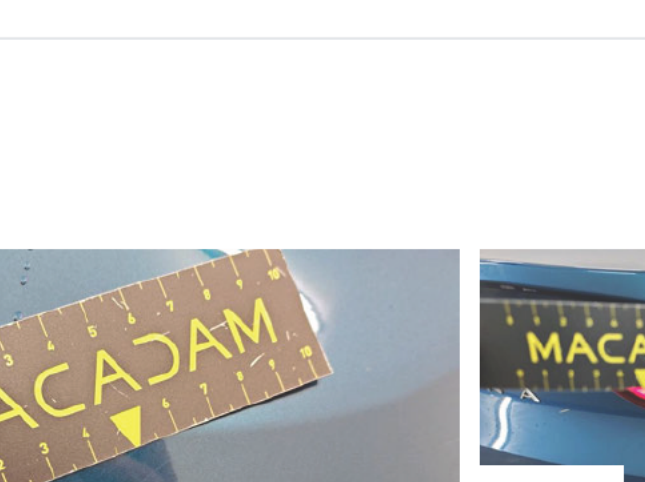
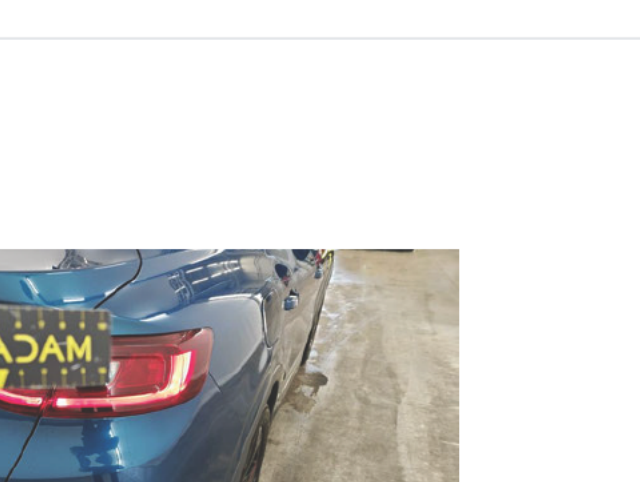
Bumper F

Scratch(es)

Repair and paint (complete)

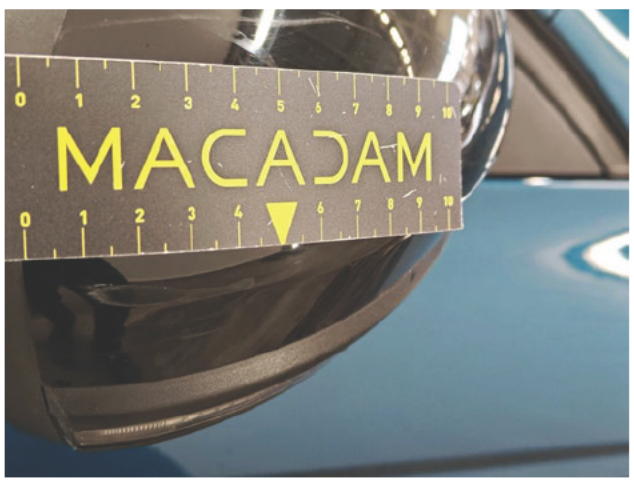
Door RL
Deformed / Strained
Repair and paint (complete)
Left

Outside rear-view mirror housing R
Scratch(es)
Replace and paint
Right

Roof liner
Worn
Replace
Interior

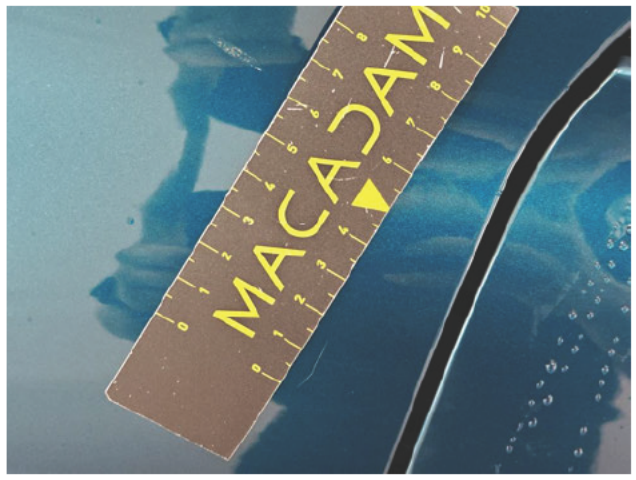
Roof pillar L
Scratch(es)
Repair and paint (complete)
Left

Shutter / cover
Broken
Replace
Interior

Wing FL
Scratch(es)
Repair and paint (complete)
Left

Wing FR
Scratch(es)
Repair and paint (complete)
Right

Wing RL
Scratch(es)
Repair and paint (complete)
Left

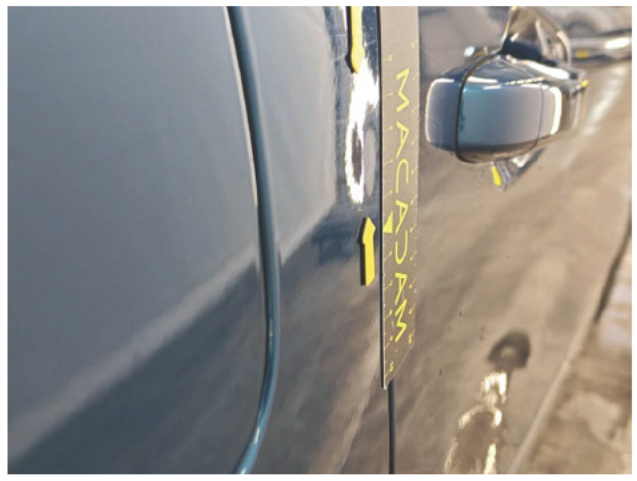
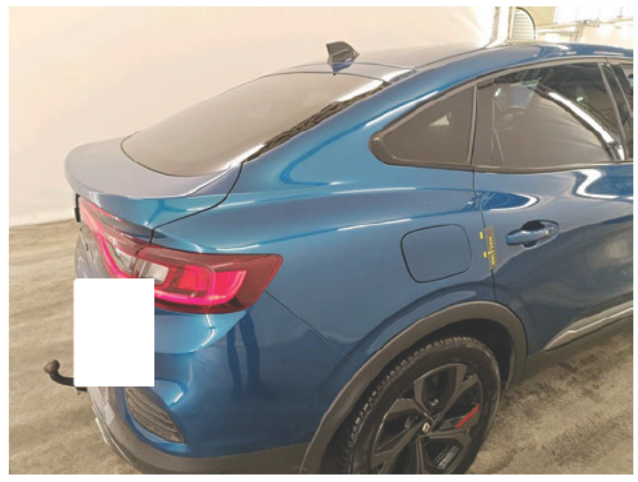
Wing RR

Dent(s) and scratch(es)

Repair and paint (complete)
