Expertise

Protocol number: 48524641
Order No. / Reference: 27248915
Inspection date: 4 Nov 2026

Manufacturer: Volkswagen	Model: Passat Variant 2.0 TDI SCR DSG Business
VIN: WVWZZZ3CZPE061198

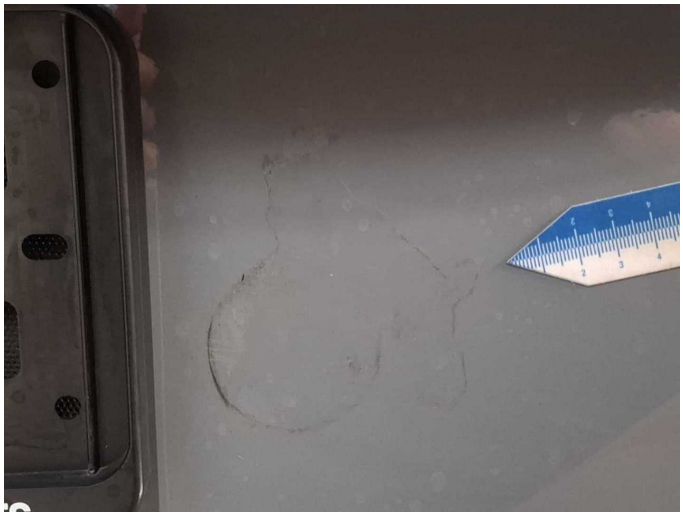
Damage 1: Boot lid / rear door: Boot lid (Klebereste) - Glued / labelled - De-glue / neutralise

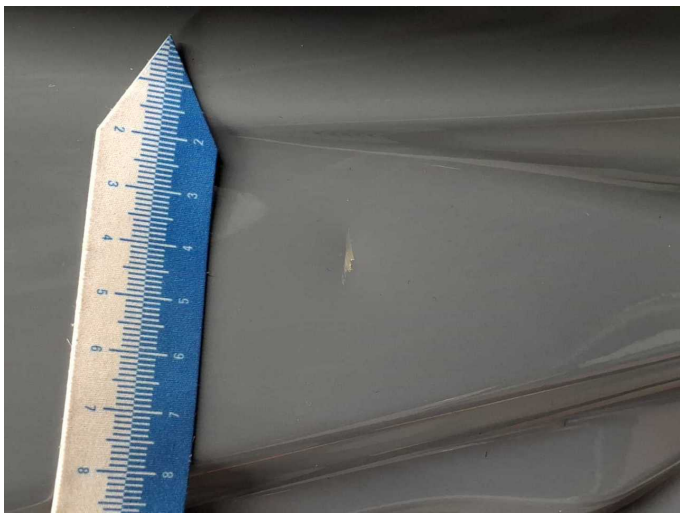
No.	Component group	Description
1	Boot lid / rear door	Boot lid (Klebereste) - Glued / labelled - De-glue / neutralise
2	Side panel - rear right side	Sill - dent(s) - Smart repair
3	Front bumper	Front bumper - Scratched - Smart repair
4	Body	Body - Damage by hail - repair according to calculation

Damage 2: Side panel - rear right side: Sill - dent(s) - Smart repair

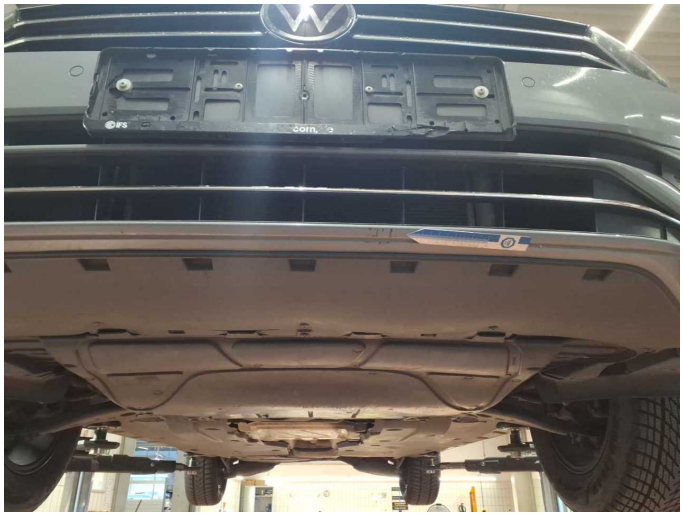
Damage 3: Front bumper: Front bumper - Scratched - Smart repair

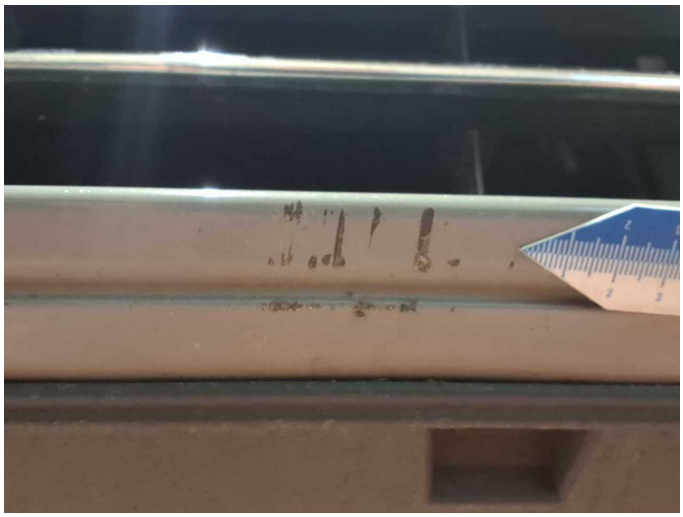
Damage 3: Front bumper: Front bumper - Scratched - Smart repair

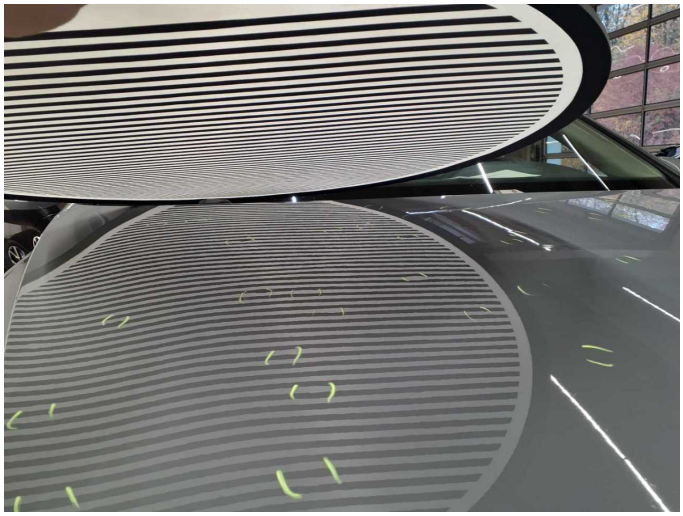
Die beigefügte Reparaturkostenkalkulation wurde nach bestem Wissen und Gewissen im demontagefreien Zustand erstellt. Es können Mehrkosten und somit Abweichung der für den Hagelschaden ausgewiesener Reparaturkosten nicht ausgeschlossen werden.

Damage 4: Body: Body - Damage by hail - repair according to calculation

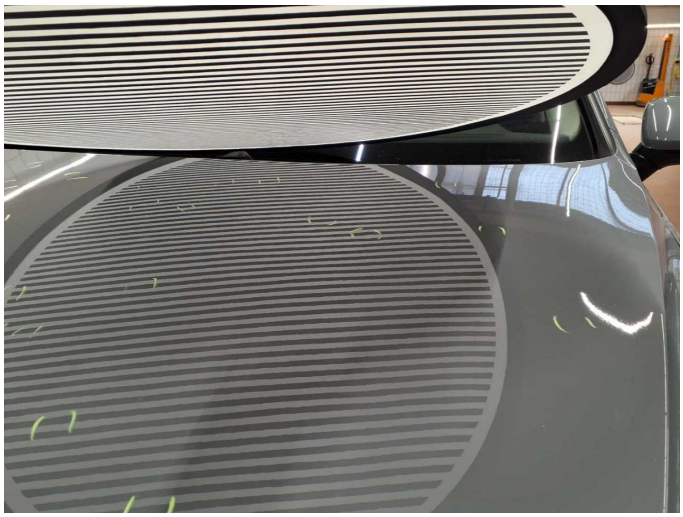
Damage 4: Body: Body - Damage by hail - repair according to calculation

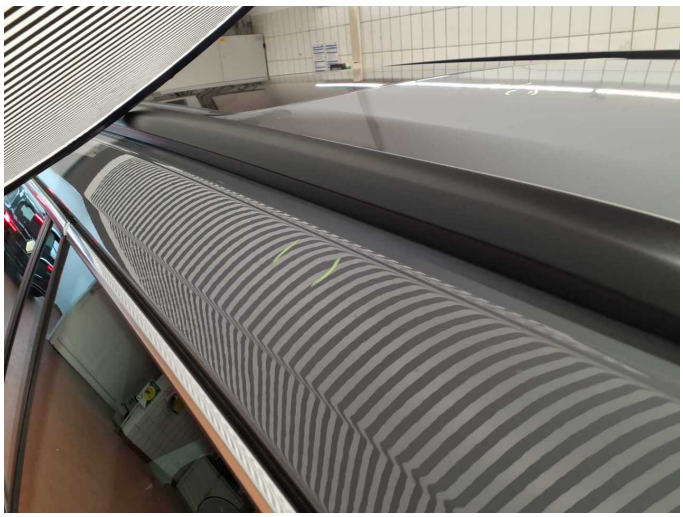
Damage 4: Body: Body - Damage by hail - repair according to calculation

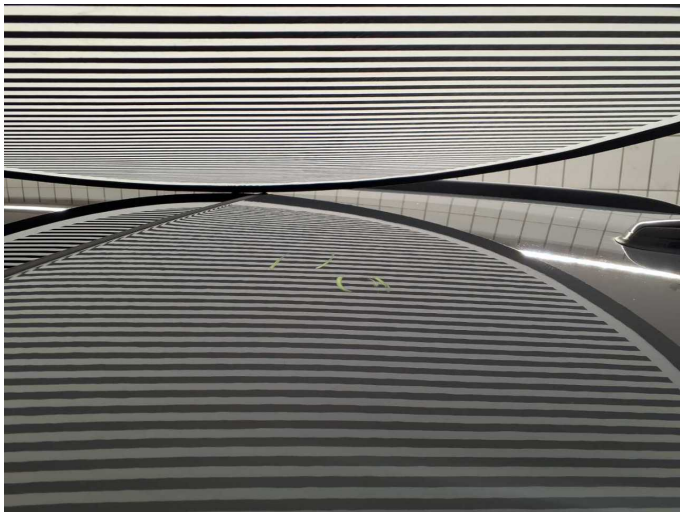
Damage 4: Body: Body - Damage by hail - repair according to calculation

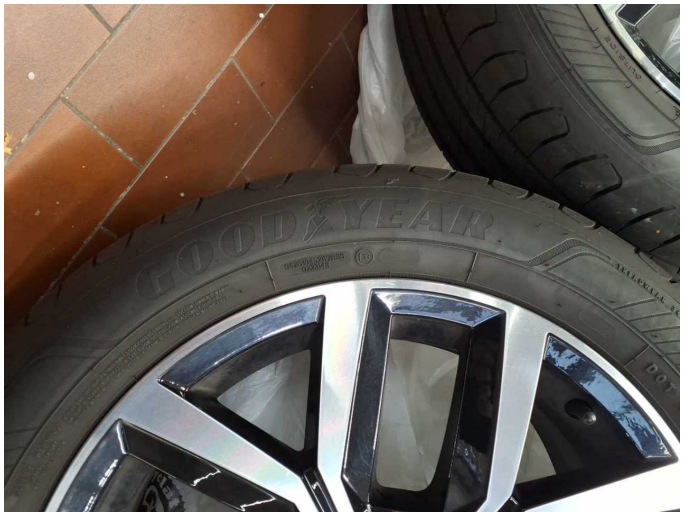
Wear and tear 4: 2nd wheel set: 3 tyres (Fehlende Notlaufeigenschaften) - Differs from the original configuration - No deduction
