TÜV SÜD Auto Partner GmbH
Wiesenring 2
04159 Leipzig

Expertise

Protocol number: 48185320
Order No. / Reference: 27092401
Inspection date: 12 Oct 2026

Manufacturer: Volkswagen	Model: Tiguan 1.4 eHybrid OPF DSG Elegance
VIN: WVGZZZ5NZNW409738

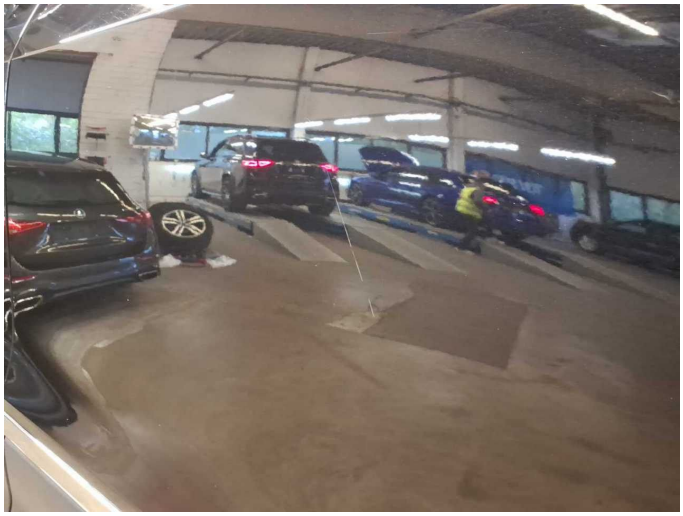
No.	Component group	Description
1	Door - rear right side	Door - Dent / paintcoat damage - Smart repair
2	Door - rear left side	Door - Scratch(es) - Paint
3	Door - front right side	Door - Scratch(es) - Paint

Damage 1: Door - rear right side: Door - Dent / paintcoat damage - Smart repair
