Expertise

Protocol number: 48377666
Order No. / Reference: 27174952
Inspection date: 27 Oct 2026

Manufacturer: Mercedes-Benz	Model: Vito 116 CDI Extralang HA BASE
VIN: W1V44760513950257

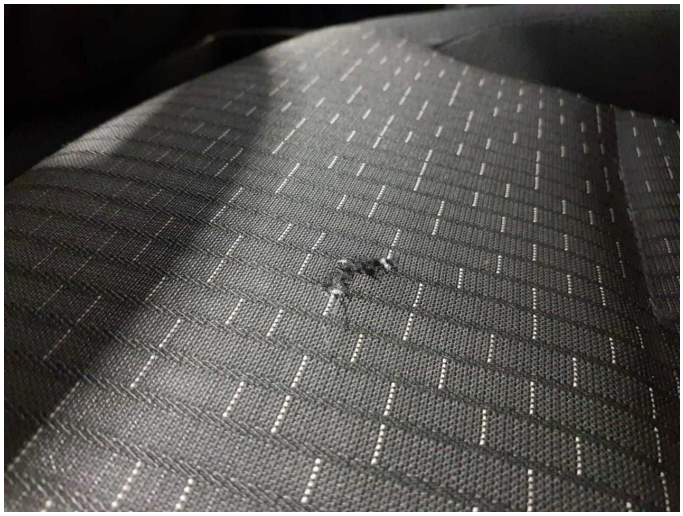
Damage 4: Seat - front: Seat cover - left side - Broken / torn - Replace

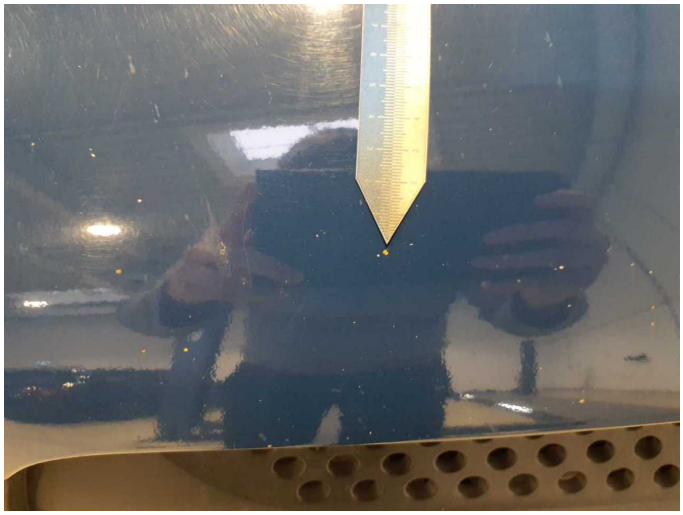
Damage 4: Seat - front: Seat cover - left side - Broken / torn - Replace

Damage 5: Bonnet: Bonnet - Corrosion - Repair and paint

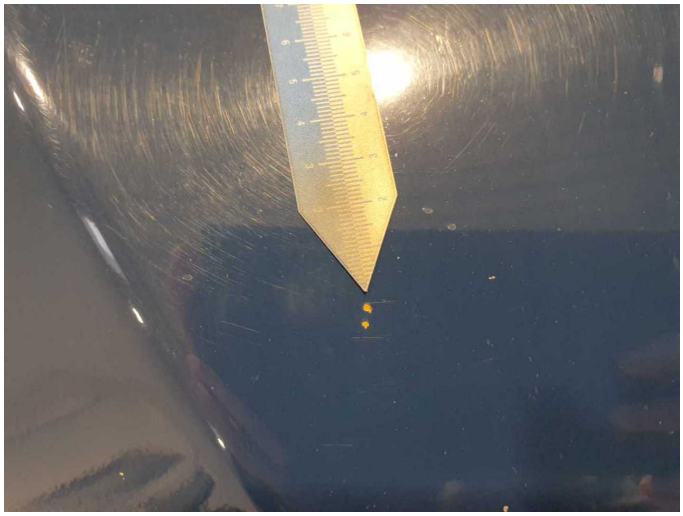
Damage 5: Bonnet: Bonnet - Corrosion - Repair and paint

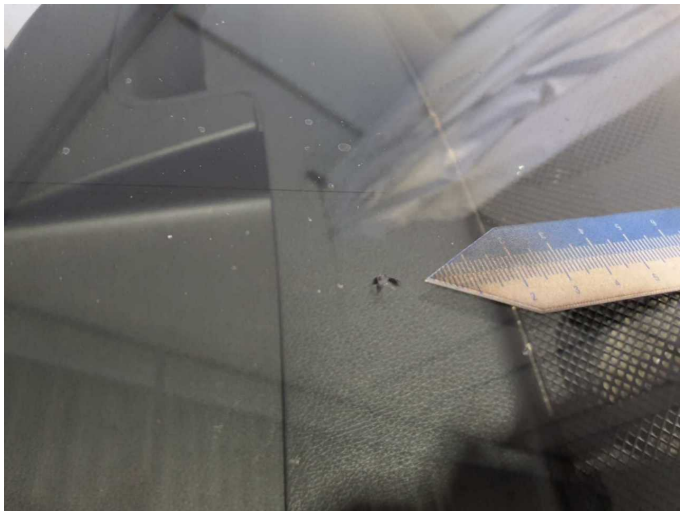
Damage 6: Vehicle glazing: Windscreen - Broken / torn - Replace
