Expertise

Protocol number: 48218340
Order No. / Reference: 27119681
Inspection date: 19 Oct 2026

Manufacturer: Volkswagen	Model: Passat Variant 2.0 TDI SCR DSG Business
VIN: WVWZZZ3CZPE076543

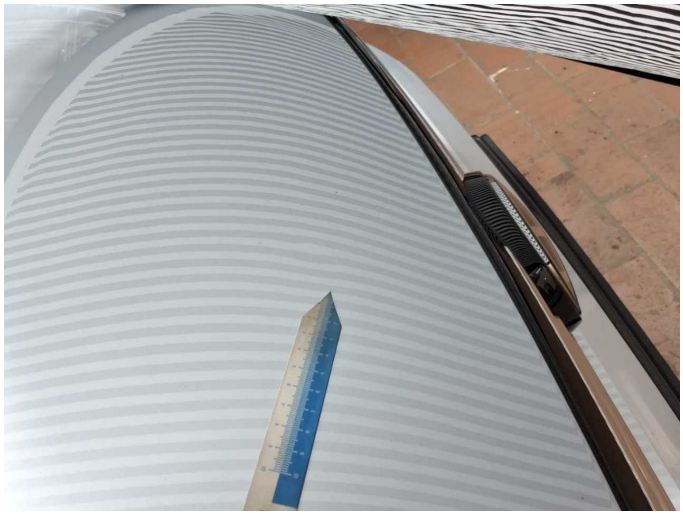
Damage 5: Bonnet: Bonnet - Dent / paintcoat damage - Paint

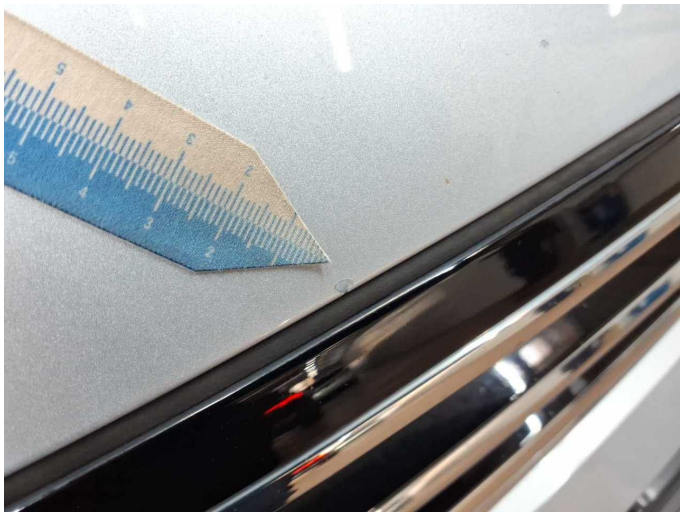
Damage 5: Bonnet: Bonnet - Dent / paintcoat damage - Paint

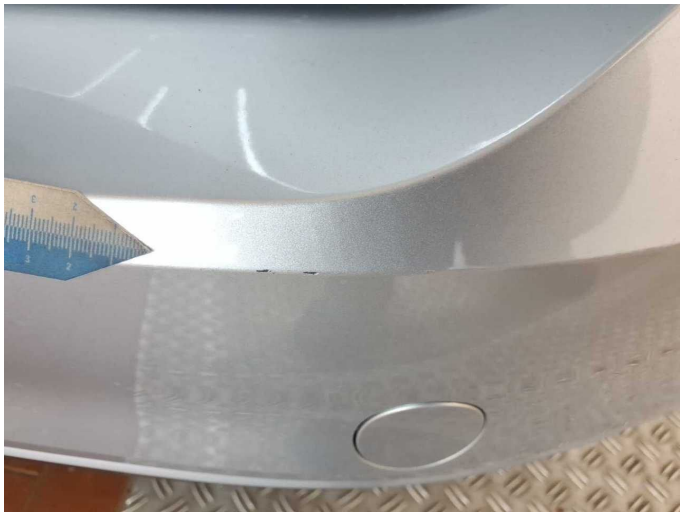
Damage 6: Rear bumper: Rear bumper - Deformed - Repair and paint
