Expertise

Protocol number: 48016319
Order No. / Reference: 27130772
Inspection date: 7 Oct 2026

Manufacturer: Skoda	Model: Octavia Combi 2.0 TDI DSG Style
VIN: TMBJG8NX1PY163448

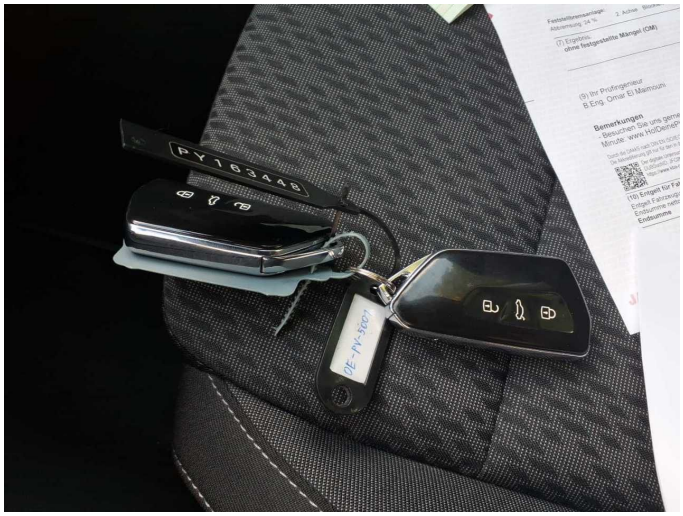
Damage 1: Trim / covers: Floor mats - Broken / torn - Replace

Damage 2: Equipment: Vehicle key with remote control (2. Batterie leer) - Empty - Replace

Damage 3: Boot lid / rear door: Boot lid - Glued / labelled - De-glue / neutralise

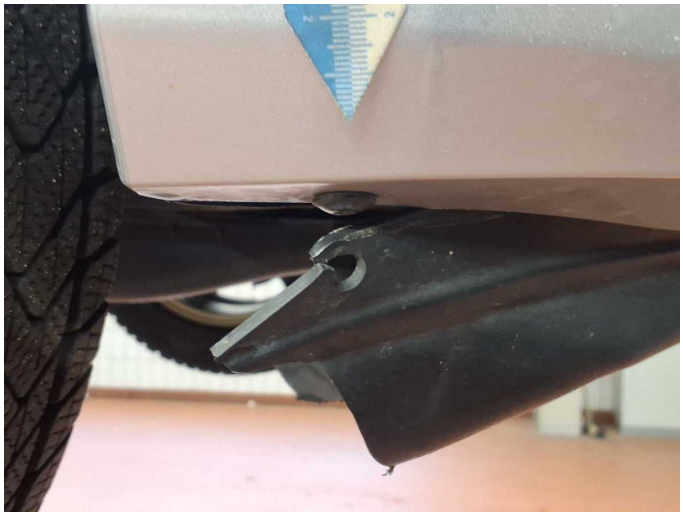
Damage 3: Boot lid / rear door: Boot lid - Glued / labelled - De-glue / neutralise

Damage 4: Body: Underbody panelling (VR) - Broken / torn - Replace

Damage 5: 2nd wheel set: 1 alloy rim (Optischer Mangel) - Scratched - Loss in value

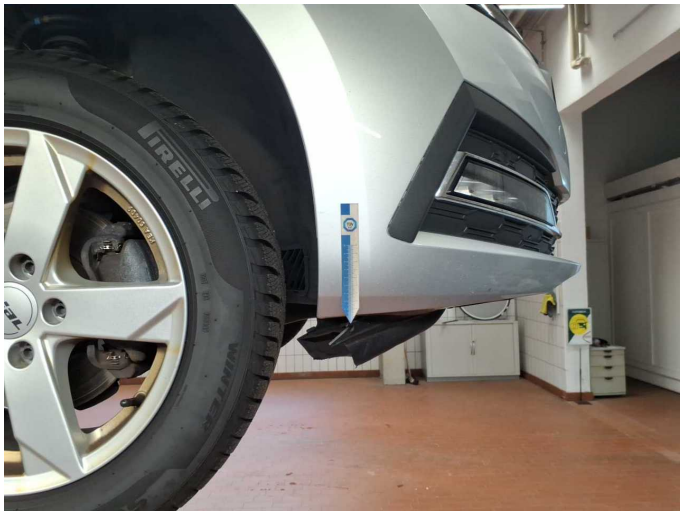
Damage 6: Body: Underbody (Konnte nicht besichtigt werden) - Specify findings - Diagnosed and repair if necessary

Damage 7: Interior: Boot cover / roller cover - Damaged - Replace

Damage 8: 2nd wheel set: 2 tyres (Fremdkörper und platt) - Damaged - Replace

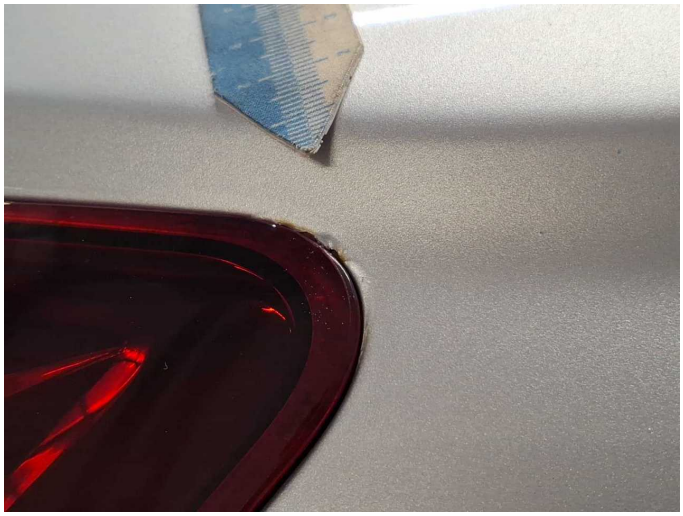
Damage 8: 2nd wheel set: 2 tyres (Fremdkörper und platt) - Damaged - Replace

Damage 9: Side panel - rear right side: Side panel - Unprofessionally repaired - Repair and paint

Accident 1: Front

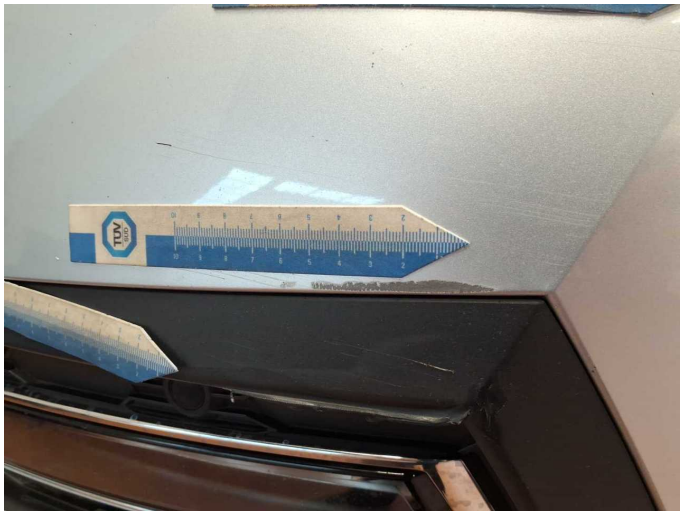
Accident 1: Front

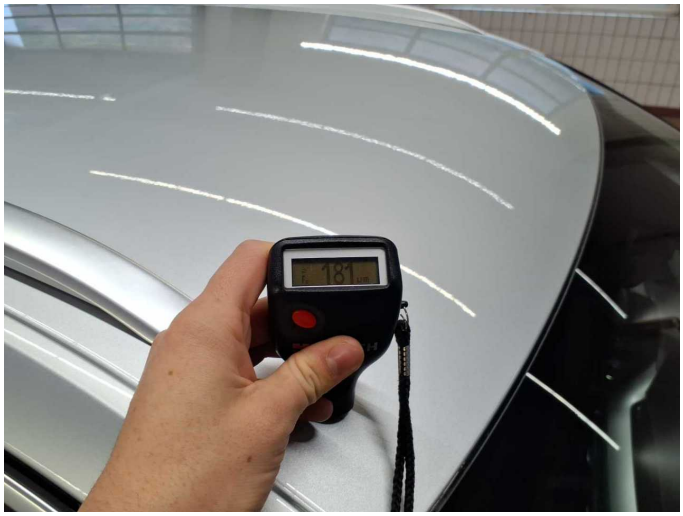
Roof	181 µm	Boot lid / rear door	194 µm
Bonnet	271 µm	Side panel - rear right side	1,460 µm
Door - rear right side	224 µm

Accident 1: Front

Repainting 1: Roof

Repainting 2: Boot lid / rear door

Repainting 3: Bonnet

Repainting 4: Side panel - rear right side

Repainting 5: Door - rear right side
