TÜV SÜD Auto Partner GmbH
Wiesenring 2
04159 Leipzig

Expertise

Protocol number: 48249677
Order No. / Reference: 27156781
Inspection date: 20 Oct 2026

Manufacturer: Mercedes-Benz	Model: A 180 d 8G-DCT Entry
VIN: W1K3F1AB1SJ459039

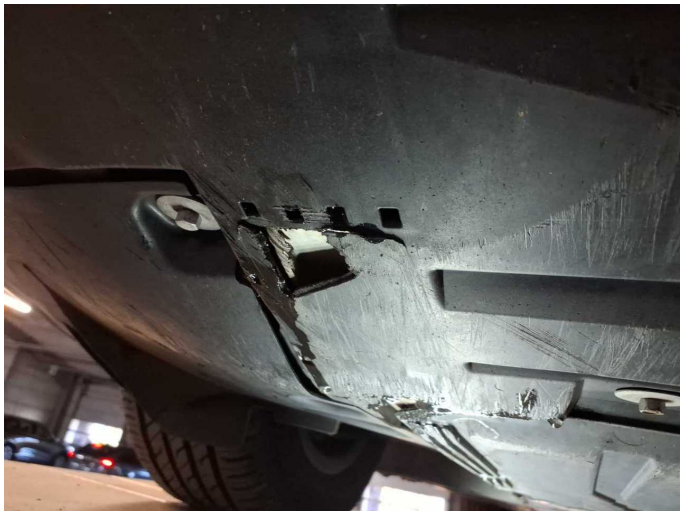
Damage 1: Engine: Engine cowling - lower - Broken / torn - Replace

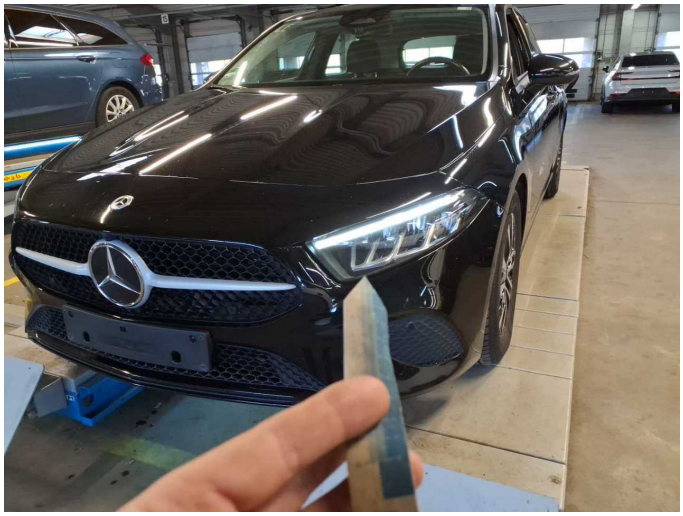
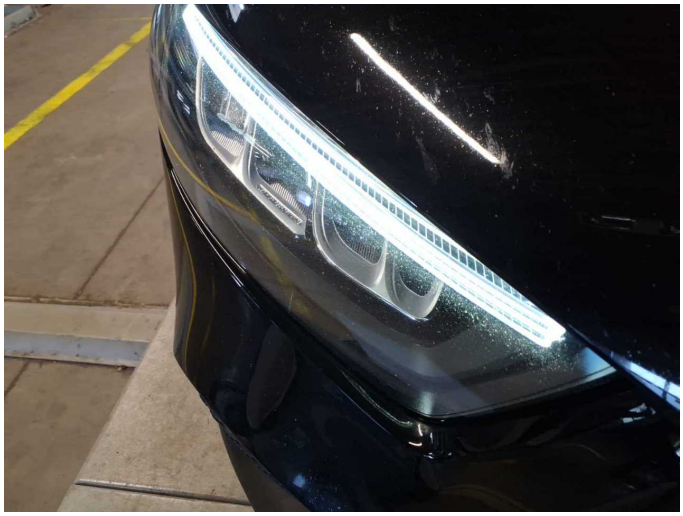
Damage 2: Headlight: Headlight - left side (+ Rechts) - Stone chips - Loss in value

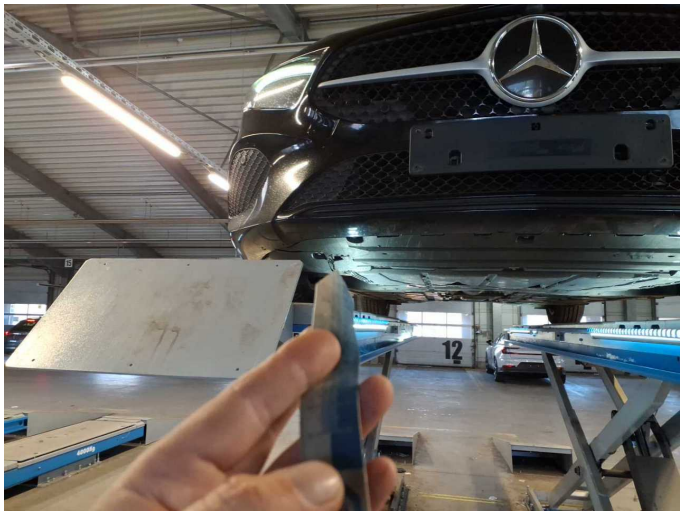
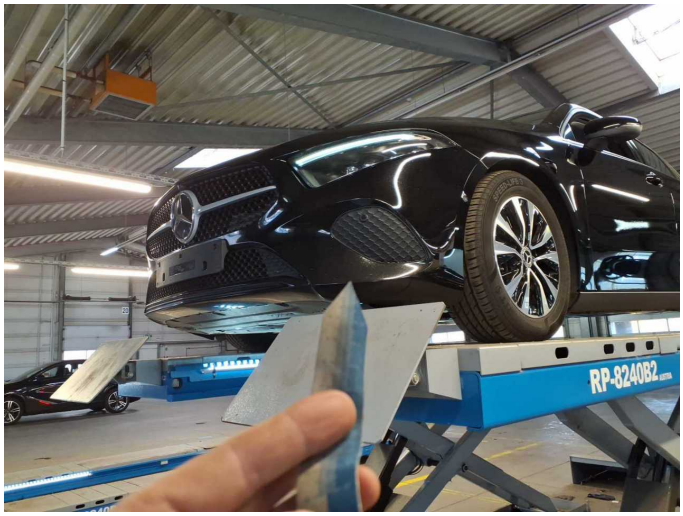
Damage 3: Misc.: Misc. (Aluträger unterhalb) - Scratched - Replace

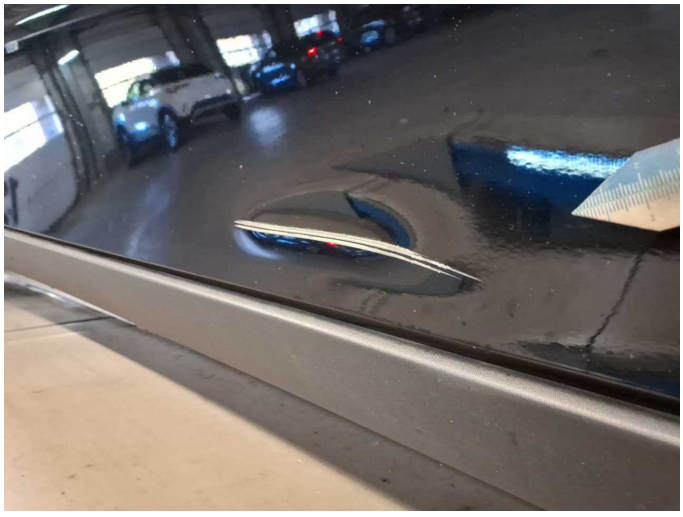
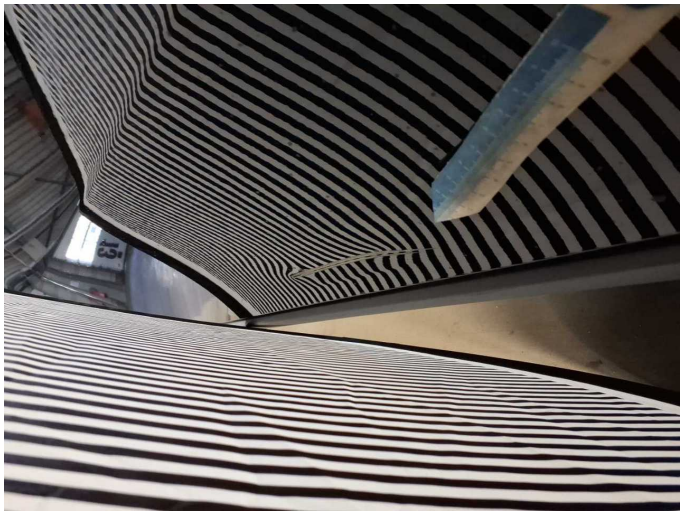
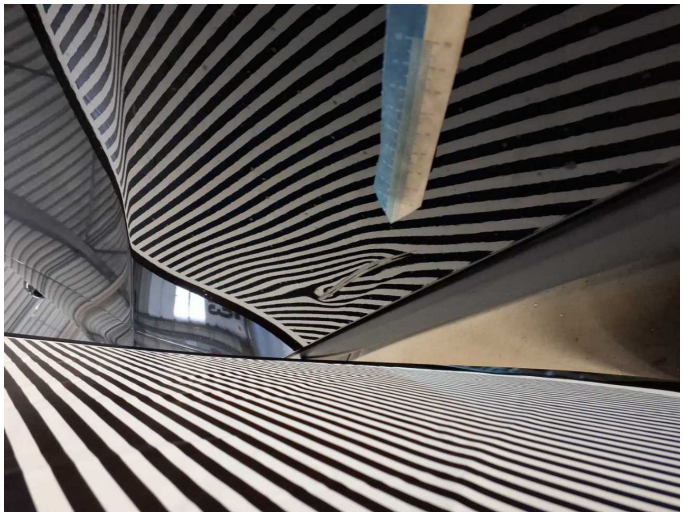
Damage 5: Door - front right side: Door - Dent / paintcoat damage - Repair and paint

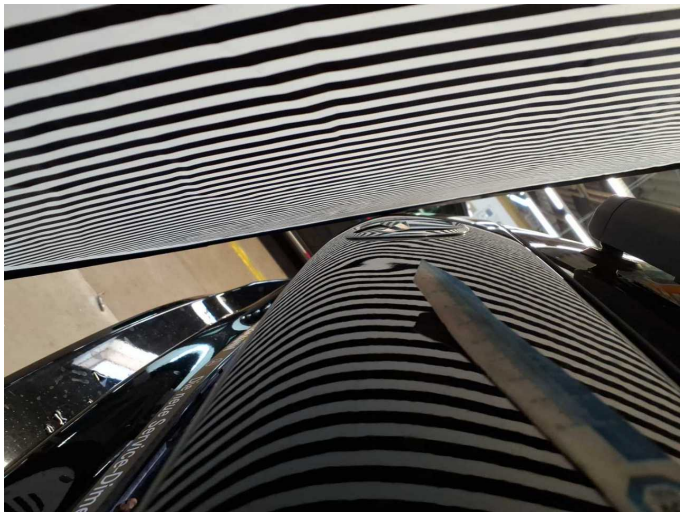
Damage 6: Bonnet: Bonnet (Sandstrahleffekt) - Stone chips - Paint
