Expertise

Protocol number: 48509530
Order No. / Reference: 27198740
Inspection date: 29 Oct 2026

Manufacturer: Opel	Model: Mokka 1.2 DI Turbo Automatik Elegance
VIN: VXKUSHNSSNW043160

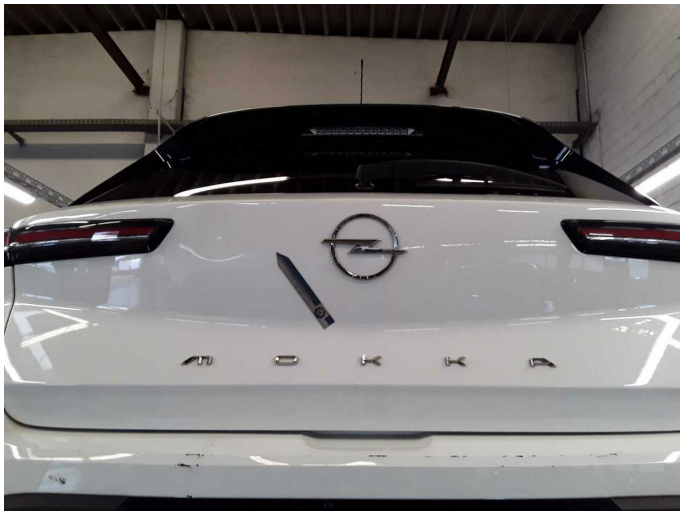
Accident 2: Rear

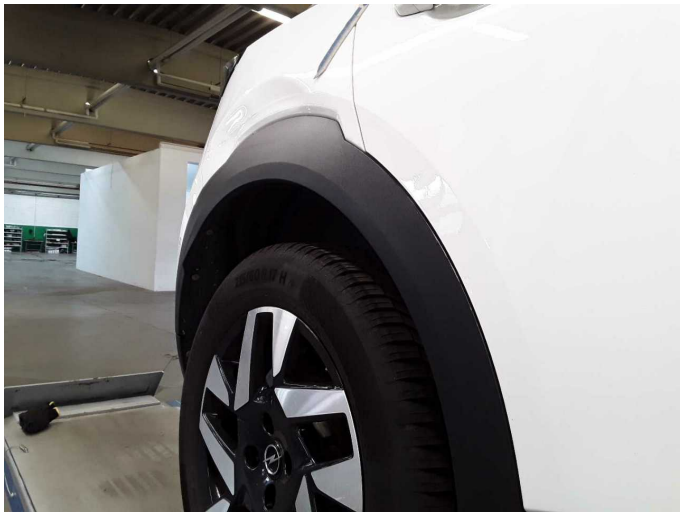
Accident 3: Side right
