# Expertise

Protocol number: 48473261
Order No. / Reference: 27252799
Inspection date: 2 Nov 2026

| Manufacturer: Volkswagen | Model: Tiguan 1.4 eHybrid OPF DSG Elegance |
| VIN: WVGZZZ5NZNW407312 | |

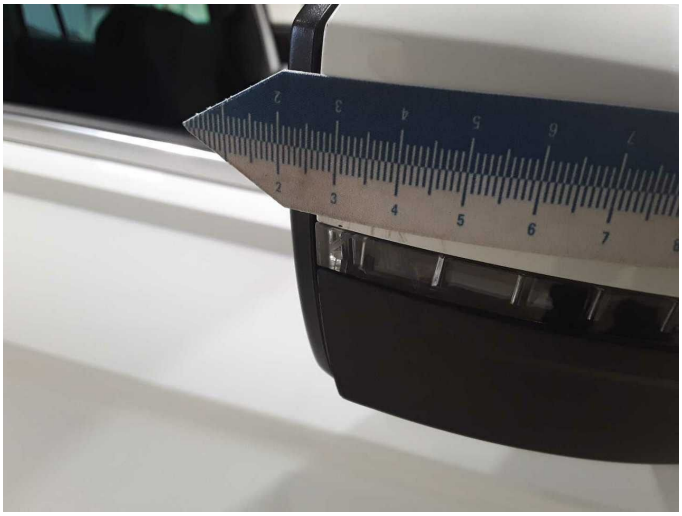
| No. | Component group | Description |
|---|---|---|
| 3 | Indicator - front | Mirror - right side - Scratch(es) - Replace |

**Damage 3:** Indicator - front: Mirror - right side - Scratch(es) - Replace
