Ford Mustang '19 BEV

Vehicle information

Make:	**Ford**	License:	**N157DL**
Gearbox:	**Automatic**	Body color:	
Model:	**Mustang '19 BEV**	VIN:	**WF0TK1EMXMMA22319**
Fuel type:	**Electric**	Power:	**198 kW**
Version:	**Mustang EV 75kWh RWD St.Ran.**	First registration	**27/09/2021**
Mileage:	**94433 km**	N° of doors:

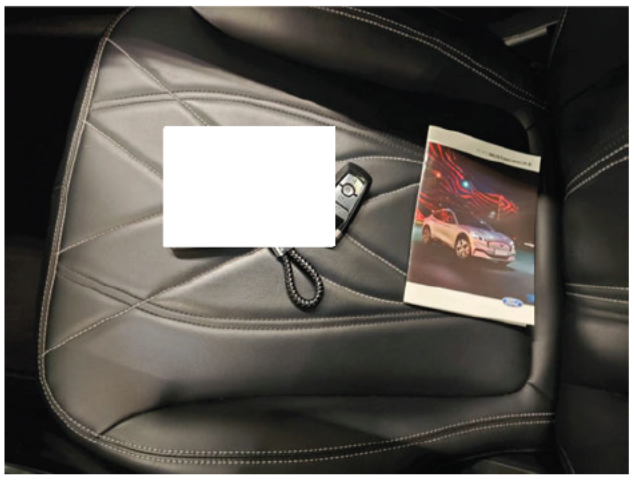
Rijbereik
322 km
Veiligheids-
gordels
OK
km/h
0
P
R
N
D
L
READY
94433.0km

Batterijcertificaat
Datum van diagnose: 01/10/2026
94,5%
Status van de gezondheid (SOH)*
Ford Mustang MACH e
Standard Range
VIN : WF0TK1EMXMMA22319
Kilometerstand : 94.433 km
*SOH berekend op basis van fabrieksgegevens, informatie om rekening mee te houden voor de fabrieksgarantie
Raadpleeg het Moba-certificaat door deze QR-code te scannen
Meer weten over:
www.get-moba.com
CARA
