TÜV SÜD Auto Partner GmbH
Wiesenring 2
04159 Leipzig

# Expertise

Protocol number: 48118789
Order No. / Reference: 27085450
Inspection date: 15 Oct 2026

| Manufacturer: Skoda | Model: Kodiaq 2.0 TSI 4x4 DSG L&K |

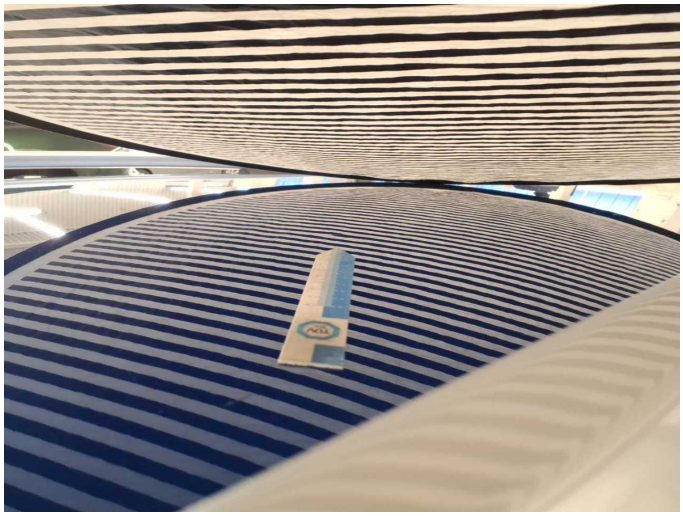
| No. | Component group | Description |
|---|---|---|
| 2 | Roof | Roof - dent(s) - Smart repair |

**Damage 2:** Roof: Roof - dent(s) - Smart repair
