Expertise

Protocol number: 48151248
Order No. / Reference: 27014751
Inspection date: 24 Sept 2026

Manufacturer: Volvo	Model: XC60 B4 D Geartronic RDesign
VIN: YV1UZK5VDM1845421

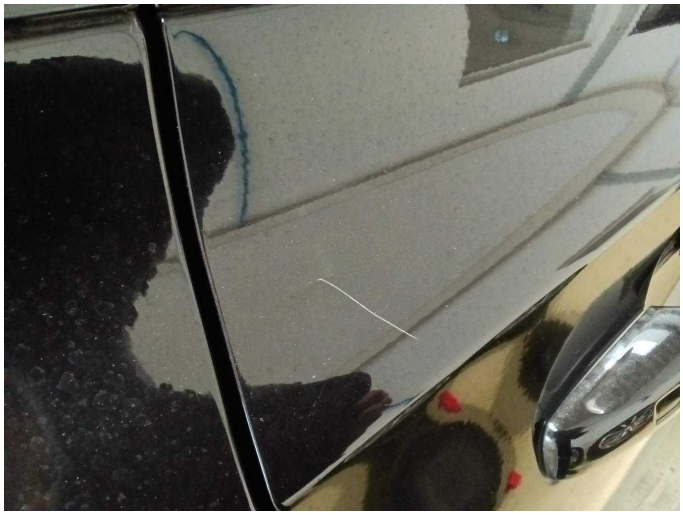
Damage 1: Mudguard - right side: Mudguard - right side - Scratch(es) - Smart repair

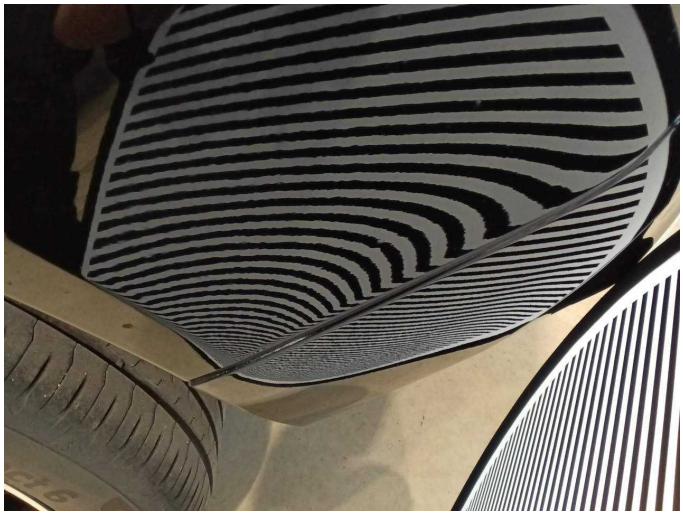
Damage 4: Door - front left side: Door - Dent / paintcoat damage - Repair and paint
