TÜV SÜD Auto Partner GmbH
Wiesenring 2
04159 Leipzig

Expertise

Protocol number: 48237417
Order No. / Reference: 27056799
Inspection date: 20 Oct 2026

Manufacturer: Volkswagen	Model: Tiguan Allspace 2.0 TDI SCR DSG Life
VIN: WVGZZZ5N1PM142295

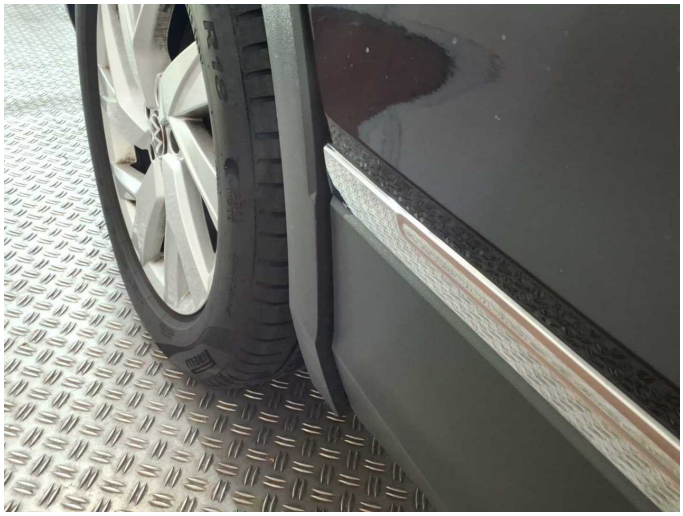
Damage 3: Side panel - rear right side: Wheel well extension (+ lose) - Scratched - Replace

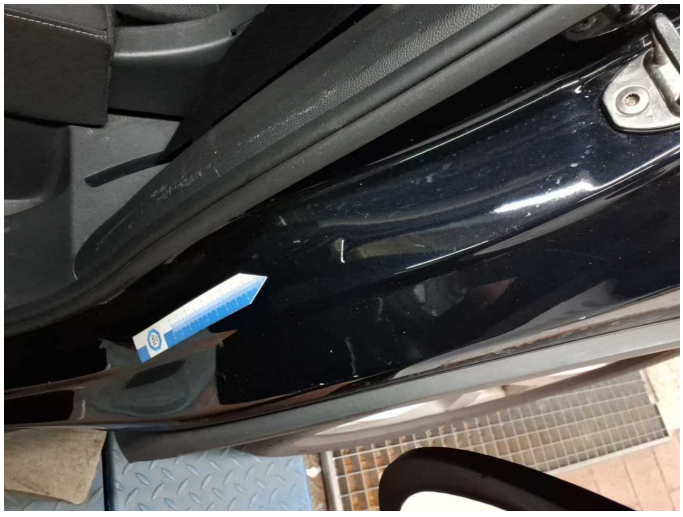
Damage 4: Side panel - rear left side: Sill (+ Kratzer) - Dent / paintcoat damage - Repair and paint

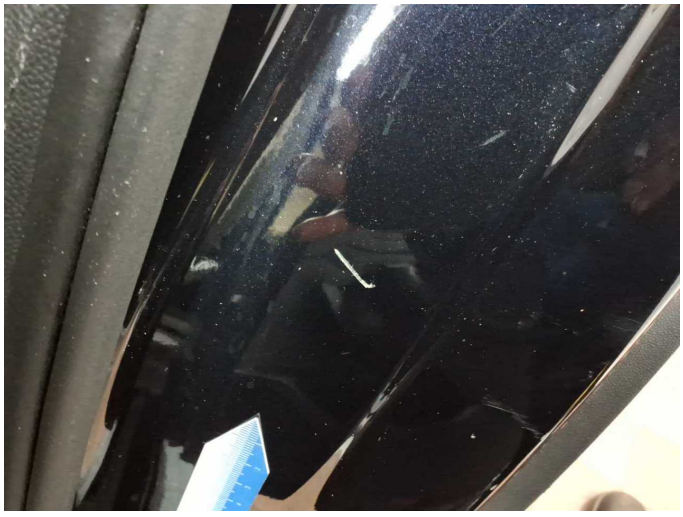
Damage 4: Side panel - rear left side: Sill (+ Kratzer) - Dent / paintcoat damage - Repair and paint

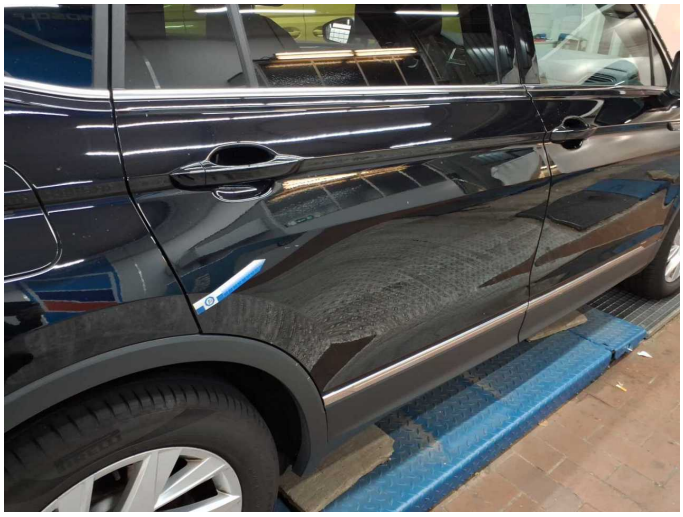
Damage 4: Side panel - rear left side: Sill (+ Kratzer) - Dent / paintcoat damage - Repair and paint

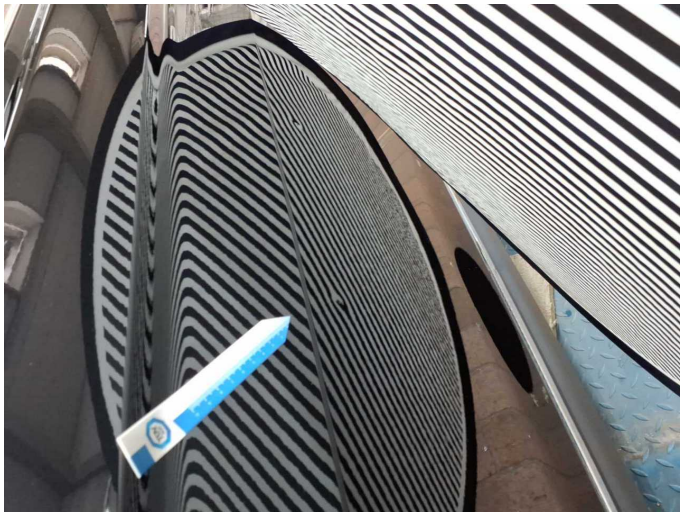
Damage 7: Door - rear left side: Door - Dent / paintcoat damage - Repair and paint

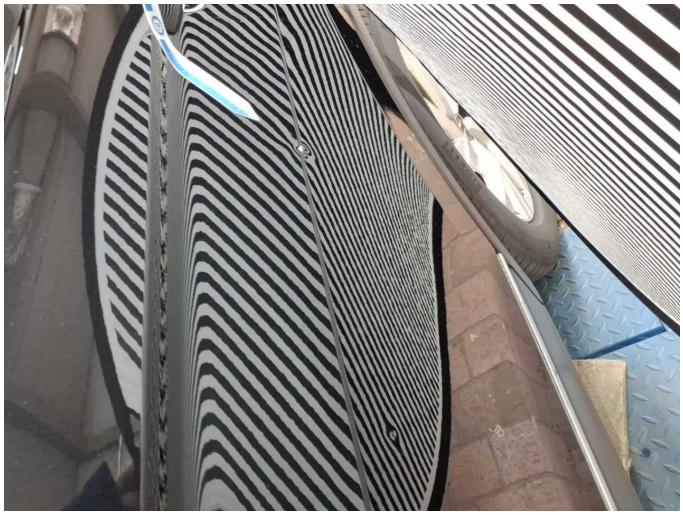
Damage 7: Door - rear left side: Door - Dent / paintcoat damage - Repair and paint
