Expertise

Protocol number: 47274686
Order No. / Reference: 26868047
Inspection date: 27 Aug 2026

Manufacturer: Skoda	Model: Kodiaq 2.0 TDI 4x4 DSG Style
VIN: TMBLJ7NS5N8029242

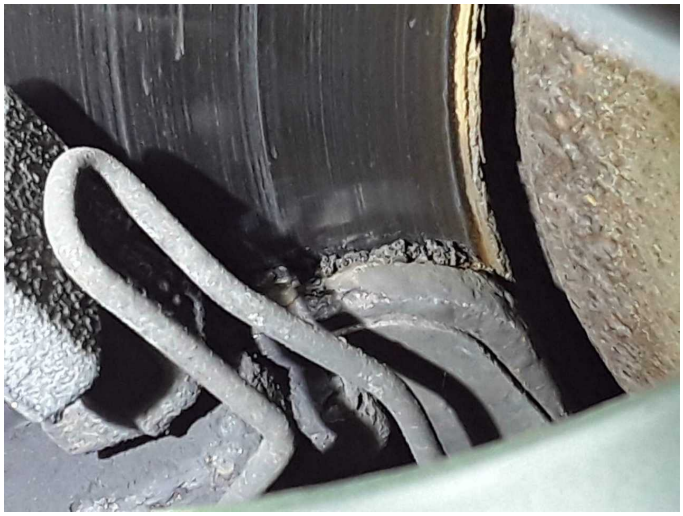
Damage 4: Braking system: Brake discs and pads - rear - Worn - Replace

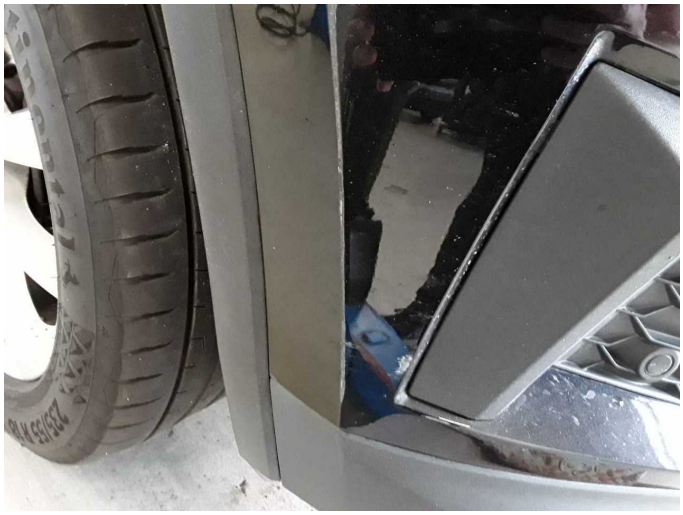
Damage 5: Front bumper: Front bumper - Scratch(es) - Paint
