TÜV SÜD Auto Partner GmbH
Wiesenring 2
04159 Leipzig

Expertise

Protocol number: 48575014
Order No. / Reference: 27235803
Inspection date: 6 Nov 2026

Manufacturer: Ford	Model: Focus Turnier 1.5 EcoBlue Start-Stopp-System Aut. TITANIUM
VIN: WF0PXXGCHPNU71903

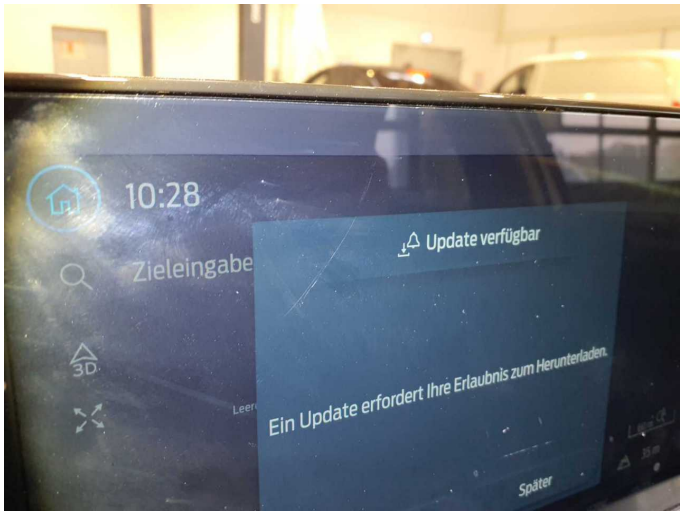
Damage 7: Boot lid / rear door: Boot lid - Dent / paintcoat damage - Smart repair

Damage 8: Multimedia system: Screen - Scratch(es) - Replace

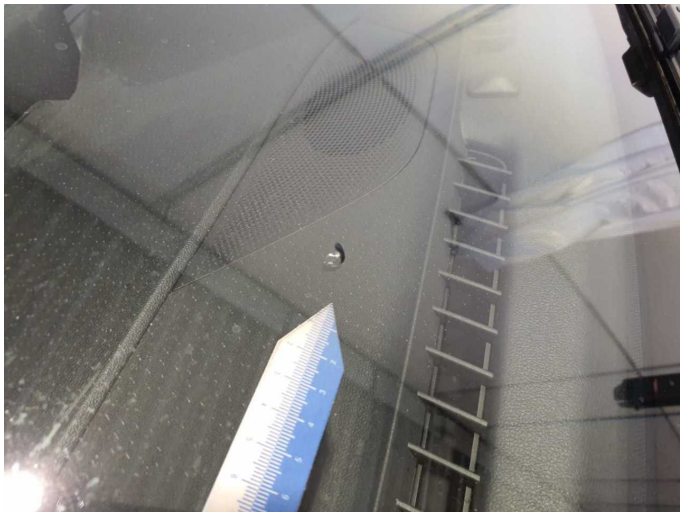
Damage 9: Vehicle glazing: Windscreen - Stone chips - Replace
