MACADAM

TESLA Model Y: 2CMZ470

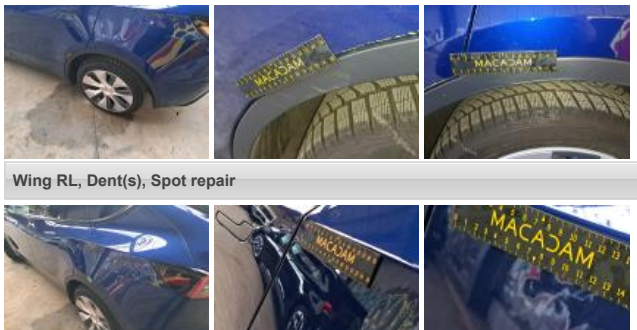
Wing trim RL, Scratch(es), Replace	15,84

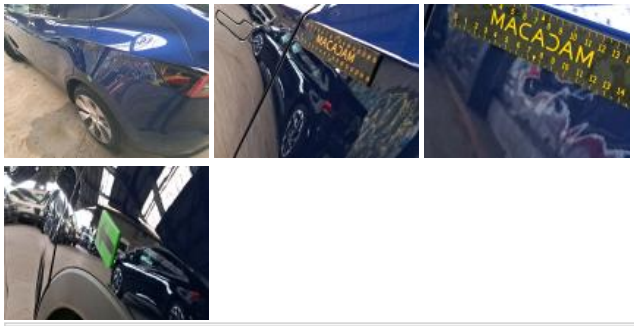
Wing RL, Dent(s), Spot repair	183,21

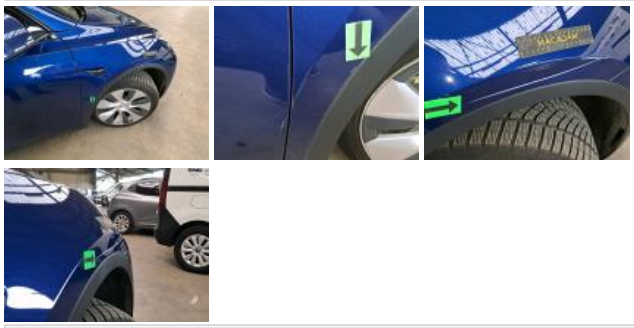
Wing FR, Dent(s) and scratch(es), Repair and paint (complete)	242,20
