Expertise

Protocol number: 48612738
Order No. / Reference: 27249044
Inspection date: 2 Nov 2026

Manufacturer: Mercedes-Benz	Model: 315 CDI Sprinter Lang HA
VIN: W1V9071351N218759

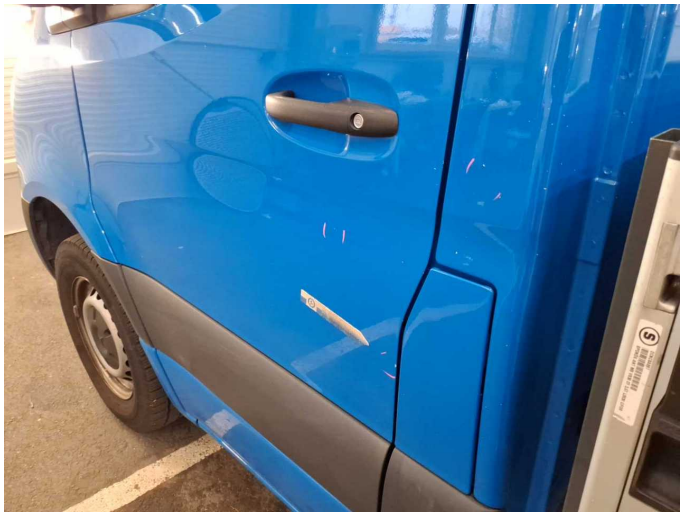
Damage 1: Door - front left side: Door edge - Scratch(es) - Smart repair

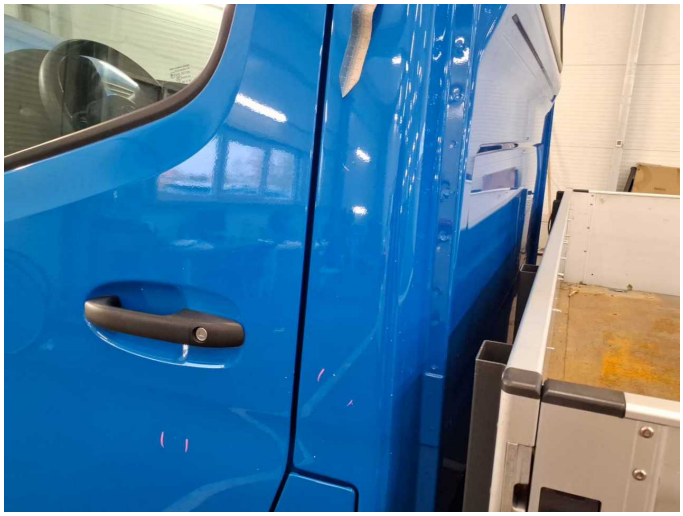
Damage 4: Body: B-pillar - right side - Scratched - Smart repair

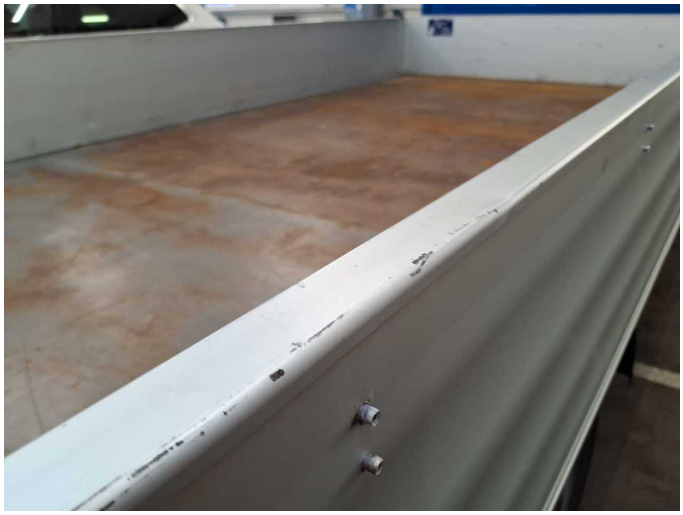
Damage 9: Interior: Cargo area floor (Pritschen Ladeboden & verkratzt/verschürft) - Corrosion - Loss in value

Damage 10: Side panel - rear right side: Side panel (Pritschen Bordwand rechts & verkratzt/verschürft) - Deformed - Loss in value

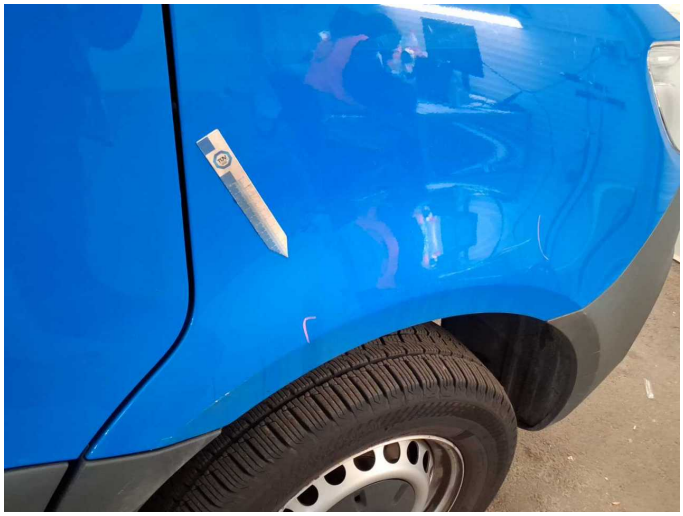
Damage 11: Side panel - rear left side: Side panel (Pritschen Bordwand links & verkratzt/verschürft) - Deformed - Loss in value

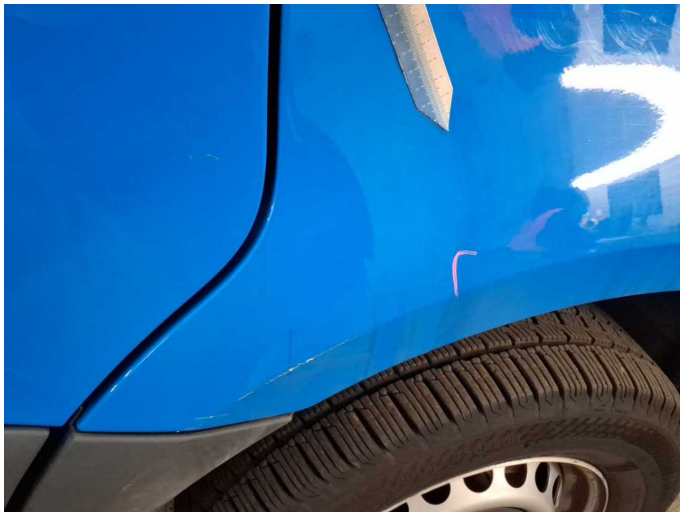
Damage 12: Mudguard - right side: Mudguard - right side - Scratched - Paint

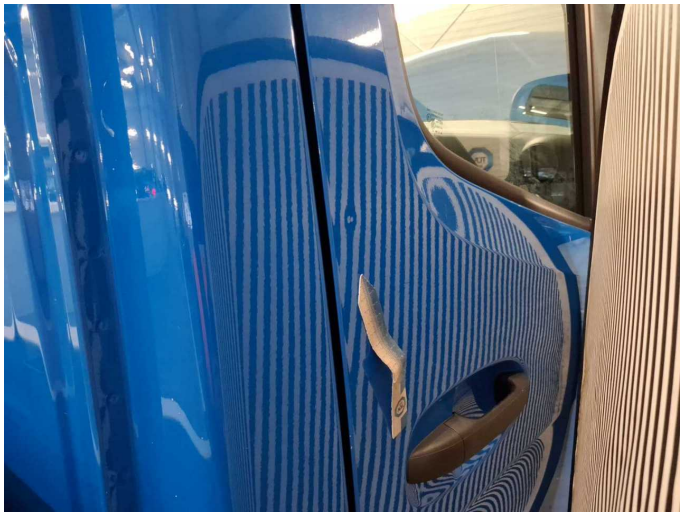
Wear and tear 1: Door - front right side: Door - Scratched - No deduction

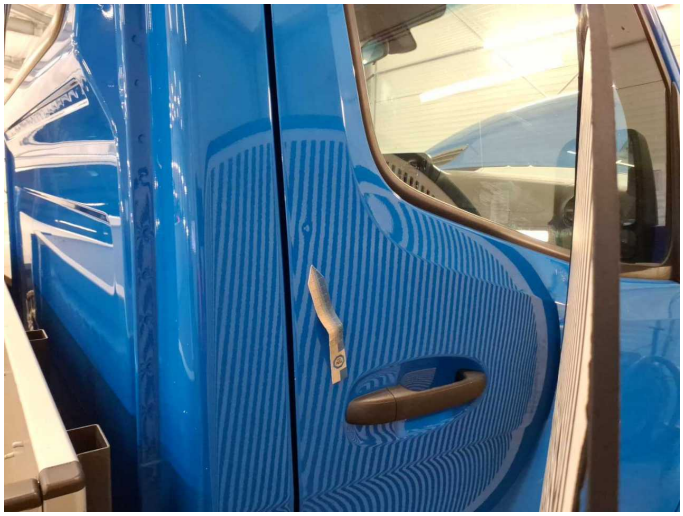
Wear and tear 1: Door - front right side: Door - Scratched - No deduction

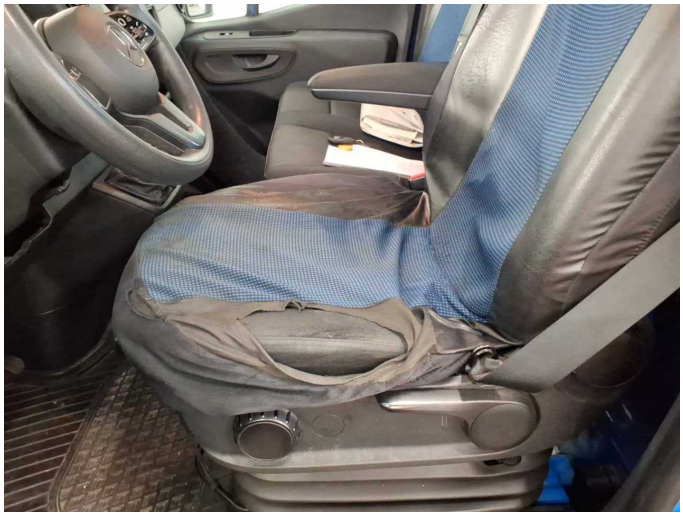
Wear and tear 2: Seat - front: Seat cover - left side (Schonbezug, nicht Bestandteil der Ausstattung) - Damaged - No deduction

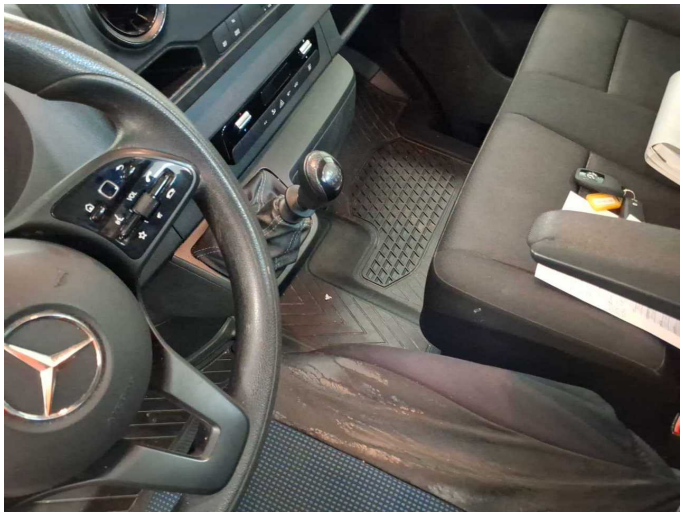
Wear and tear 2: Seat - front: Seat cover - left side (Schonbezug, nicht Bestandteil der Ausstattung) - Damaged - No deduction

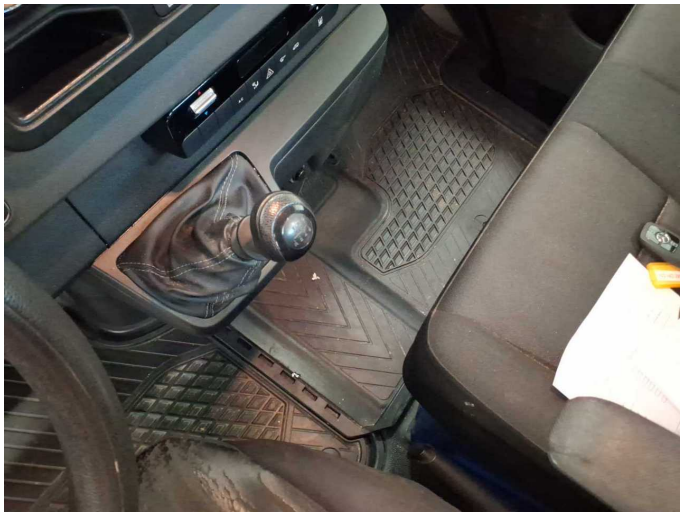
Wear and tear 3: Interior: Interior - Soiled - No deduction
