Audi

VIN: WAUZZZGY5MA086853

Estimated repair cost

Statement details

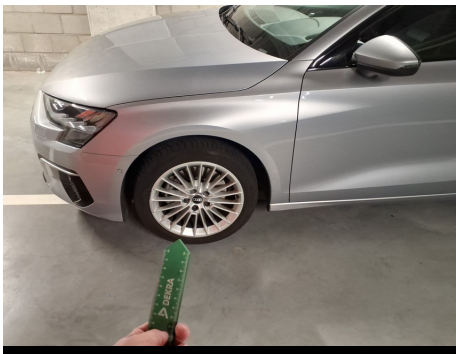
#	Element	Defect	Correction	net cost
001	Rim / Front Right Rim/Tyre diameter : 17 " / Surface : Painted	Scratched	Smart repair	165.00 EUR

002	Rim / Front Left Rim/Tyre diameter : 17 " / Surface : Painted	Scratched	Acceptable	-

003	Rim / Back Left Rim/Tyre diameter : 17 " / Surface : Painted	Scratched	Acceptable	-

004	Rim / Back Right Rim/Tyre diameter : 17 " / Surface : Painted	Scratched	Acceptable	-

005	Bumper / Front Painted : Yes	Scratched	Painting	269.50 EUR

Rim / Front Right / Scratched

Rim / Front Left / Scratched

Rim / Back Left / Scratched

Rim / Back Right / Scratched

Bumper / Front / Scratched

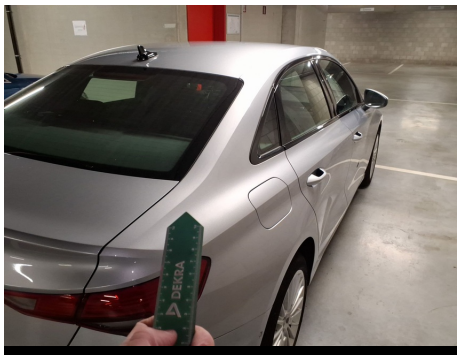
006	Roof post A/B/C / Back Right	Scratched	Polishing	37.50 EUR

007	Roof / -	Scratched	Acceptable	-

Bumper / Front / Scratched

Roof post A/B/C / Back Right / Scratched

Roof / - / Scratched
