TÜV SÜD Auto Partner GmbH
Wiesenring 2
04159 Leipzig

Expertise

Protocol number: 48071379
Order No. / Reference: 26745695
Inspection date: 12 Oct 2026

Manufacturer: Audi	Model: A4 Avant 35 TDI S tronic
VIN: WAUZZZF47PA068969

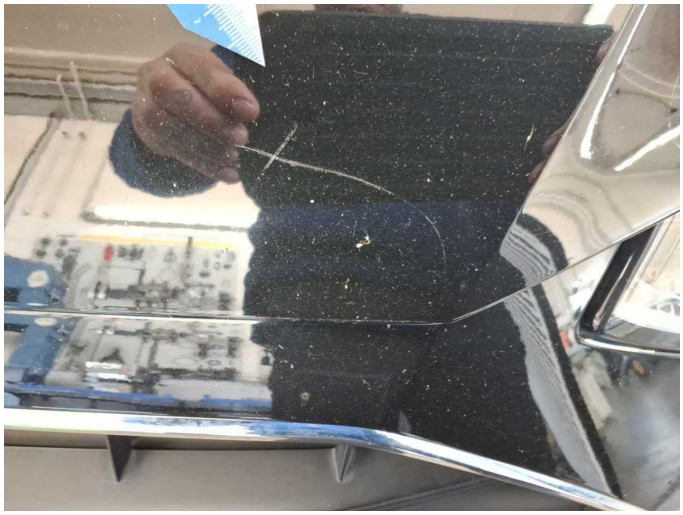
Damage 4: Bonnet: Bonnet (+Steinschläge) - Scratch(es) - Paint

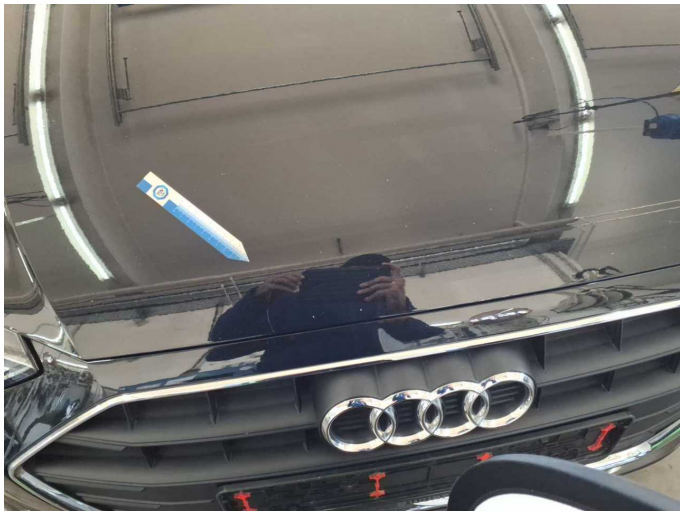
Damage 4: Bonnet: Bonnet (+Steinschläge) - Scratch(es) - Paint
