Expertise

Protocol number: 48142801
Order No. / Reference: 26826387
Inspection date: 12 Oct 2026

Manufacturer: Mercedes-Benz	Model: C 200 d T 9G-TRONIC Avantgarde
VIN: W1KAH0DB2PF117018

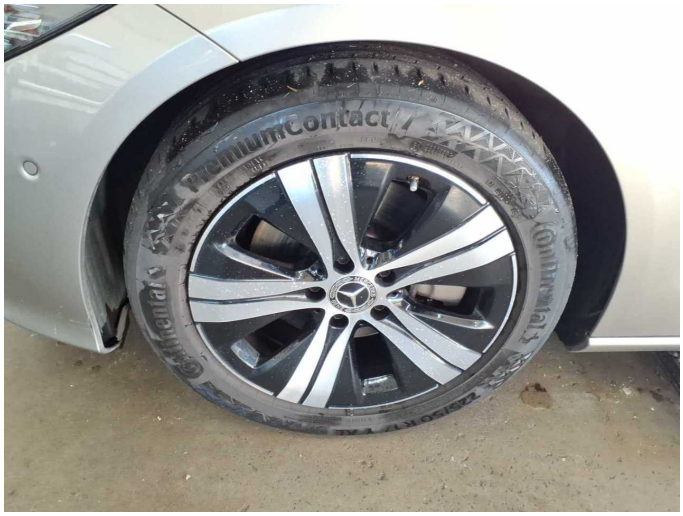
Figure 11: Mounted tyres

#	Tyre size	Type of tyre	Manufacturer	Tread depth
1)	225/50 R17 98Y	Summer tyres on Light alloy	Bridgestone	1mm / 1mm
2)	225/50 R17 98Y	Summer tyres on Light alloy	Bridgestone	4mm / 4mm

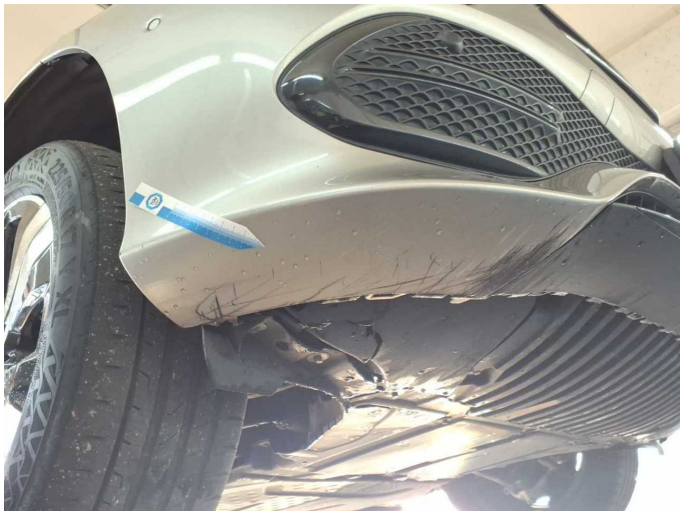
Damage 4: Front bumper: Front bumper - Scratched - Paint
