TÜV SÜD Auto Partner GmbH
Wiesenring 2
04159 Leipzig

Expertise

Protocol number: 48122421
Order No. / Reference: 27105143
Inspection date: 15 Oct 2026

Manufacturer: Opel	Model: Vivaro 2.0 D Cargo L EHZ
VIN: VXEVFEHTMPZ030147

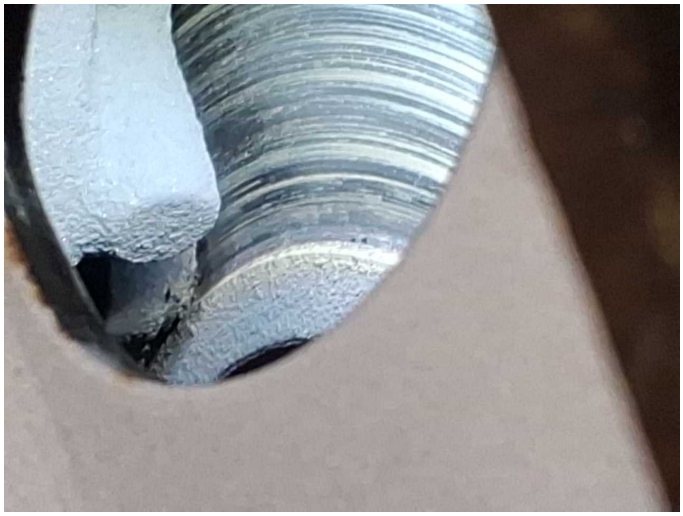
Damage 9: Braking system: Brake discs and pads - rear - Worn - Replace

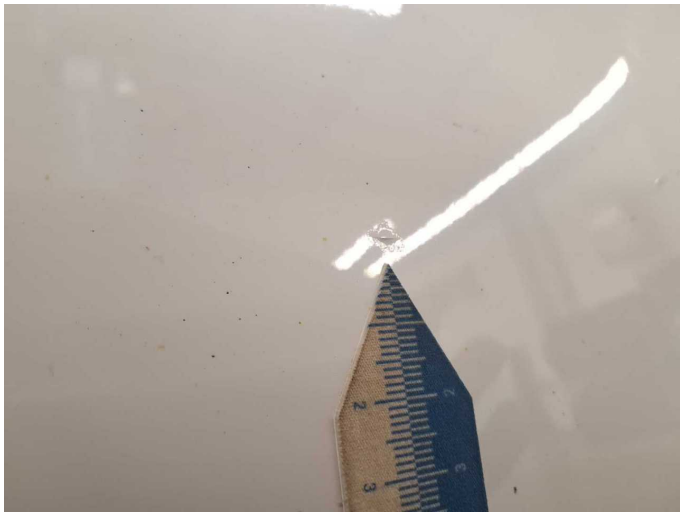
Damage 10: Sliding door, right: Sliding door (+ Kratzer) - Corrosion - Repair and paint

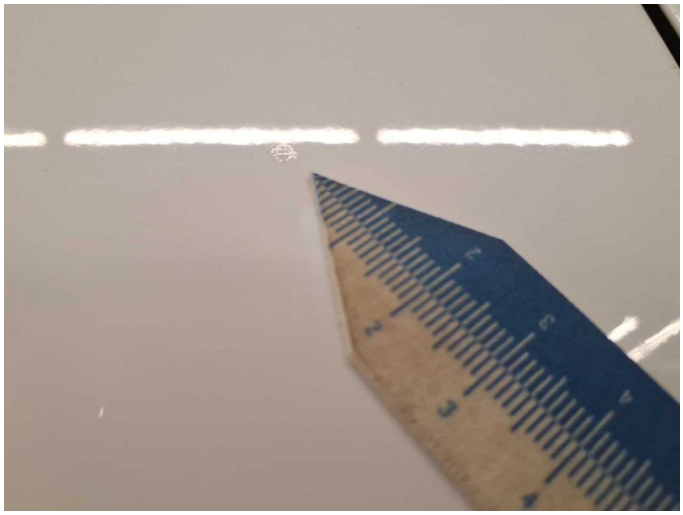
Damage 10: Sliding door, right: Sliding door (+ Kratzer) - Corrosion - Repair and paint

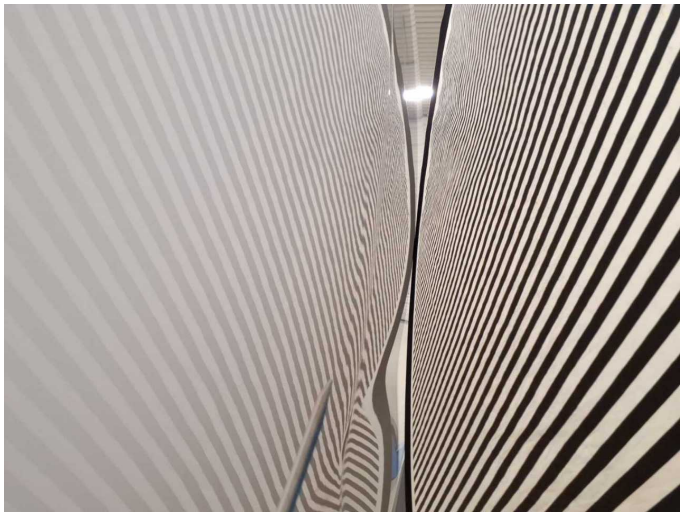
Damage 10: Sliding door, right: Sliding door (+ Kratzer) - Corrosion - Repair and paint

Damage 11: Door - front left side: Door - dent(s) - Repair and paint

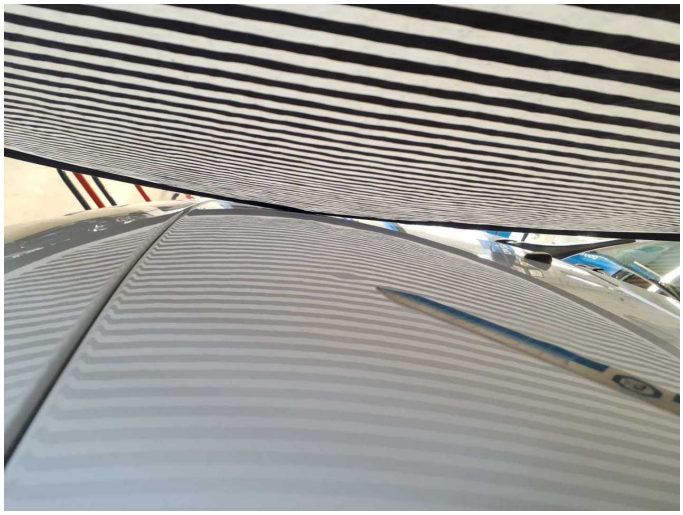
Damage 12: Rear bumper: Bumper with Parktronic (+ verformt - inkl. Stoßf. links) - Scratched - Replace
