Expertise

Protocol number: 48444557
Order No. / Reference: 27164664
Inspection date: 30 Oct 2026

Manufacturer: Opel	Model: Astra 1.2 Turbo Start/Stop Sports Tourer Business Edition
VIN: W0VBD8ES8M8022363

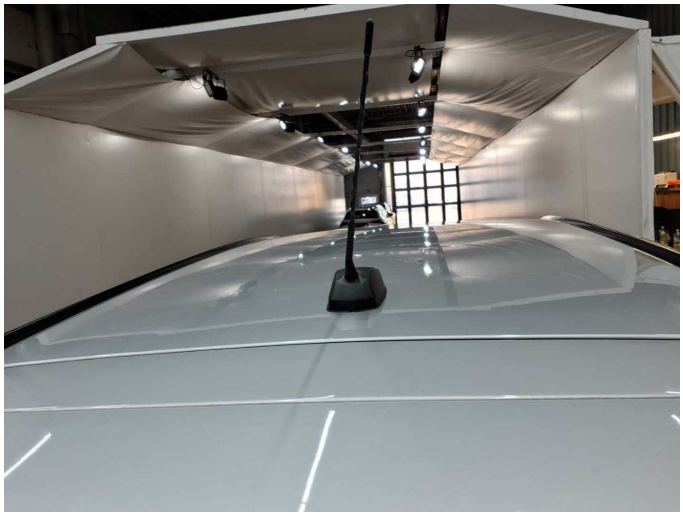
No.	Component group	Description
1	Documents	Service book (letzter Nachweis 17.10.24 43000km) - No evidence - No deduction
2	Roof	Stub aerial - Broken / torn - Replace
3	Equipment	Tirefit filler - Expired - Replace
4	Wing mirror - left side	Cap - Scratch(es) - Smart repair
5	Wing mirror - right side	Cap - Scratch(es) - Smart repair
6	Side panel - rear right side	Side panel - dent(s) - Smart repair
7	Side panel - rear right side	Sill - Scratch(es) - Smart repair
8	Vehicle glazing	Windscreen - Stone chips - Replace
9	Rear bumper	Rear bumper - Scratch(es) - Paint
10	Roof	Roof (Verätzungen) - Paint defect - Paint

Damage 2: Roof: Stub aerial - Broken / torn - Replace

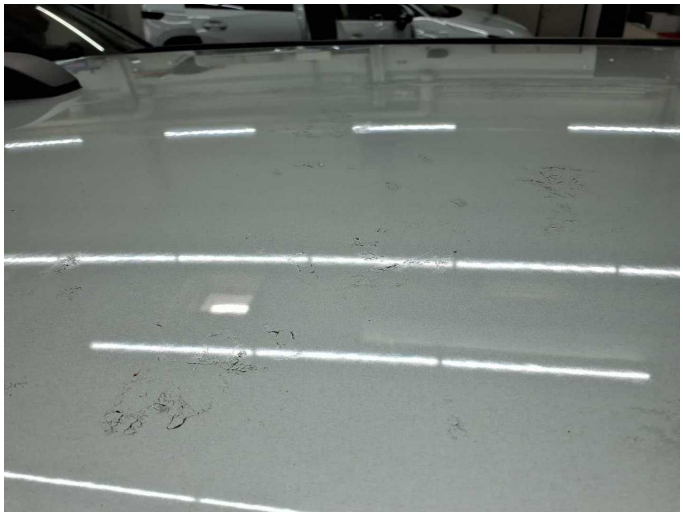
Damage 10: Roof: Roof (Verätzungen) - Paint defect - Paint
