Audi

VIN: WAUZZZFY0L2112804

Statement details

Inspection loc PARC HÖDLMAYR TONGEREN	**Statement date** 21/10/2026	**Inspection approval date** 22/10/2026

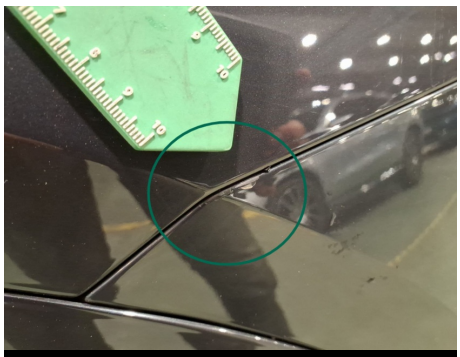
#	Element	Defect	Correction
001	Doorframe seal / Lower Back Right	Tear	Replace

002	Door sill / Back Left [1]	Scratched	Painting

003	Wing / Back Left	Dent	Acceptable

004	Bumper / Back Painted : Yes	Scratched	Acceptable

[1] Avec enfoncement

Doorframe seal / Lower Back Right / Tear

Door sill / Back Left / Scratched

Wing / Back Left / Dent

Bumper / Back / Scratched
