Expertise

Protocol number: 48034622
Order No. / Reference: 27080921
Inspection date: 8 Oct 2026

Manufacturer: Volkswagen	Model: Passat Variant 2.0 TDI SCR Business
VIN: WVWZZZ3CZPE050148

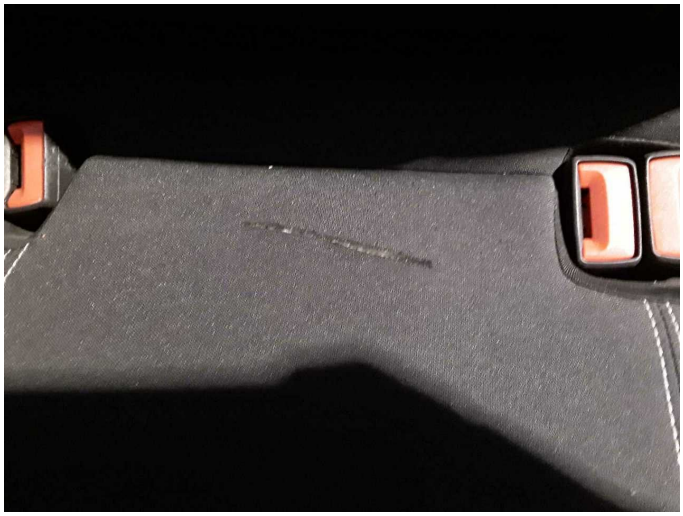
Damage 6: Seat - rear: Upholstery - Broken / torn - Replace

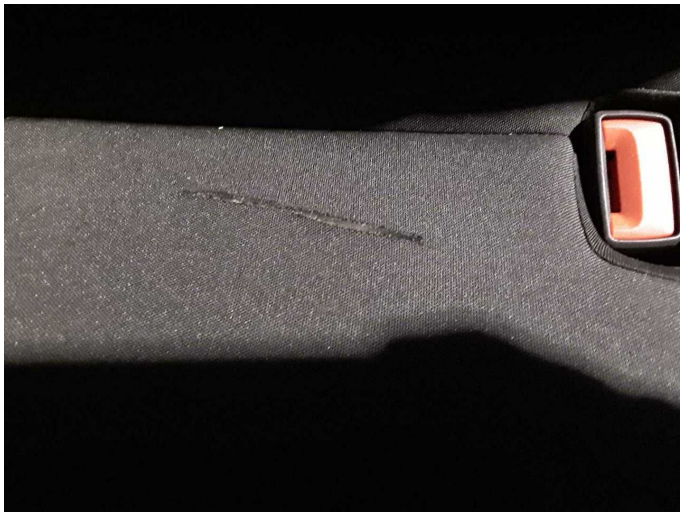
Damage 6: Seat - rear: Upholstery - Broken / torn - Replace
