Expertise

Protocol number: 48507634
Order No. / Reference: 27230238
Inspection date: 3 Nov 2026

Manufacturer: Volvo	Model: XC90 T8 AWD Recharge Geartronic Inscription Edition
VIN: YV1LFH5UDN1871602

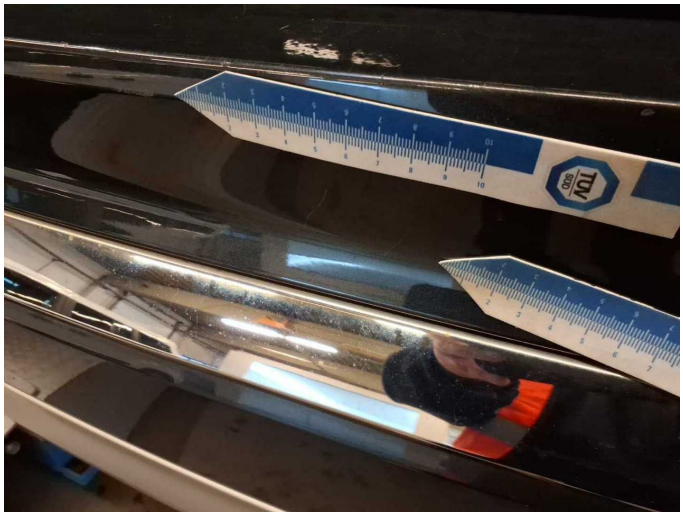
Damage 4: Rear bumper: Rear bumper - Scratch(es) - Paint

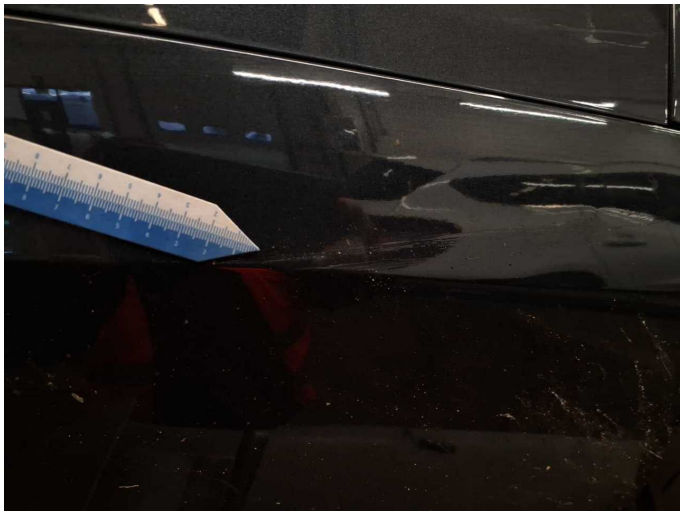
Damage 4: Rear bumper: Rear bumper - Scratch(es) - Paint

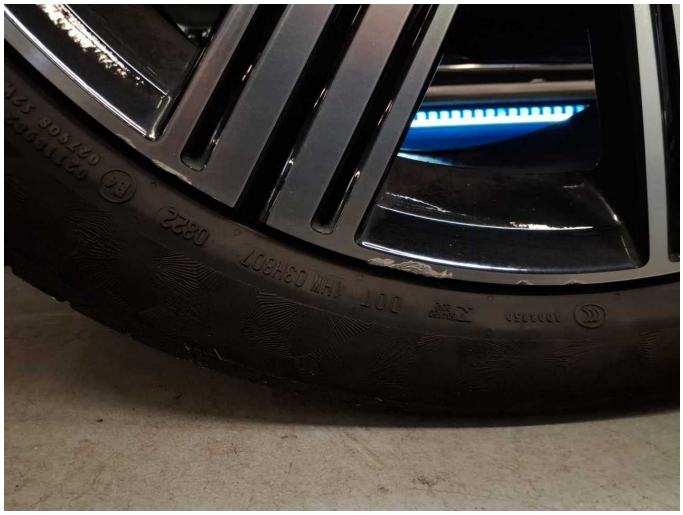
Damage 5: Wheel / tyres: Alloy rim - front right side (Materialabtrag) - Scratch(es) - Replace

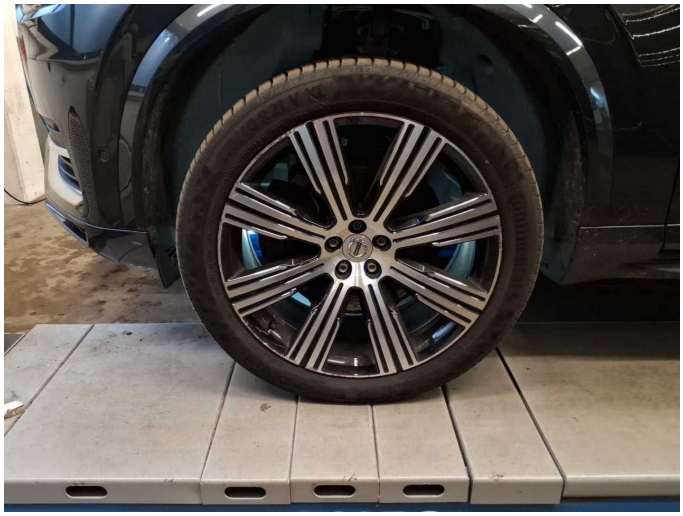
Damage 6: Wheel / tyres: Alloy rim - rear right side (Materialabtrag) - Scratch(es) - Replace
