Expertise

Protocol number: 48098024
Order No. / Reference: 26745185
Inspection date: 14 Oct 2026

Manufacturer: Opel	Model: Astra Sports Tourer 1.5 D Automatik Business Edition
VIN: VXKFCYHZ0R1019221

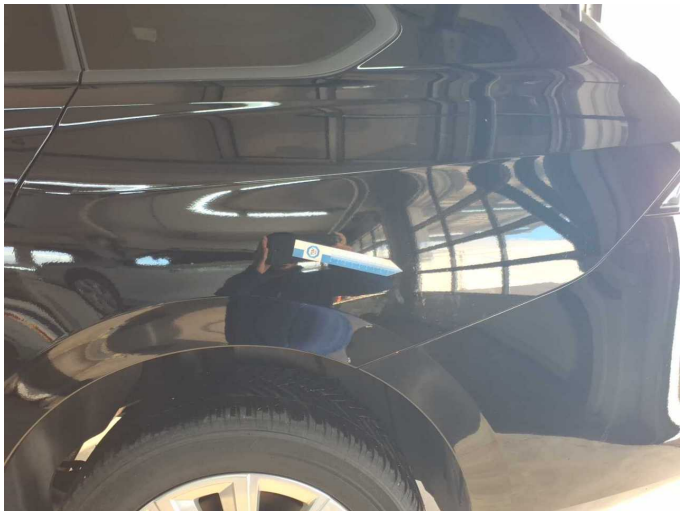
Damage 3: Mudguard - right side: Mudguard - right side - dent(s) - Smooth repair work

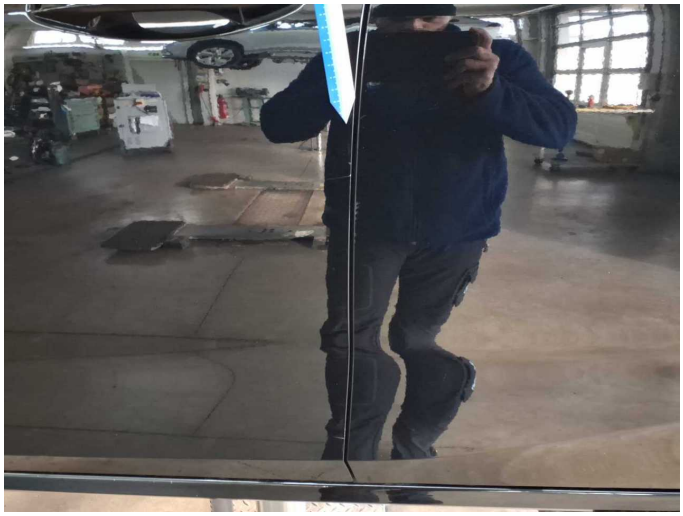
Damage 4: Side panel - rear left side: Side panel (Klebereste / hartz) - Paint defect - Smart repair

Damage 5: Engine: Engine cover - Damaged - Replace

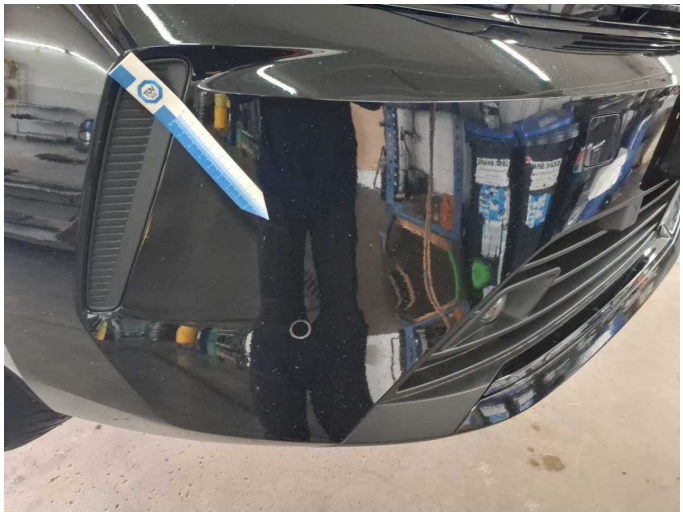
Damage 9: Side panel - rear right side: Side panel - Scratch(es) - Paint

Damage 10: Front bumper: Front bumper - Stone chips - Paint
