Expertise

Protocol number: 48535782
Order No. / Reference: 27258570
Inspection date: 4 Nov 2026

Manufacturer: Mercedes-Benz	Model: C 220 d T 9G-TRONIC AMG Line
VIN: W1KAH0EB6PF078755

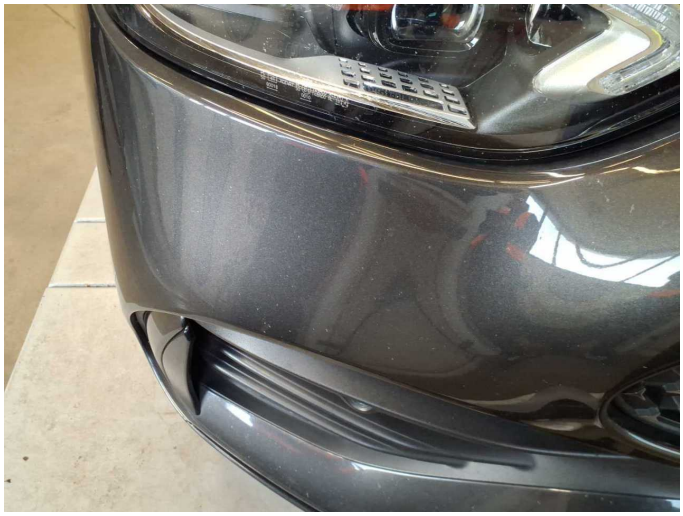
No.	Component group	Description
1	Front bumper	Front bumper - Stone chips - Paint

Damage 1: Front bumper: Front bumper - Stone chips - Paint
