Expertise

Protocol number: 48184086
Order No. / Reference: 26805485
Inspection date: 15 Oct 2026

Manufacturer: Volkswagen	Model: Passat Variant 2.0 TDI SCR DSG Business
VIN: WVWZZZ3CZPE075629

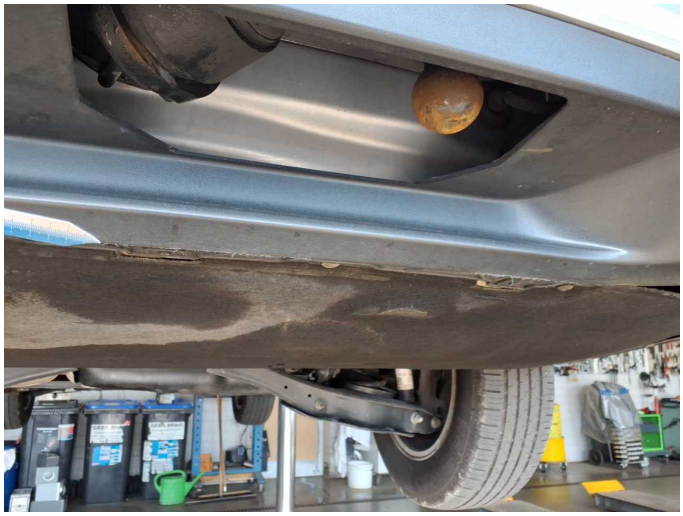
Damage 2: Rear bumper: Spoiler - Scratched - Replace

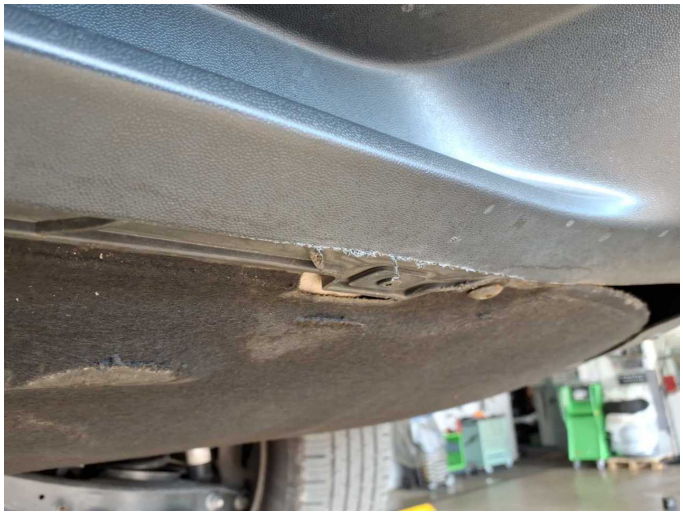
Damage 2: Rear bumper: Spoiler - Scratched - Replace
