Expertise

Protocol number: 48407615
Order No. / Reference: 26856684-1
Inspection date: 30 Oct 2026

Manufacturer: Mercedes-Benz	Model: C 300 d 9G-TRONIC 4Matic AMG Line
VIN: W1KAF0HB6PR147525

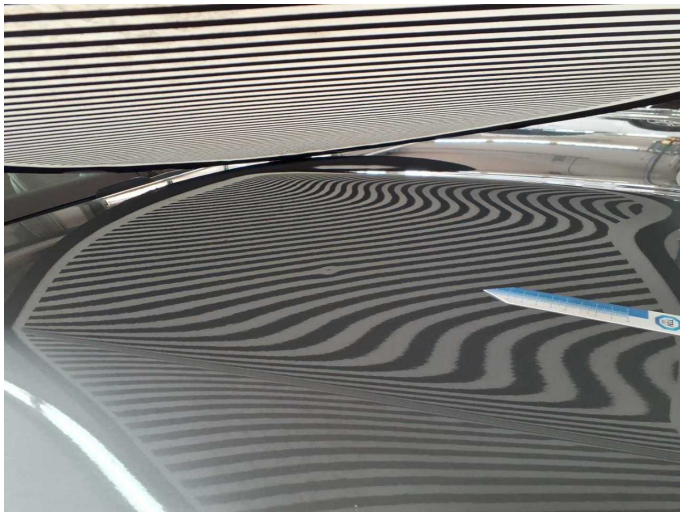
No.	Component group	Description
1	Bonnet	Bonnet - dent(s) - Smart repair
2	Door - rear right side	Door - dent(s) - Smart repair
3	Wheel / tyres	Alloy rim - front left side - Scratch(es) - Loss in value
4	Indicator - front	Mirror - left side - Broken / torn - Replace
5	2nd wheel set	Tyres - complete set - Does not meet the leasing specifications - Replace
6	Front bumper	Front bumper - Scratch(es) - repair according to calculation

Damage 1: Bonnet: Bonnet - dent(s) - Smart repair

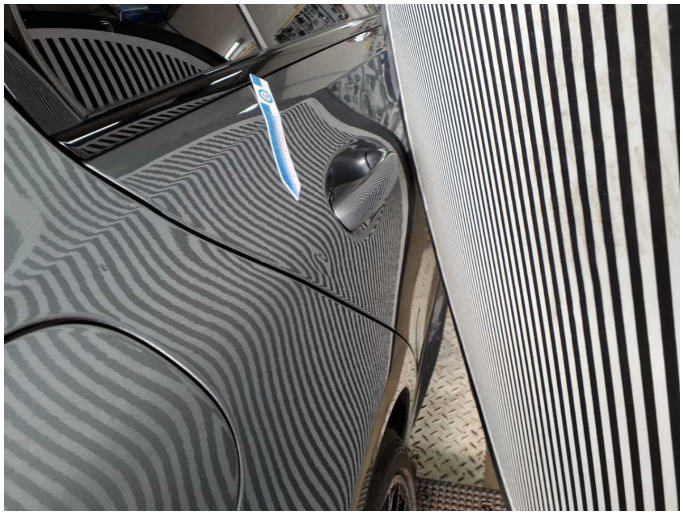
Damage 2: Door - rear right side: Door - dent(s) - Smart repair

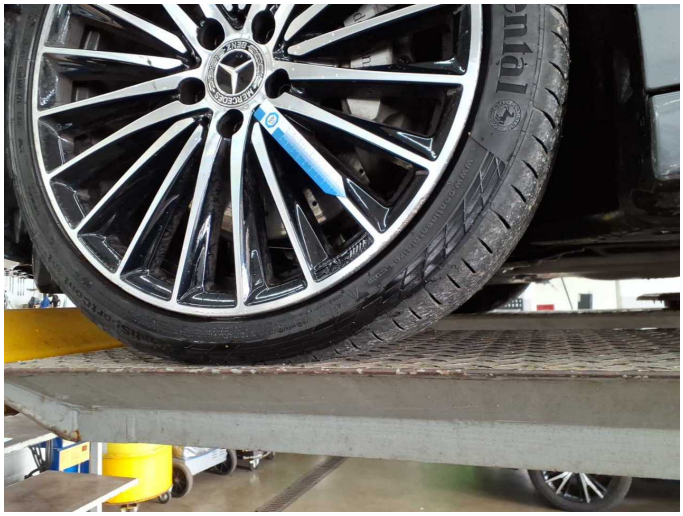
Damage 3: Wheel / tyres: Alloy rim - front left side - Scratch(es) - Loss in value

Damage 4: Indicator - front: Mirror - left side - Broken / torn - Replace

Damage 5: 2nd wheel set: Tyres - complete set - Does not meet the leasing specifications - Replace

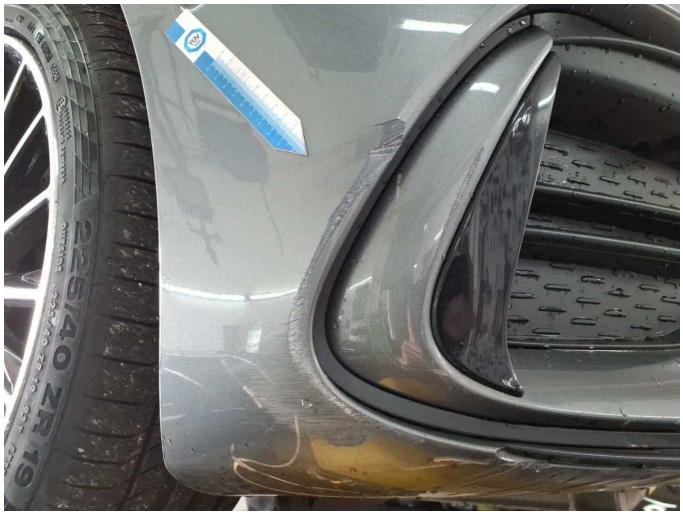
Damage 6: Front bumper: Front bumper - Scratch(es) - repair according to calculation
