Expertise

Protocol number: 48111337
Order No. / Reference: 27113669
Inspection date: 13 Oct 2026

Manufacturer: Ford	Model: Transit Custom 280 L1H1 LKW VA Trend
VIN: WF0YXXTTGYLT42087

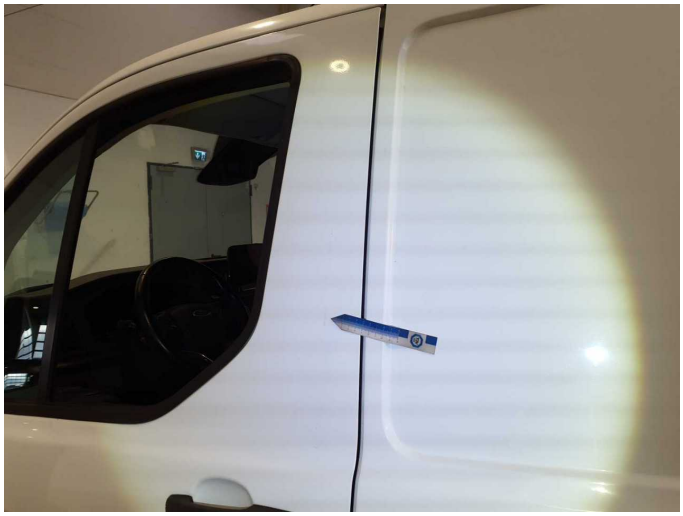
Damage 2: Trim / covers: Door trim - front left side - Scratch(es) - Smart repair

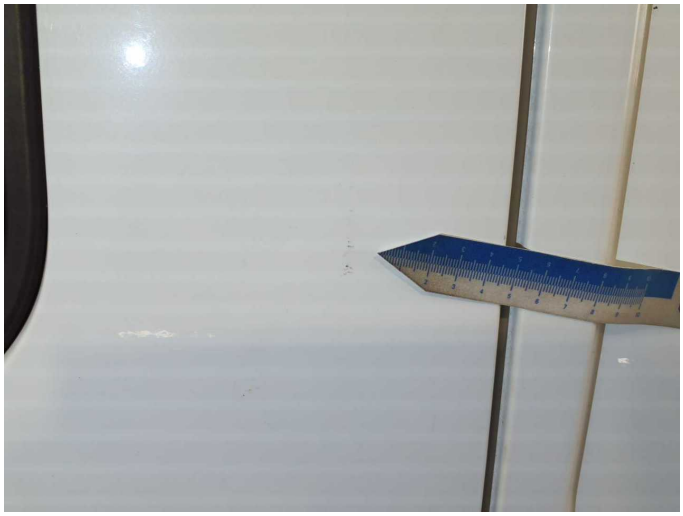
Damage 3: Door - front left side: Door - Scratch(es) - Smart repair

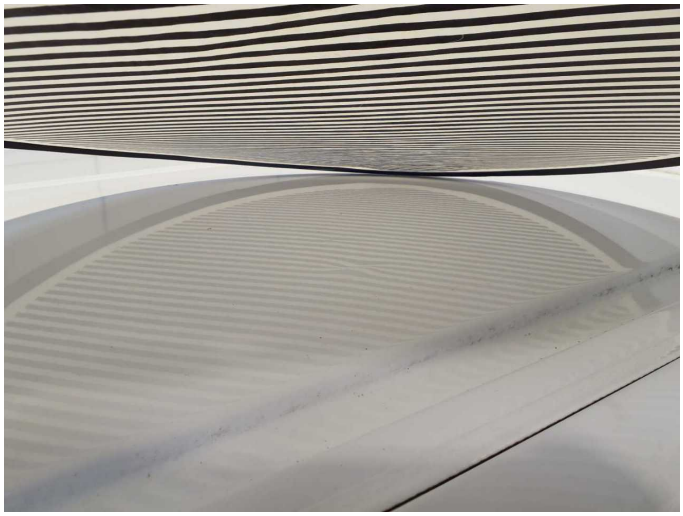
Damage 5: Door - front right side: Door - Dent / paintcoat damage - Smart repair

Damage 6: Roof: Roof - Dent / paintcoat damage - Loss in value

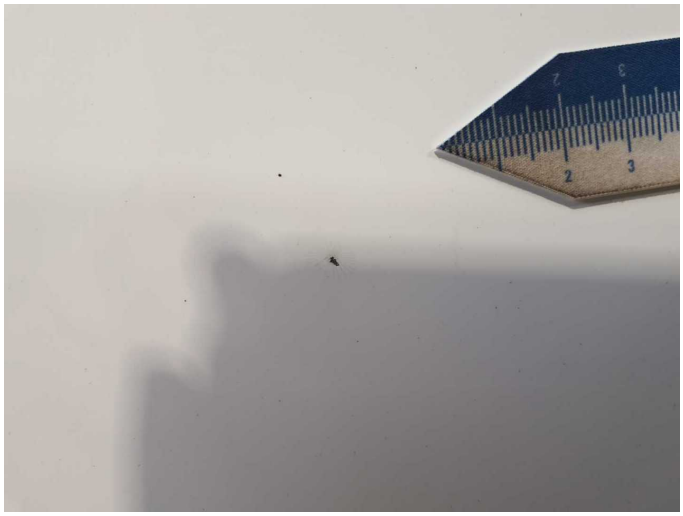
Damage 9: Door - front left side: Brightware - lower - Scratch(es) - Replace

Damage 10: Sliding door, right: Sliding door - Dent / paintcoat damage - Smart repair

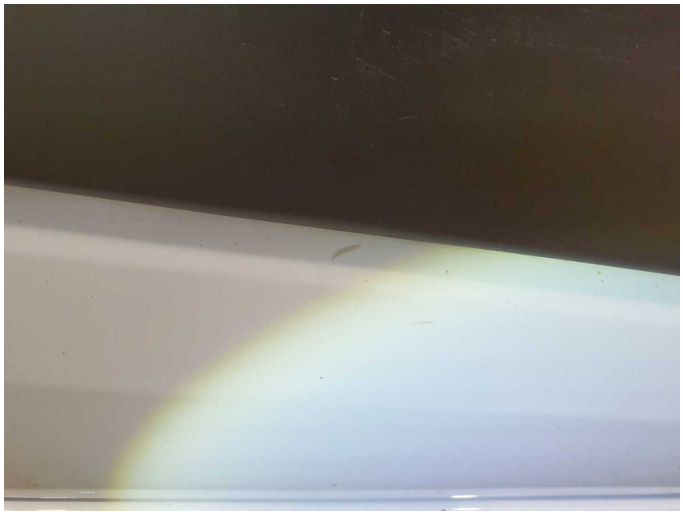
Damage 10: Sliding door, right: Sliding door - Dent / paintcoat damage - Smart repair

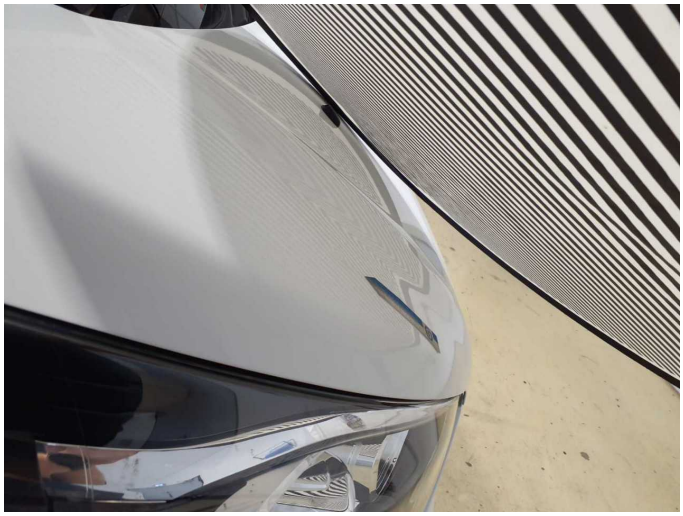
Wear and tear 7: Side panel - rear right side: Sill - Dent / paintcoat damage - No deduction

Wear and tear 10: Bonnet: Bonnet - dent(s) - Smooth repair work
