Expertise

Protocol number: 48412088
Order No. / Reference: 27136169
Inspection date: 20 Oct 2026

Manufacturer: Skoda	Model: Octavia Combi 2.0 TDI DSG Style
VIN: TMBJJ7NX8NY059659

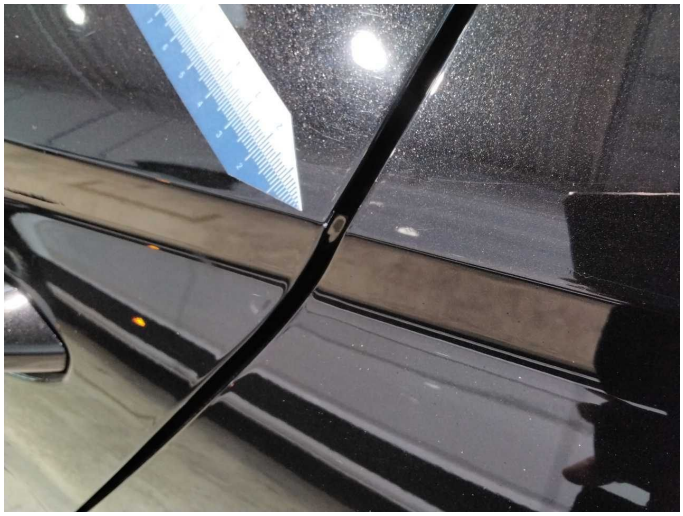
Damage 2: Door - rear left side: Door edge - Scratch(es) - Smart repair

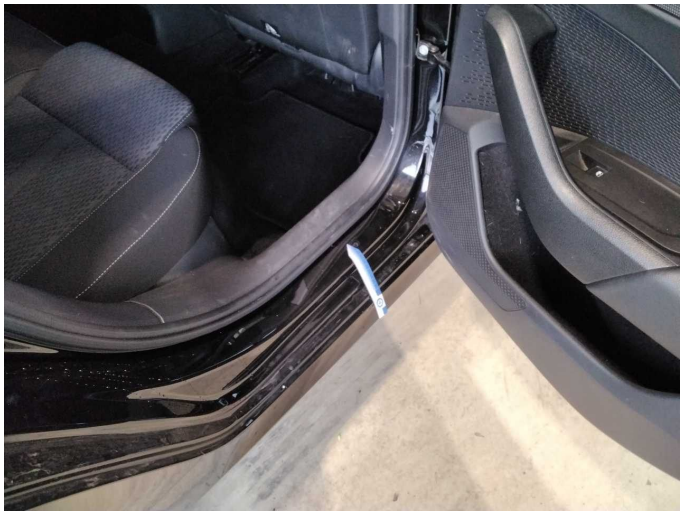
Damage 2: Door - rear left side: Door edge - Scratch(es) - Smart repair

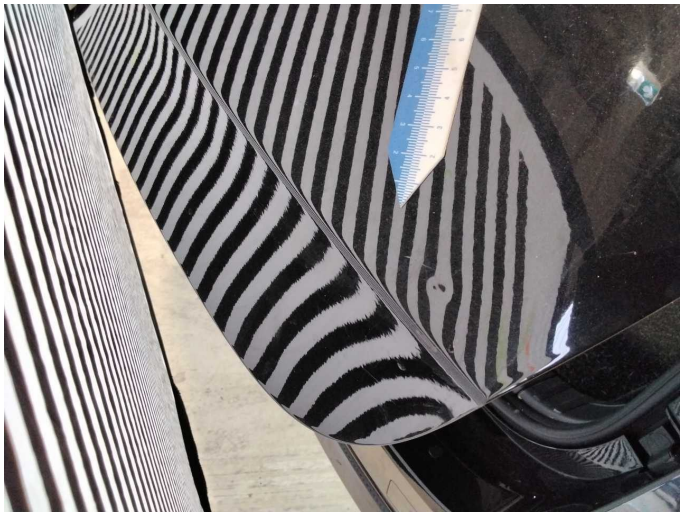
Damage 3: Side panel - rear right side: Sill - Scratch(es) - Smart repair

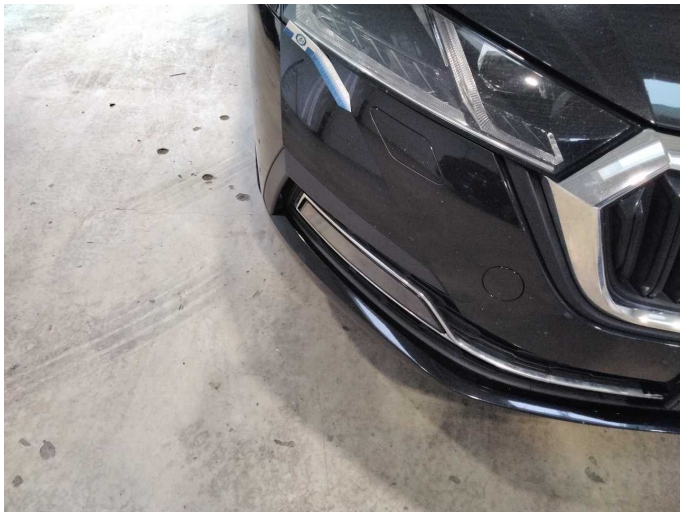
Damage 6: Front bumper: Front bumper - Scratch(es) - Paint

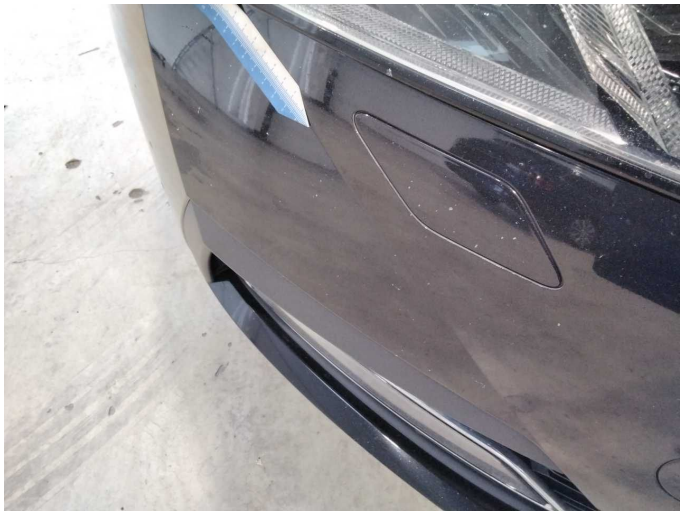
Damage 6: Front bumper: Front bumper - Scratch(es) - Paint

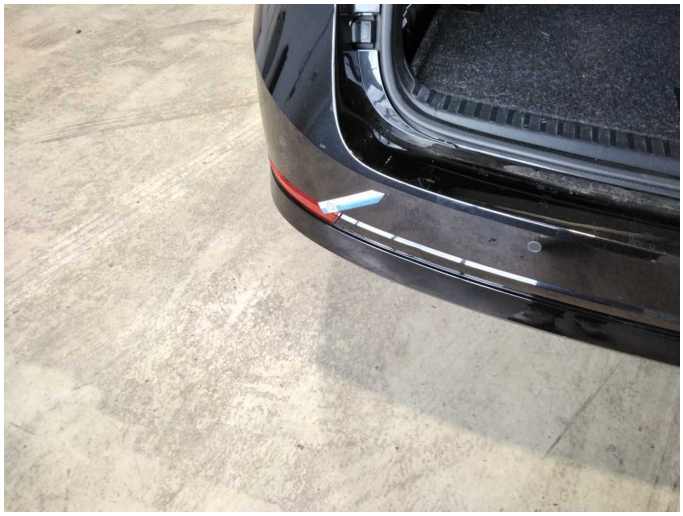
Damage 7: Rear bumper: Rear bumper - Scratch(es) - Paint

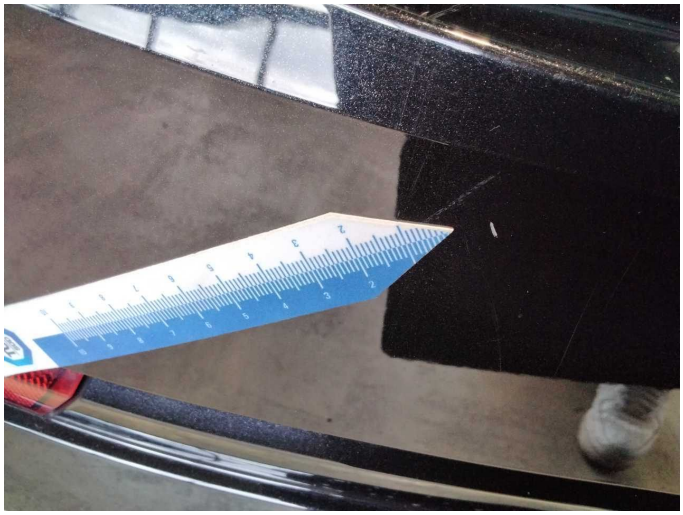
Damage 7: Rear bumper: Rear bumper - Scratch(es) - Paint

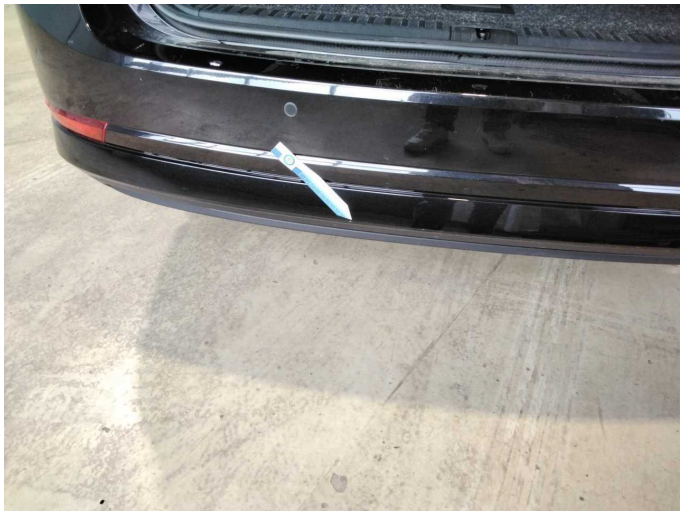
Damage 7: Rear bumper: Rear bumper - Scratch(es) - Paint

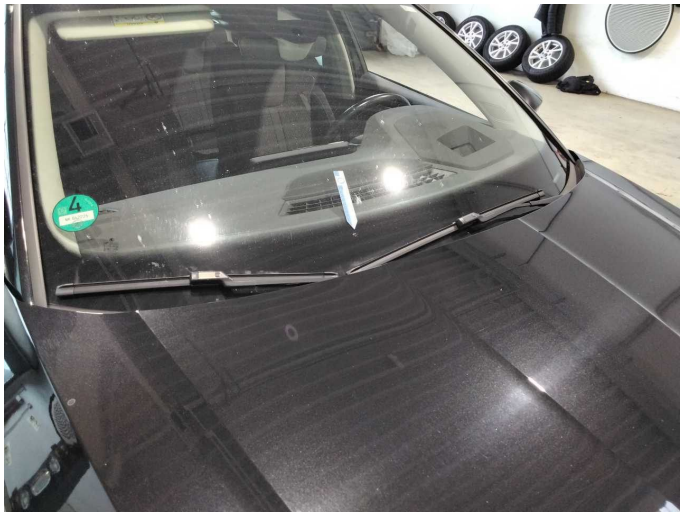
Damage 8: Bonnet: Bonnet - Scratch(es) - Paint

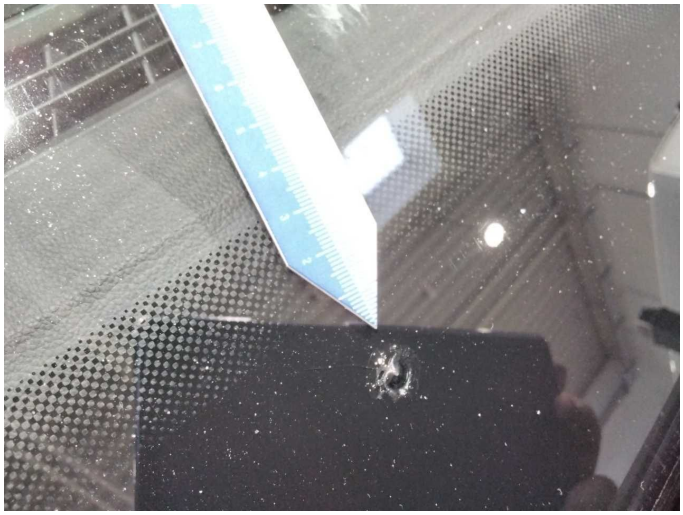
Damage 9: Vehicle glazing: Windscreen - Stone chips - Replace
