APPRAISAL REPORT

IDENTIFICATION VEHICLE

Driver name:	HM Tongeren
Make:	BMW
Model / version:	3 SERIES TOURING
Vin:	WBA6N91020FM83712
Plate:	2BXU061
Mileage:	129250
SOH:	
First registration:	03/05/2022
Color:	MINERALGRAU

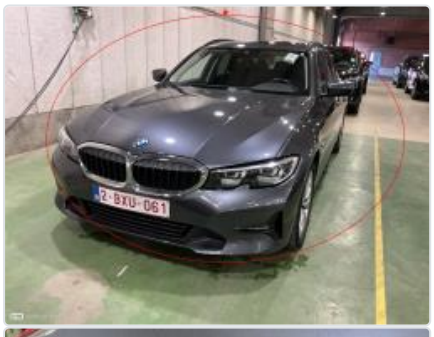
11 - Door FR - Dent(s)
