Expertise

Protocol number: 48505958
Order No. / Reference: 27248236
Inspection date: 3 Nov 2026

Manufacturer: Mercedes-Benz	Model: Vito 116 CDI Lang HA Aut. PRO
VIN: W1V44760313854076

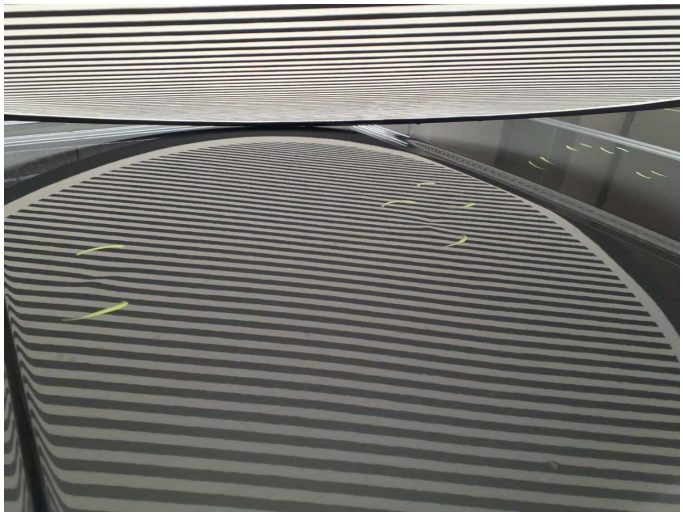
Damage 3: Roof: Roof (teilweise) - Dent / paintcoat damage - Smart repair

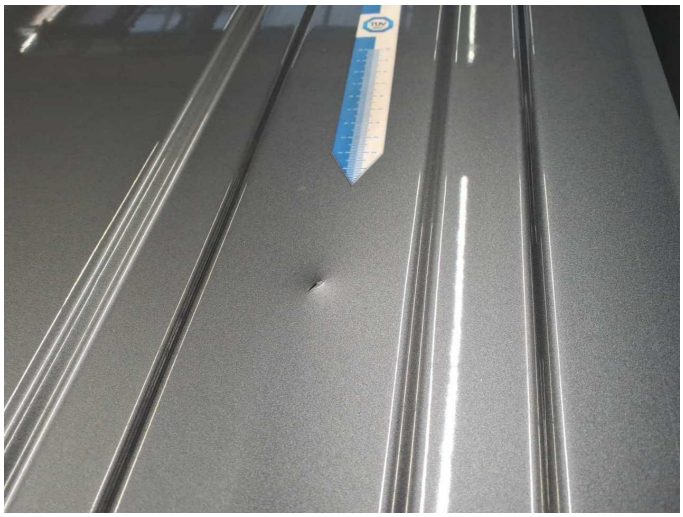
Damage 3: Roof: Roof (teilweise) - Dent / paintcoat damage - Smart repair

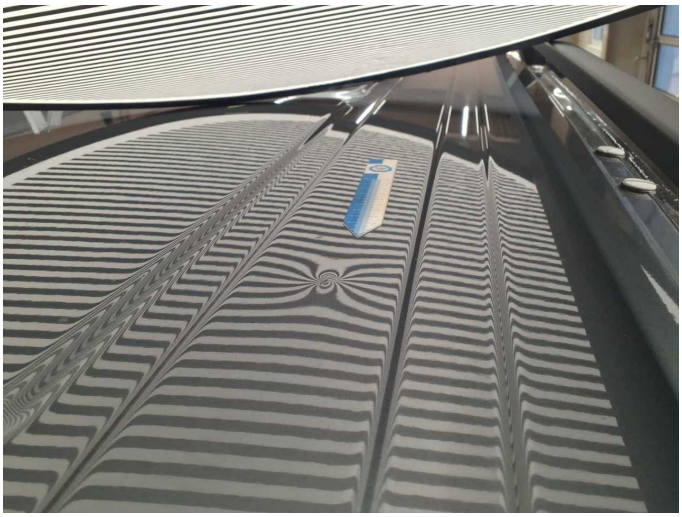
Damage 3: Roof: Roof (teilweise) - Dent / paintcoat damage - Smart repair

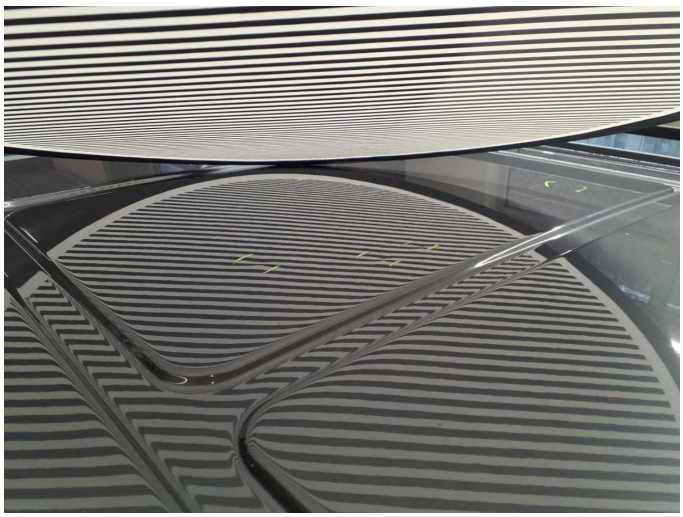
Damage 3: Roof: Roof (teilweise) - Dent / paintcoat damage - Smart repair

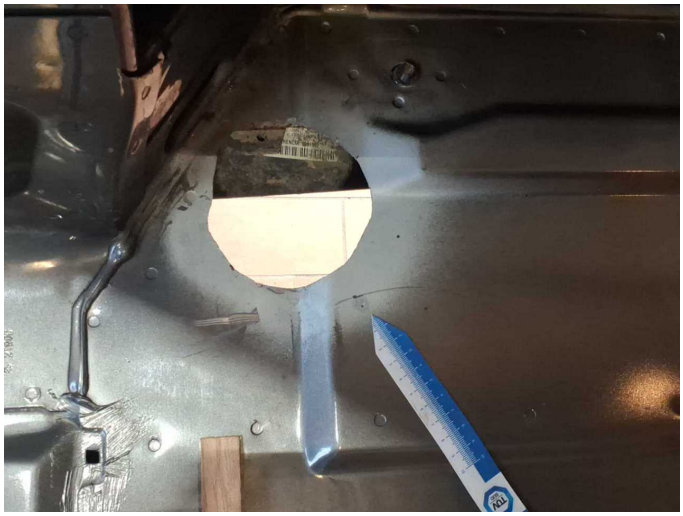
Damage 4: Interior: Cargo area floor (Holzboden) - Missing - Replace

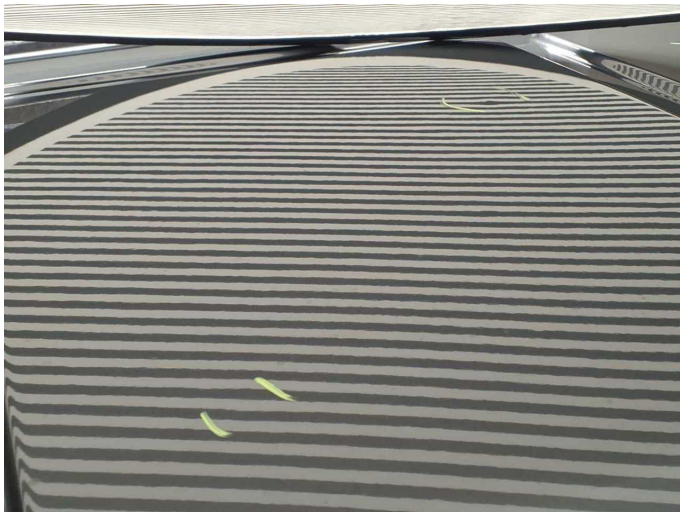
Damage 7: Roof: Roof - Damage by hail - Smooth repair work

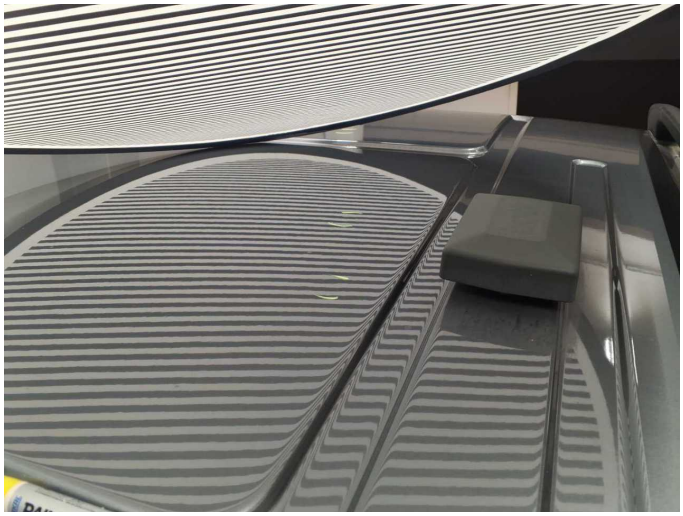
Damage 7: Roof: Roof - Damage by hail - Smooth repair work

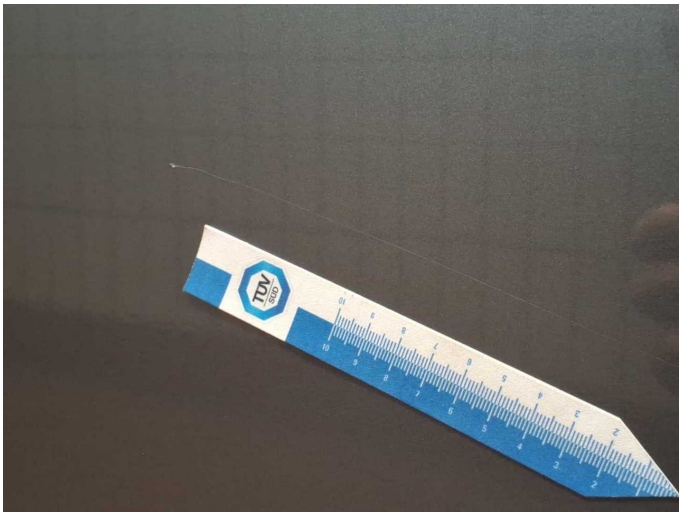
Damage 8: Side panel - rear left side: Side panel (Teilweise) - Dent / paintcoat damage - Repair and paint

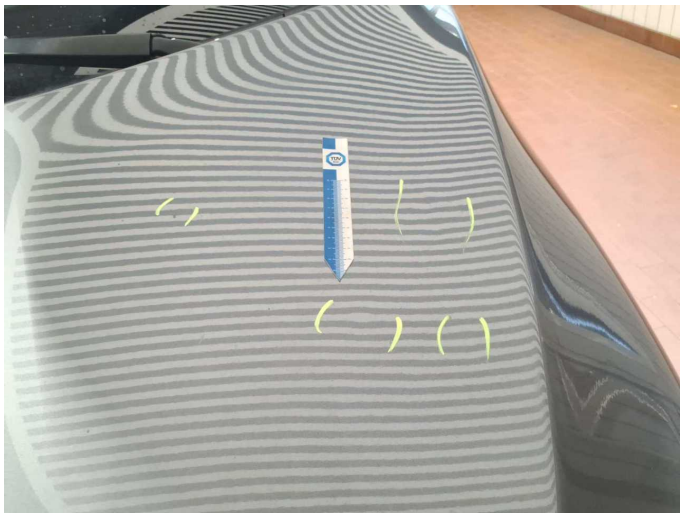
Damage 9: Bonnet: Bonnet - Dent / paintcoat damage - Repair and paint

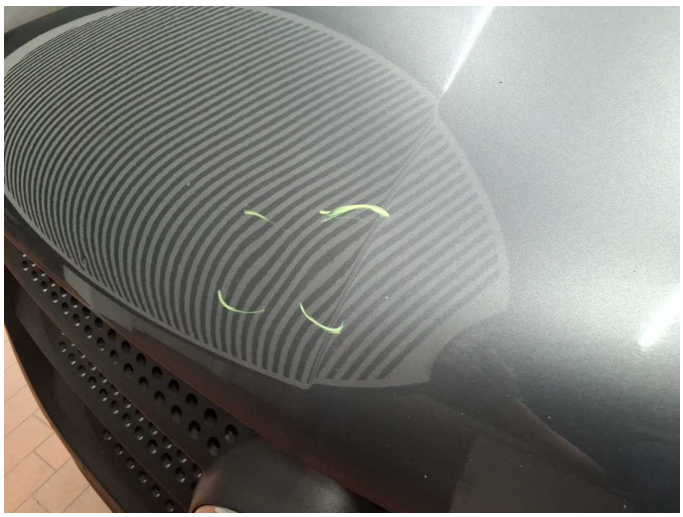
Damage 9: Bonnet: Bonnet - Dent / paintcoat damage - Repair and paint

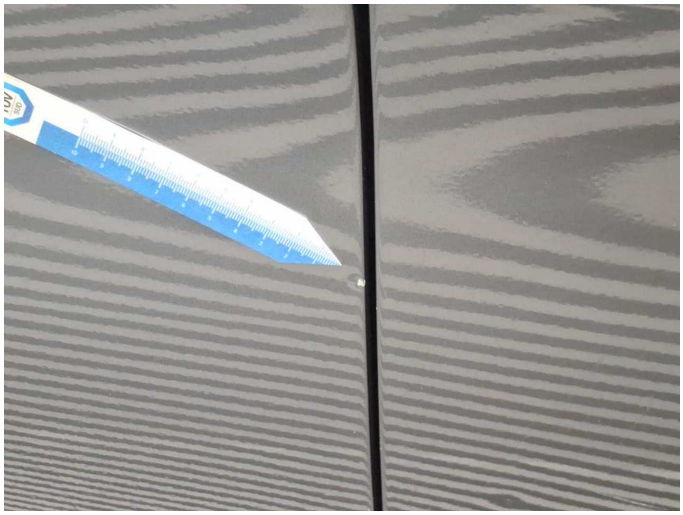
Wear and tear 4: Boot lid / rear door: Rear door - right side (+ Beule) - dent(s) - No deduction

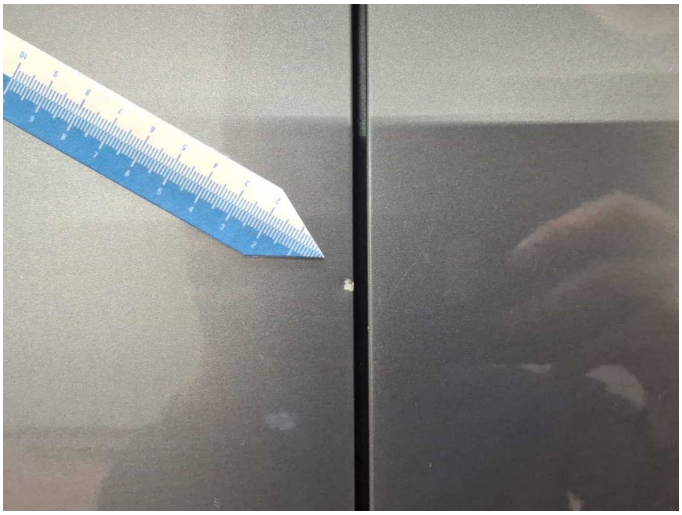
Wear and tear 5: Sliding door, right: Sliding door - Dent / paintcoat damage - Smart repair

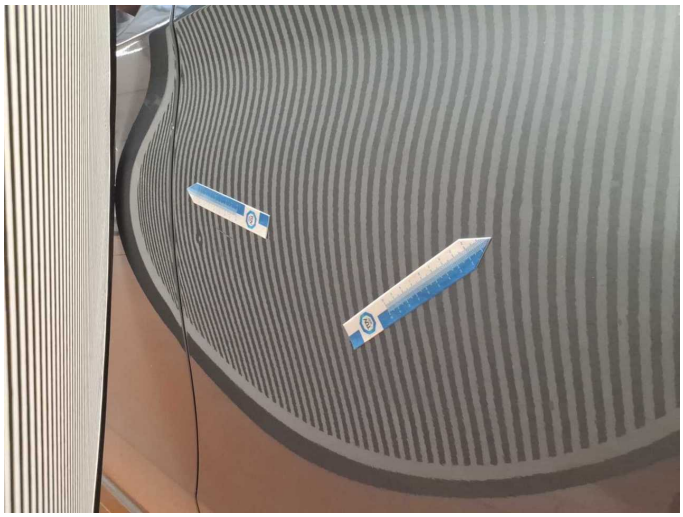
Wear and tear 5: Sliding door, right: Sliding door - Dent / paintcoat damage - Smart repair

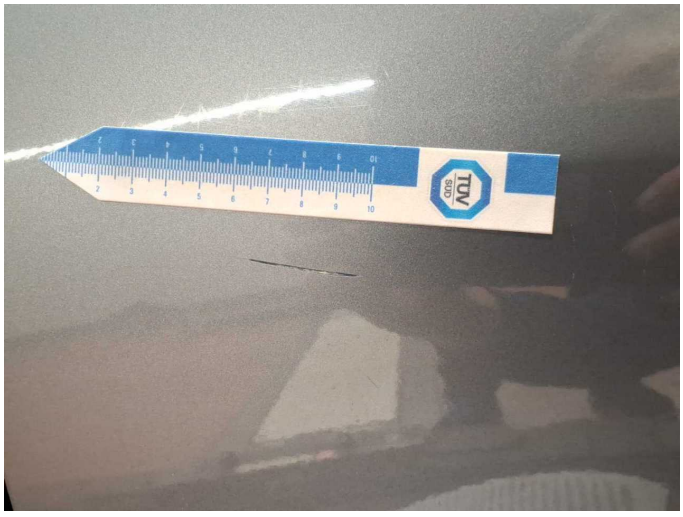
Wear and tear 6: Door - front right side: Door - Dent / paintcoat damage - Smart repair
