Expertise

Protocol number: 48197752
Order No. / Reference: 27094715
Inspection date: 19 Oct 2026

Manufacturer: Skoda	Model: Karoq 2.0 TDI 4x4 DSG Selection
VIN: TMBLJ7NU5R5046664

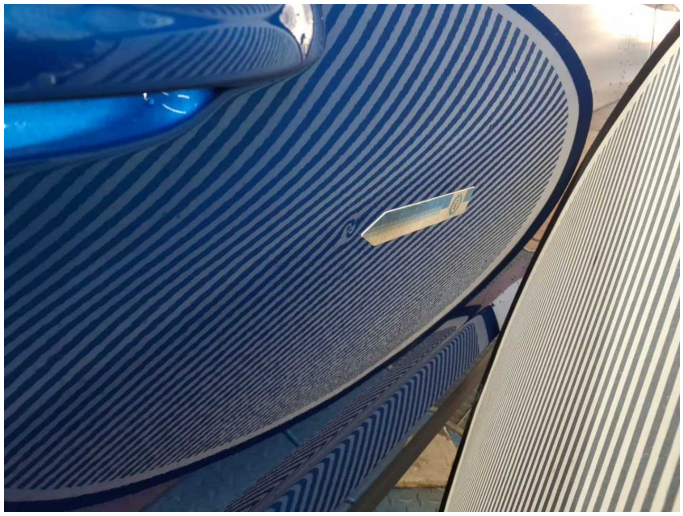
Damage 1: Door - front right side: Door - dent(s) - Smart repair
