TÜV SÜD Auto Partner GmbH
Wiesenring 2
04159 Leipzig

Expertise

Protocol number: 48055899
Order No. / Reference: 26768988
Inspection date: 24 Sept 2026

Manufacturer: Volkswagen	Model: Passat Variant 2.0 TDI SCR DSG 4Motion Elegance
VIN: WVWZZZ3CZNE033884

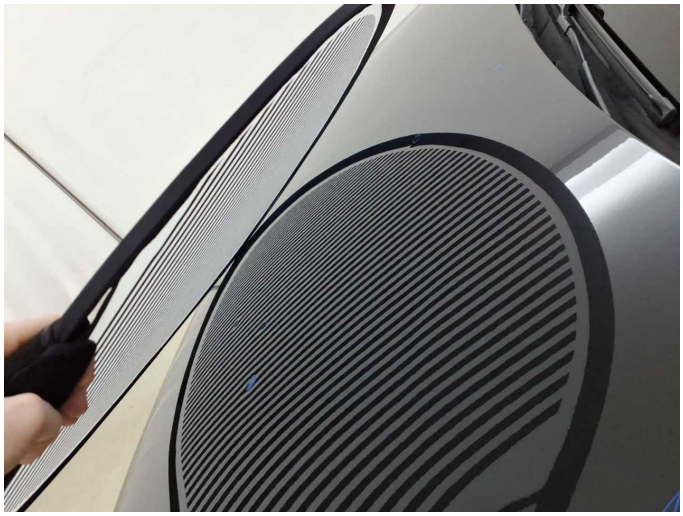
Damage 5: Body: Body - Damage by hail - repair according to calculation

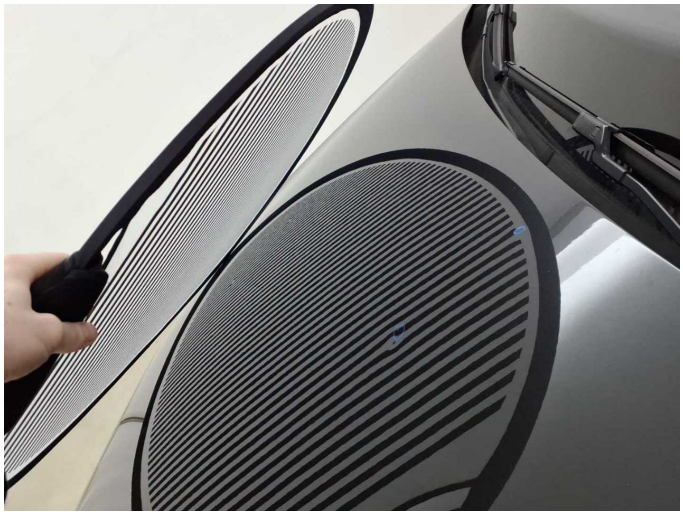
Damage 5: Body: Body - Damage by hail - repair according to calculation

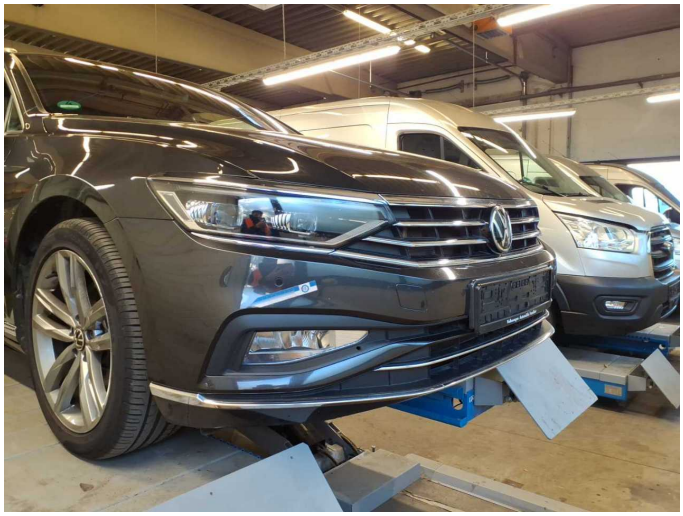
Damage 6: Wheel / tyres: Alloy rim - front right side (Materiallabtrag) - Scratched - Replace

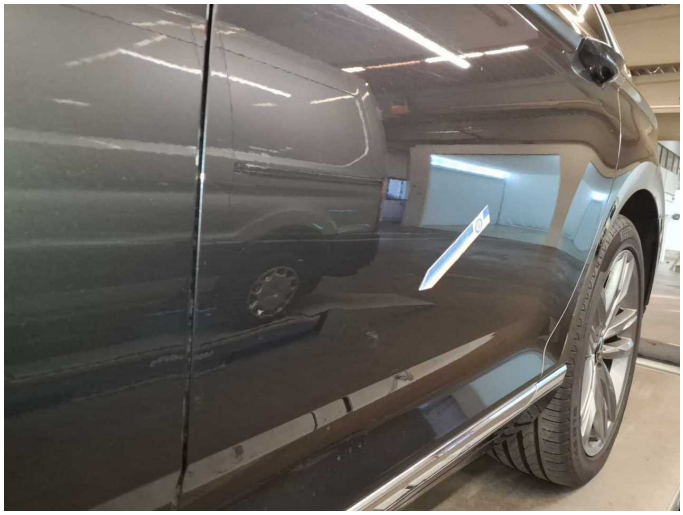
Damage 9: Door - rear left side: Door - Dent / paintcoat damage - Repair and paint

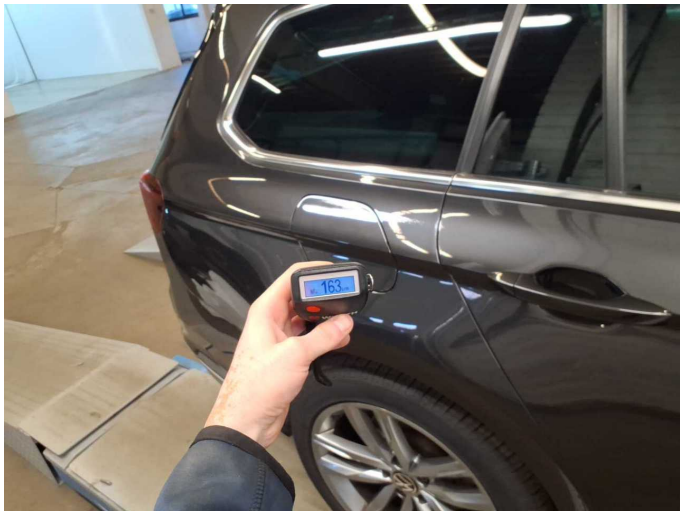
Repainting 1: Mudguard - right side
