Expertise

Protocol number: 48027606
Order No. / Reference: 27085334
Inspection date: 8 Oct 2026

Manufacturer: Skoda	Model: Octavia Combi 2.0 TSI DSG RS
VIN: TMBJU0NX2PY149326

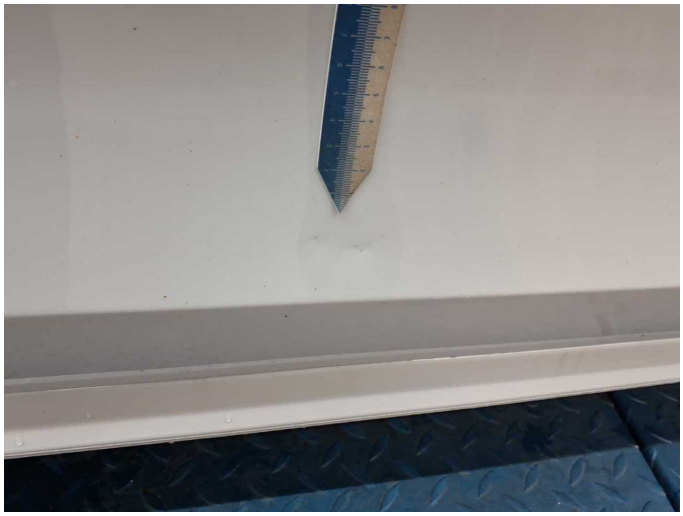
No.	Component group	Description
1	Door - front right side	Door - Dent / paintcoat damage - Repair and paint

Damage 1: Door - front right side: Door - Dent / paintcoat damage - Repair and paint
