TÜV SÜD Auto Partner GmbH
Wiesenring 2
04159 Leipzig

Expertise

Protocol number: 48496793
Order No. / Reference: 27253144
Inspection date: 4 Nov 2026

Manufacturer: Opel	Model: Corsa 1.2 Direct Injection Turbo Start/Stop Elegance
VIN: VXKUPHNEKN4169526

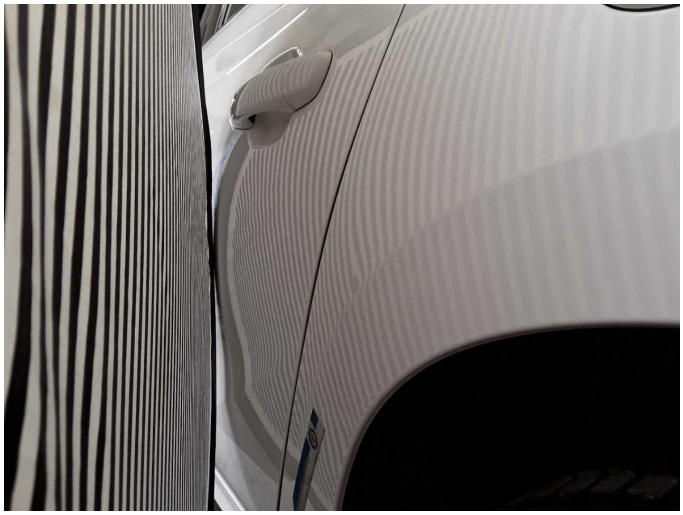
No.	Component group	Description
1	Trim / covers	Floor mats - Broken / torn - Replace
2	Door - front right side	Door handle - outside - Scratch(es) - Smart repair
3	Equipment	Tirefit filler - Expired - Replace
4	Trim / covers	Door trim - rear right side - Scratch(es) - Loss in value
5	Trim / covers	Door trim - rear left side - Scratch(es) - Loss in value
6	Side panel - rear left side	Side panel - dent(s) - Smooth repair work

Damage 6: Side panel - rear left side: Side panel - dent(s) - Smooth repair work

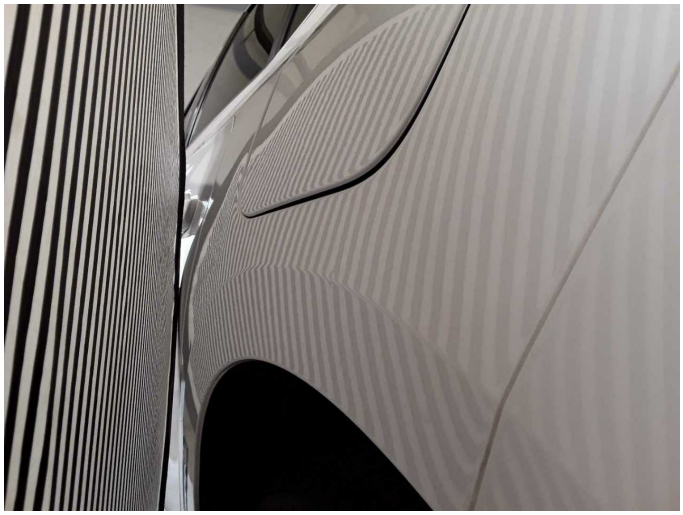
Damage 6: Side panel - rear left side: Side panel - dent(s) - Smooth repair work
