Expertise

Protocol number: 48540467
Order No. / Reference: 27258547
Inspection date: 4 Nov 2026

Manufacturer: Opel	Model: Combo Cargo 1.5 D Edition
VIN: W0VEFYHT2MJ901539

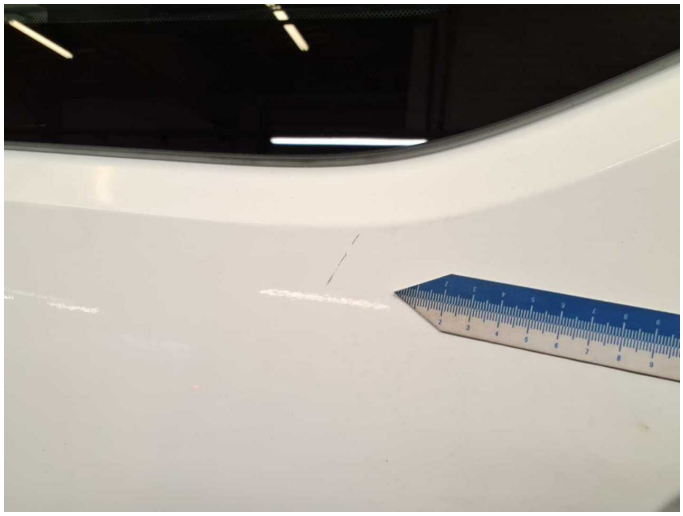
Damage 6: Body: Body (Ausbleichungen) - Glued / labelled - Loss in value
