Expertise

Protocol number: 48514018
Order No. / Reference: 27208543
Inspection date: 29 Oct 2026

Manufacturer: Ford	Model: Focus Turnier 1.0 EcoBoost Hybrid TITANIUM
VIN: WF0PXXGCHPMC82184

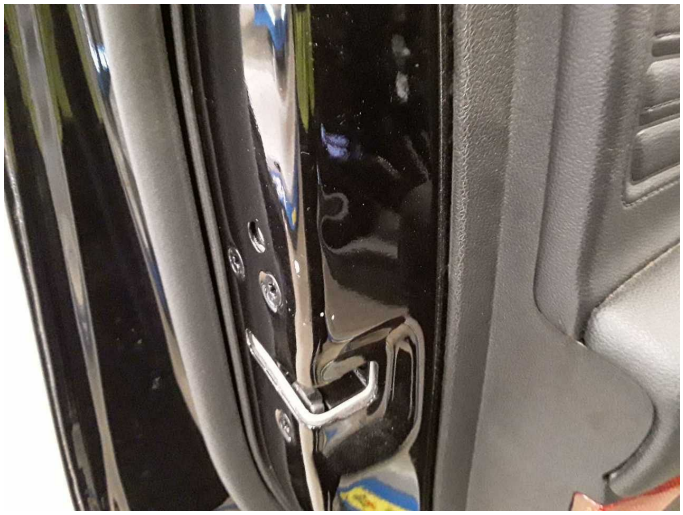
Damage 4: Door - front left side: Door (Innen Rahmen) - Dent / paintcoat damage - Smart repair

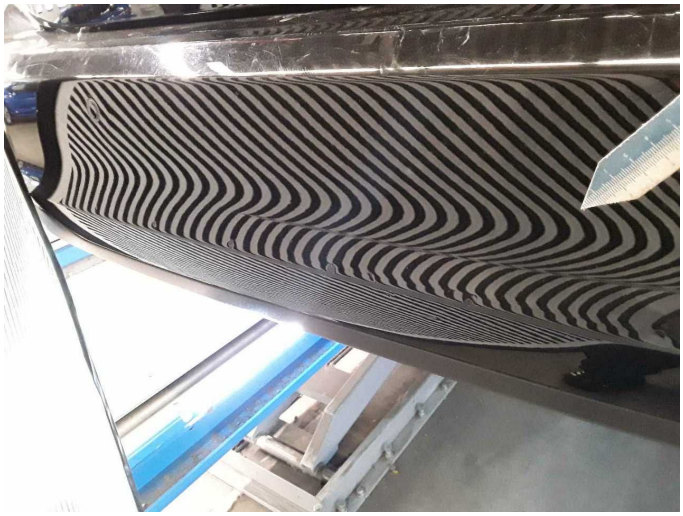
Damage 7: Rear bumper: Rear bumper - Dent / paintcoat damage - Repair and paint

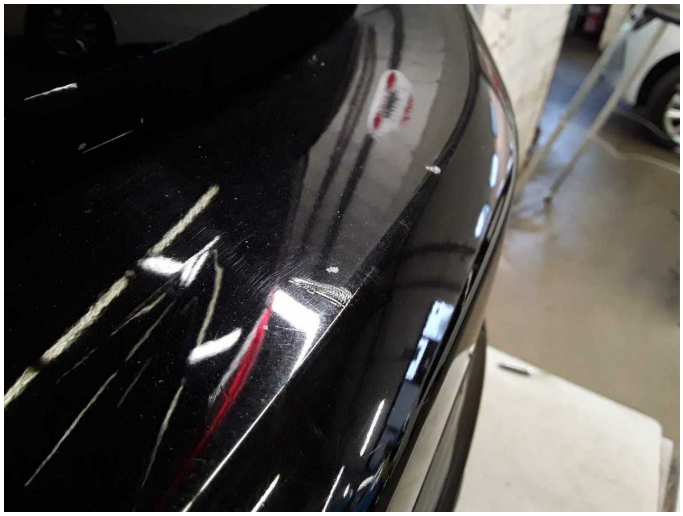
Damage 7: Rear bumper: Rear bumper - Dent / paintcoat damage - Repair and paint

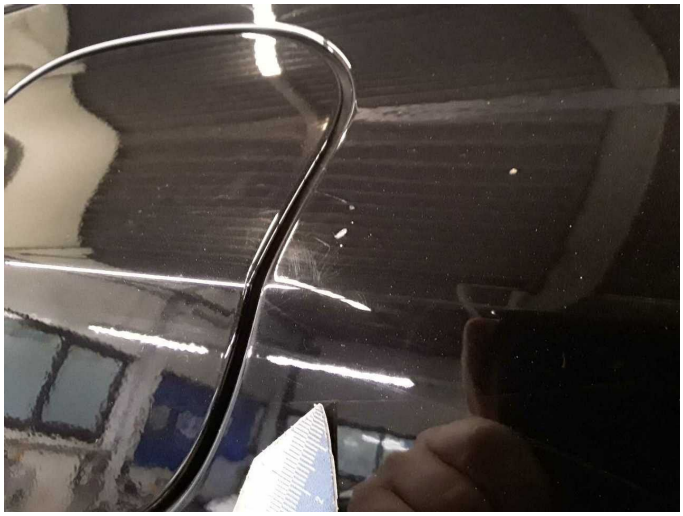
Damage 8: Side panel - rear left side: Side panel - Scratch(es) - Paint

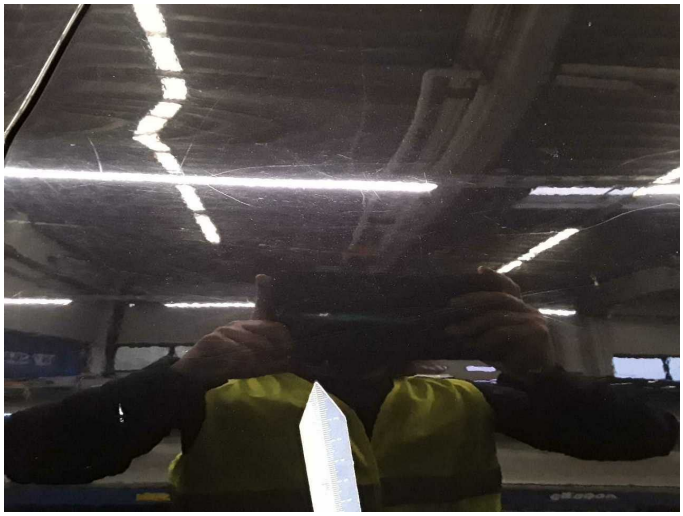
Damage 10: Door - rear left side: Door - Scratch(es) - Paint

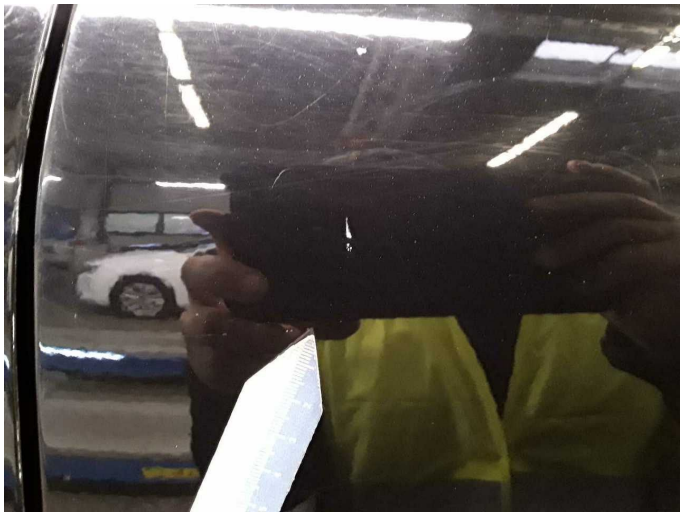
Damage 10: Door - rear left side: Door - Scratch(es) - Paint

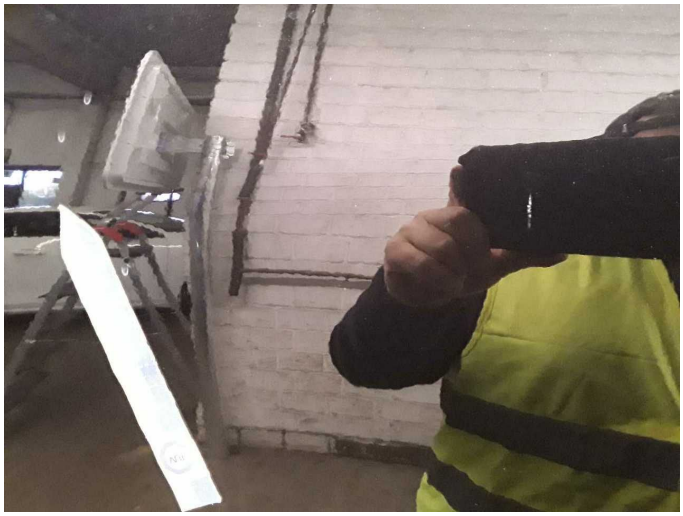
Damage 11: Door - rear right side: Door - Scratch(es) - Paint

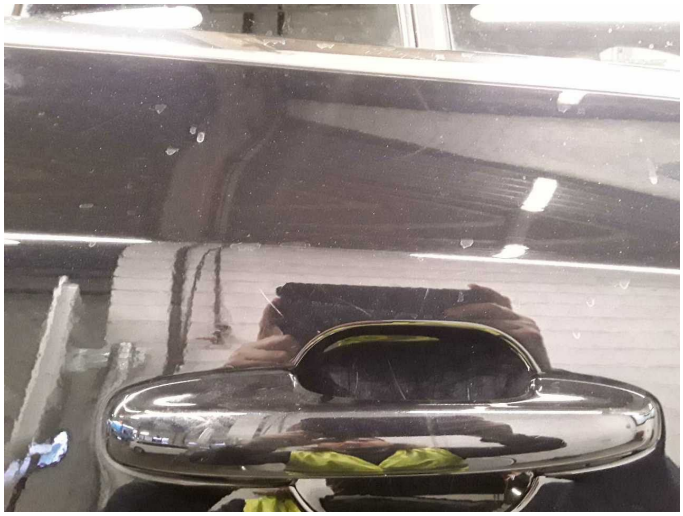
Damage 11: Door - rear right side: Door - Scratch(es) - Paint

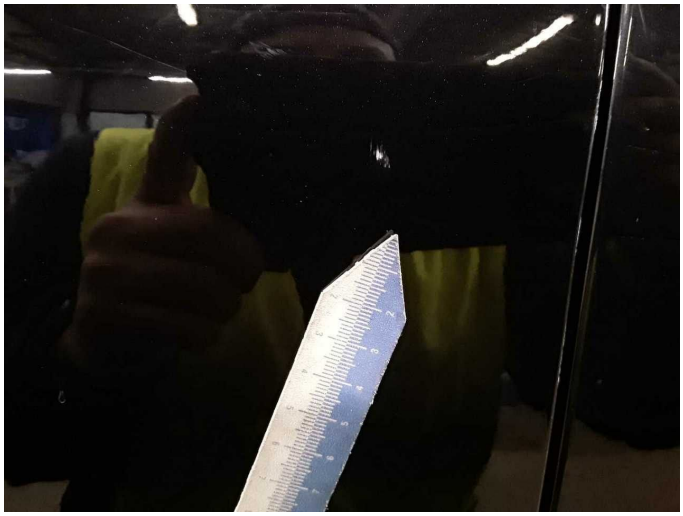
Damage 12: Door - front left side: Door - Scratch(es) - Paint

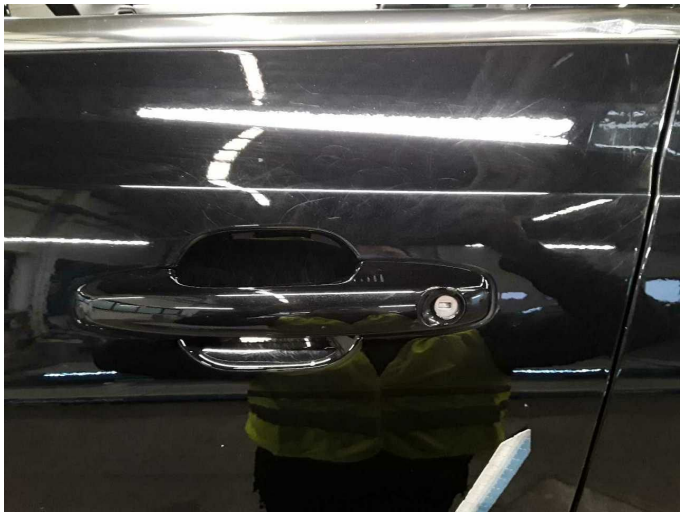
Damage 12: Door - front left side: Door - Scratch(es) - Paint

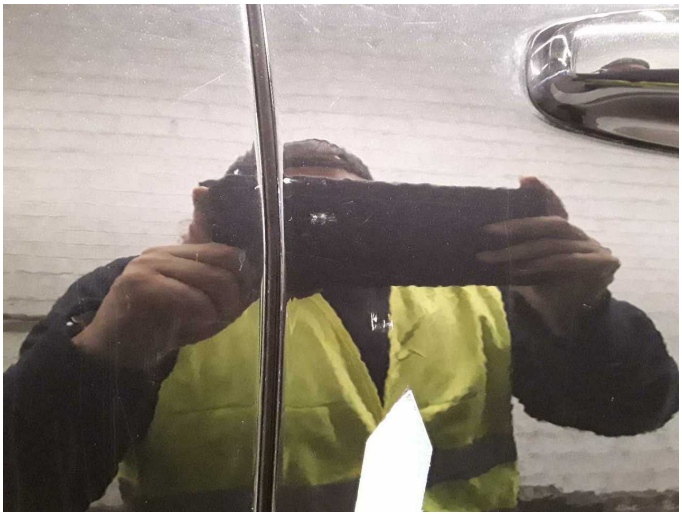
Damage 13: Door - front right side: Door - Scratch(es) - Paint

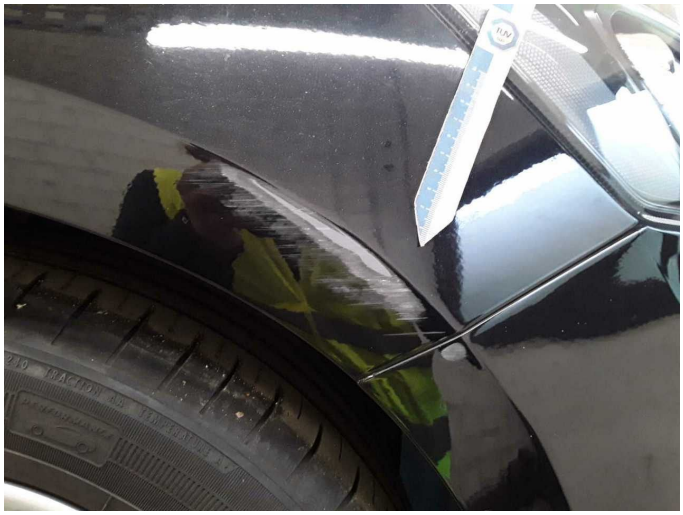
Accident 1: Front, Side right

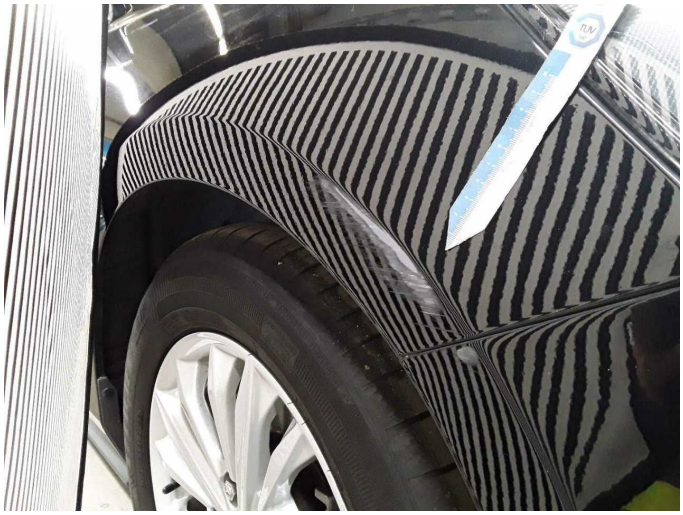
Accident 1: Front, Side right

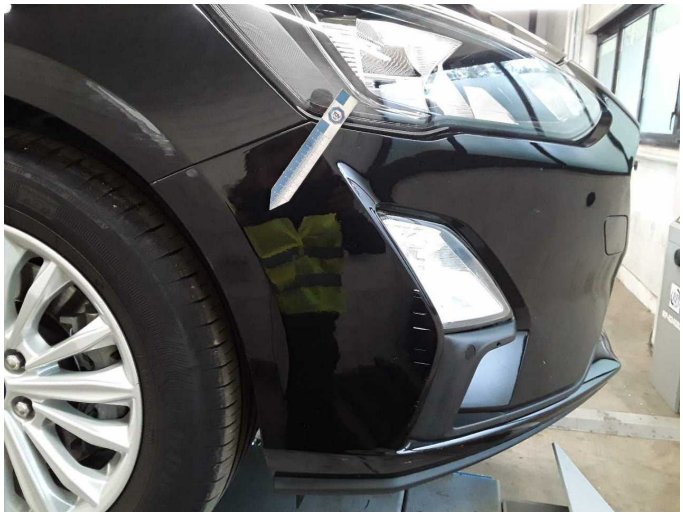
Accident 1: Front, Side right

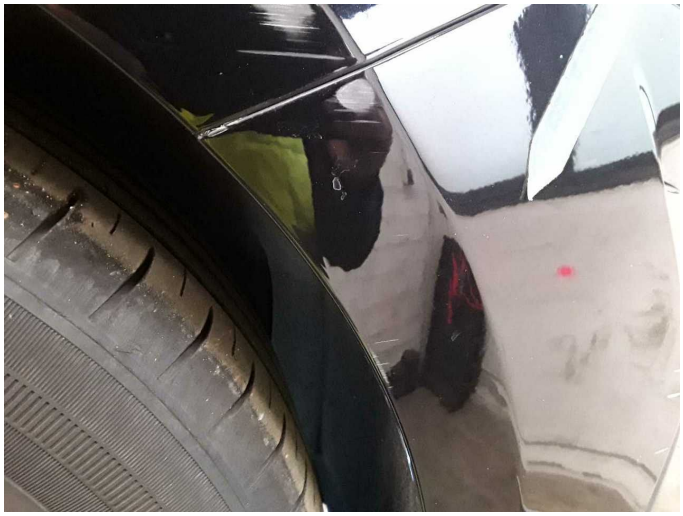
Accident 1: Front, Side right

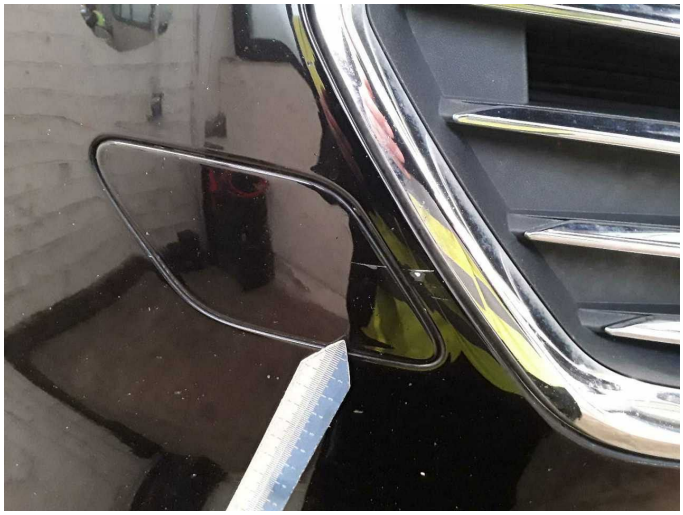
Accident 1: Front, Side right

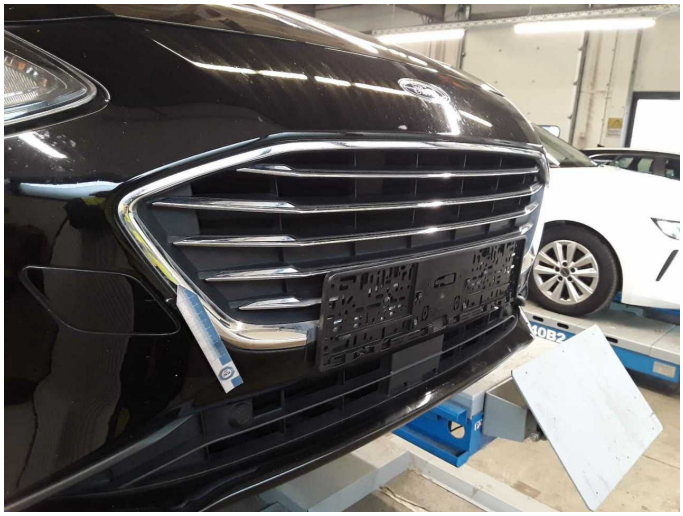
Accident 1: Front, Side right

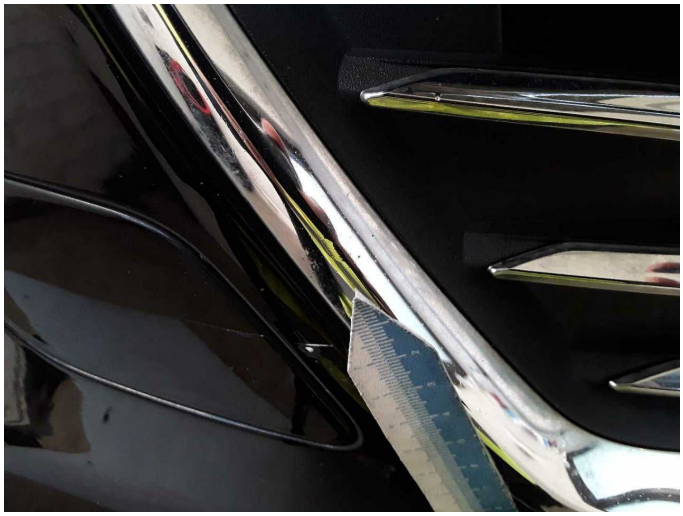
Accident 1: Front, Side right
