TÜV SÜD Auto Partner GmbH
Wiesenring 2
04159 Leipzig

# Expertise

Protocol number: 48363425
Order No. / Reference: 27204961
Inspection date: 26 Oct 2026

| Manufacturer: Opel | Model: Grandland 1.5 D Automatik Ultimate |

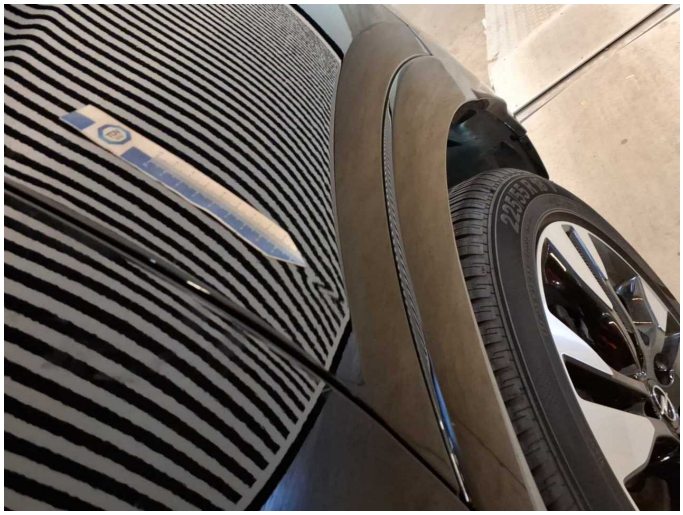
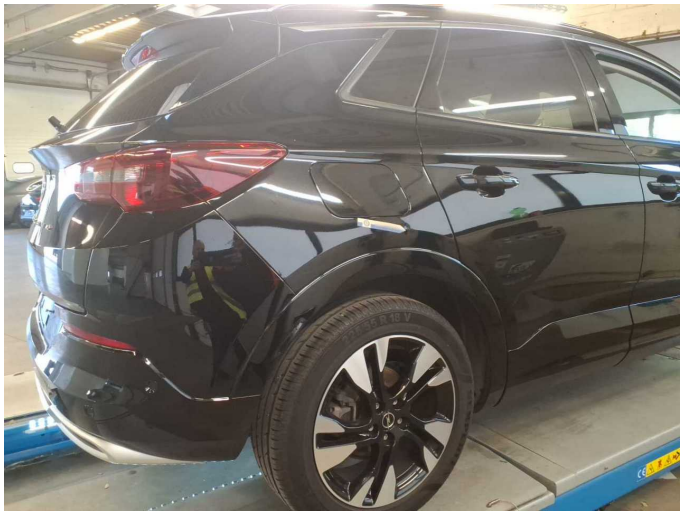
| No. | Component group | Description |
|---|---|---|
| 3 | Side panel - rear left side | Side panel - dent(s) - Smooth repair work |

**Damage 3:** Side panel - rear left side: Side panel - dent(s) - Smooth repair work

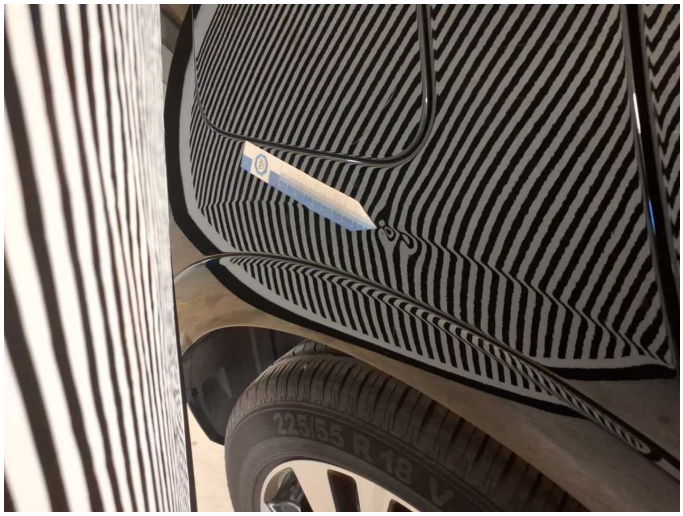
| No. | Component group | Description |
|---|---|---|
| 4 | Side panel - rear right side | Side panel - dent(s) - Smooth repair work |

**Damage 4:** Side panel - rear right side: Side panel - dent(s) - Smooth repair work

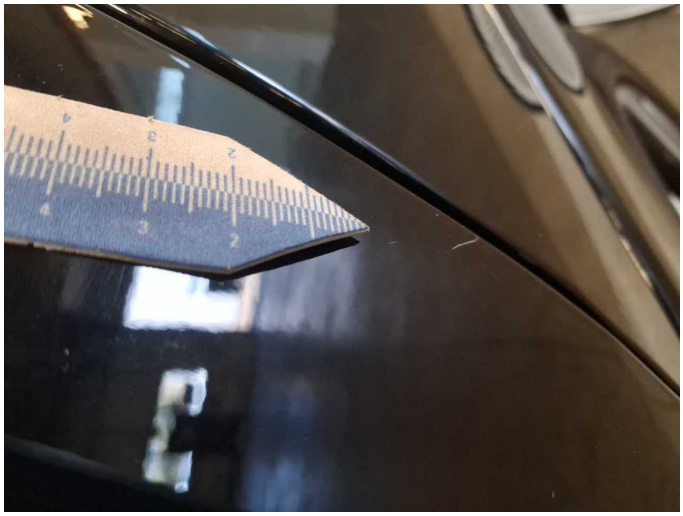
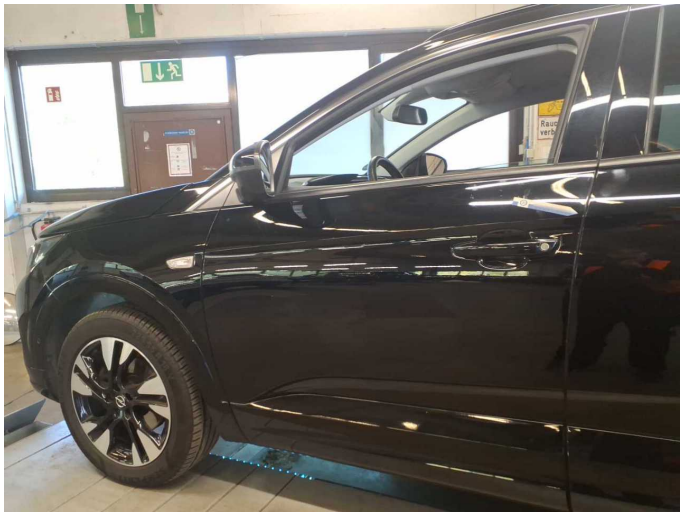
| No. | Component group | Description |
|---|---|---|
| 8 | Door - rear left side | Door - Scratch(es) - Paint |

**Damage 8:** Door - rear left side: Door - Scratch(es) - Paint

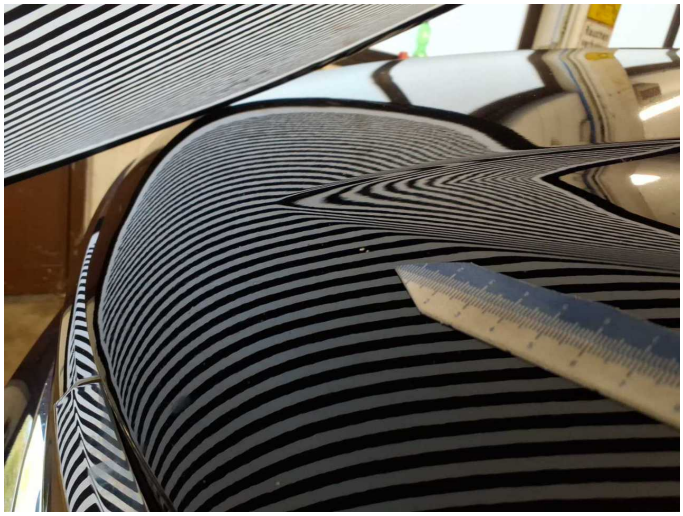
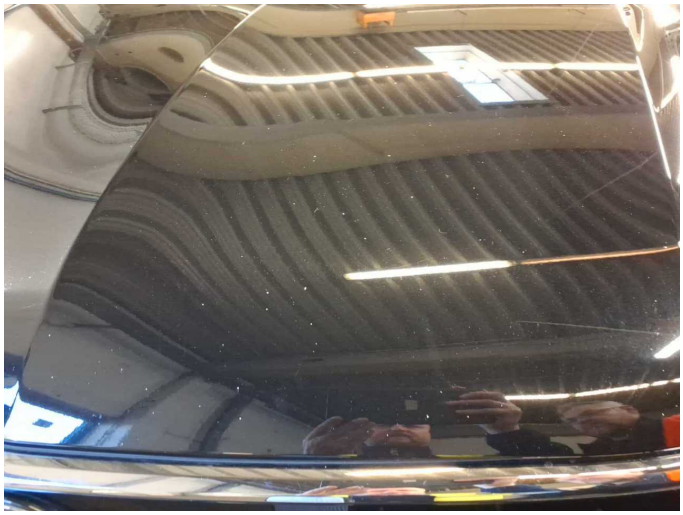
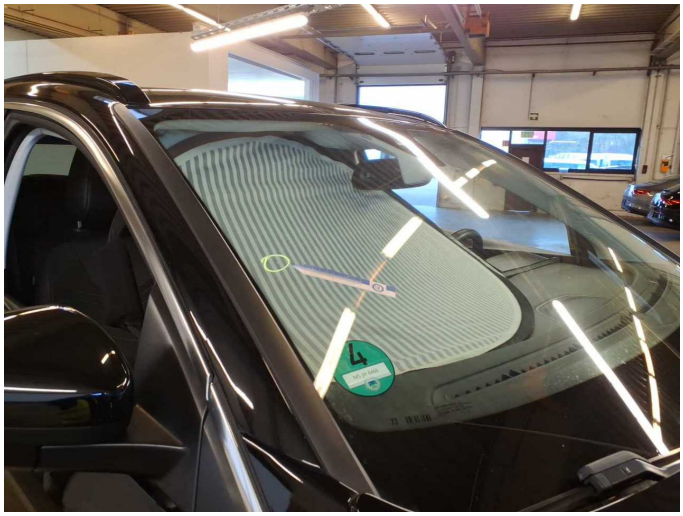
| No. | Component group | Description |
|---|---|---|
| 10 | Bonnet | Bonnet (Sandstrahleffekt) - Stone chips - Paint |

**Damage 10:** Bonnet: Bonnet (Sandstrahleffekt) - Stone chips - Paint

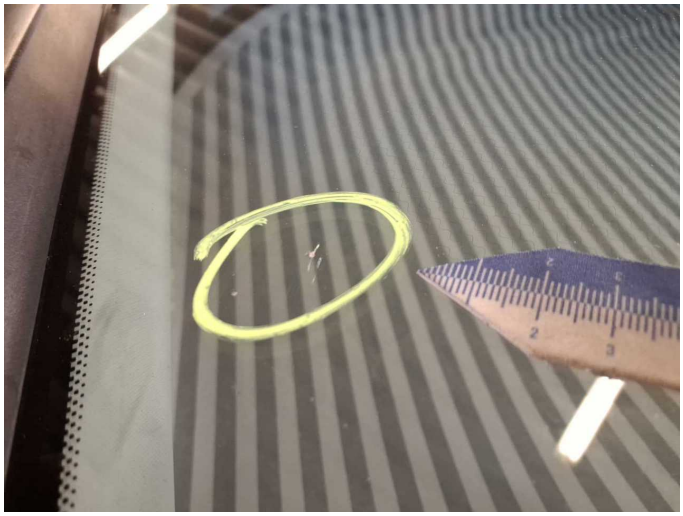
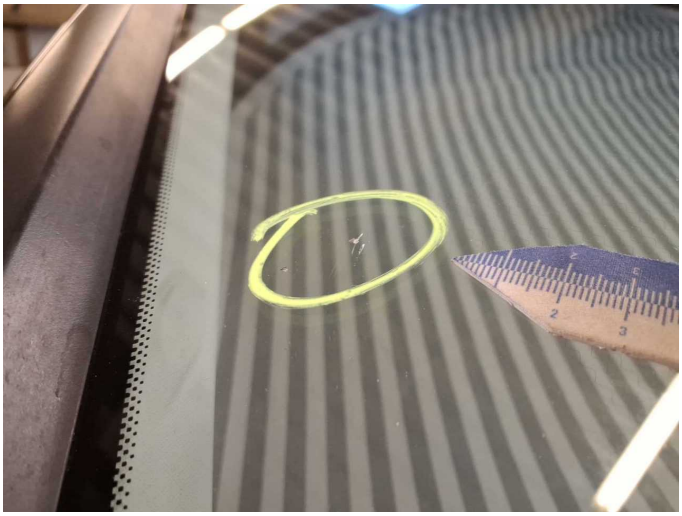
| No. | Component group | Description |
|---|---|---|
| 11 | Vehicle glazing | Windscreen (Rissbildung) - Stone chips - Replace |

**Damage 11:** Vehicle glazing: Windscreen (Rissbildung) - Stone chips - Replace
