Expertise

Protocol number: 48594291
Order No. / Reference: 27211862
Inspection date: 26 Oct 2026

Manufacturer: Skoda	Model: Kodiaq 2.0 TDI 4x4 DSG Sportline
VIN: TMBLN7NS2R8010898

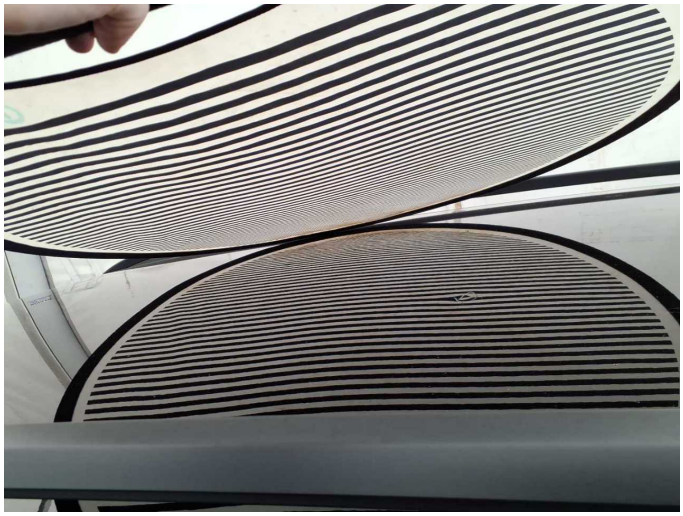
Damage 5: Roof: Roof - Damage by hail - Smooth repair work

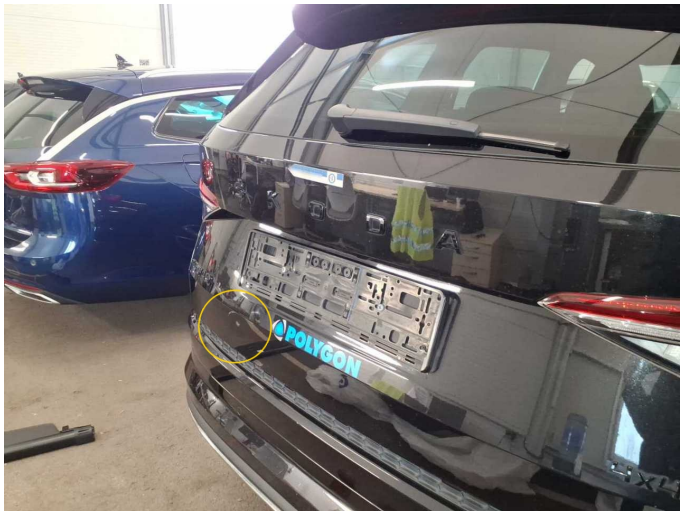
Damage 7: Boot lid / rear door: Boot lid (Inkl. Entkleben Heckklappe) - Dent / paintcoat damage - Repair and paint
