Expertise

Protocol number: 48585402
Order No. / Reference: 27234341
Inspection date: 5 Nov 2026

Manufacturer: Mercedes-Benz	Model: E 220 d 4Matic T 9G-TRONIC Avantgarde
VIN: W1K2132051B023723

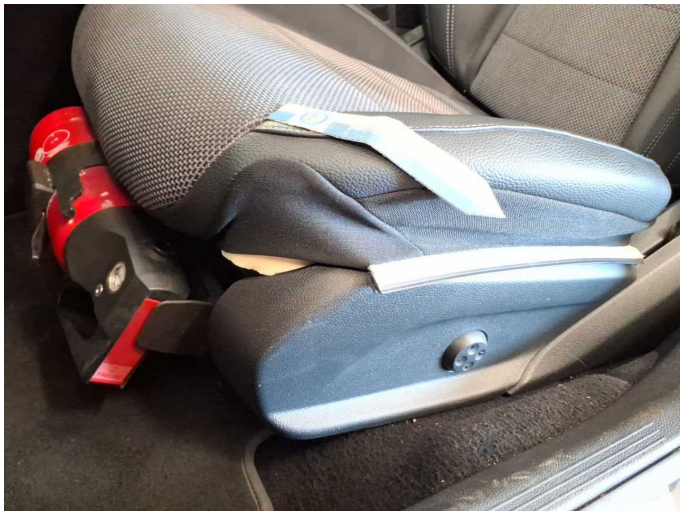
Damage 5: Seat - front: Seat upholstery - left side - Broken / torn - Replace

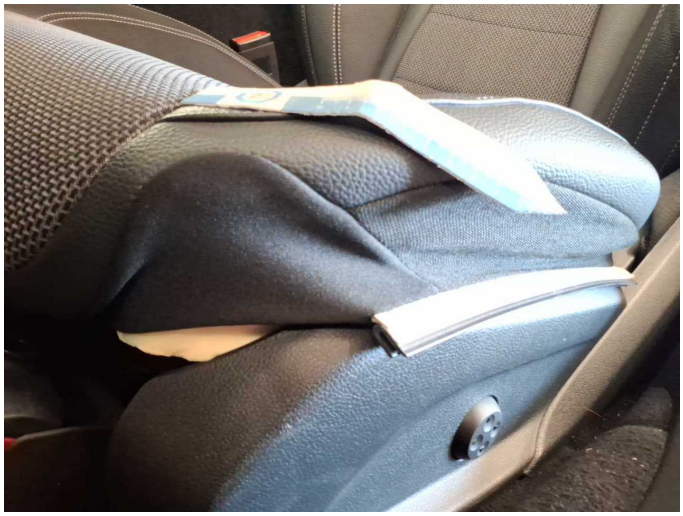
Damage 5: Seat - front: Seat upholstery - left side - Broken / torn - Replace

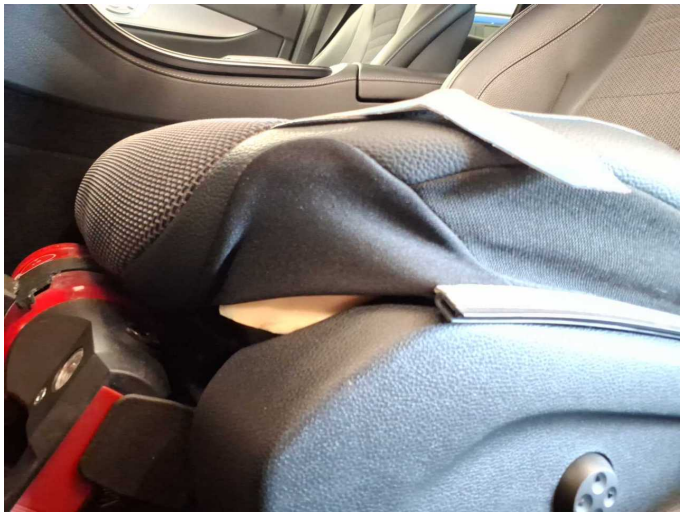
Damage 5: Seat - front: Seat upholstery - left side - Broken / torn - Replace

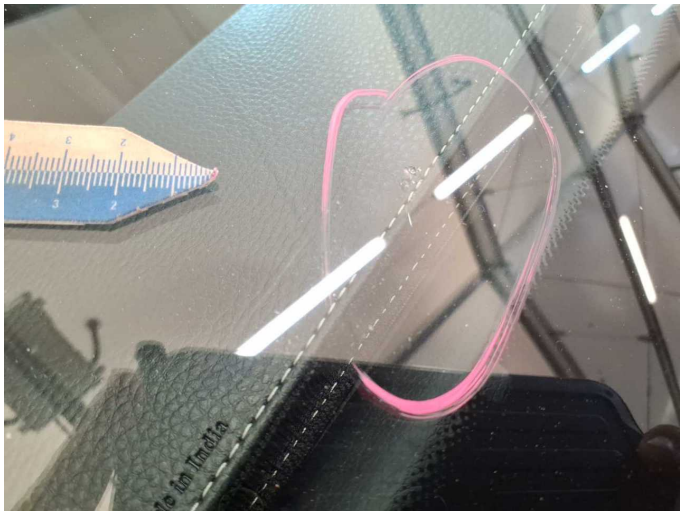
Damage 7: Vehicle glazing: Windscreen (Mit Rissbildung im Randbereich) - Stone chips - Replace

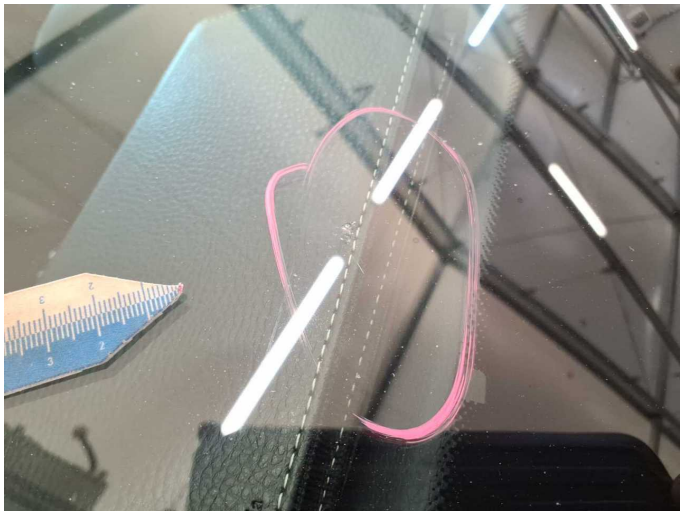
Damage 7: Vehicle glazing: Windscreen (Mit Rissbildung im Randbereich) - Stone chips - Replace

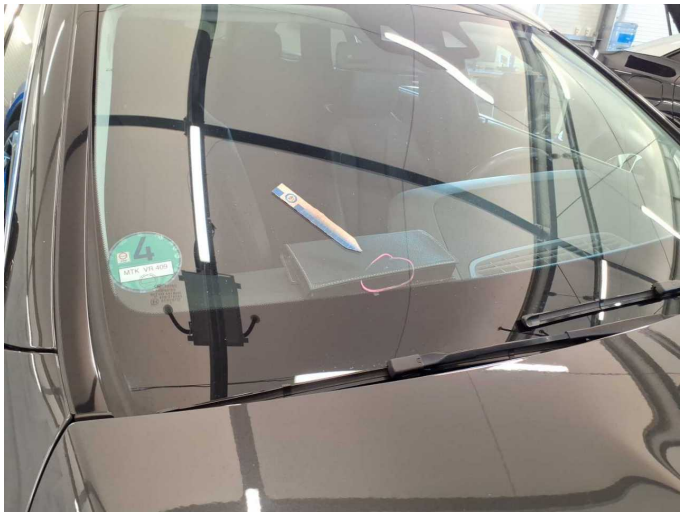
Damage 7: Vehicle glazing: Windscreen (Mit Rissbildung im Randbereich) - Stone chips - Replace

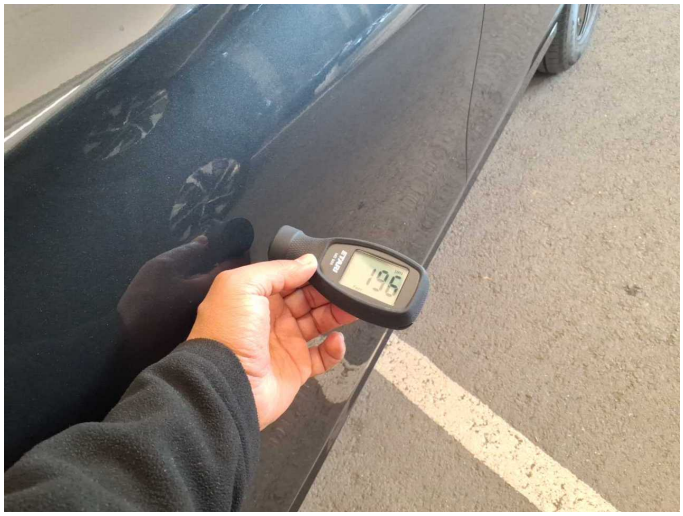
Roof rail - left side	177 µm	Side panel - rear left side	190 µm
Door - front left side	196 µm

Repainting 1: Roof rail - left side, Side panel - rear left side, Door - front left side

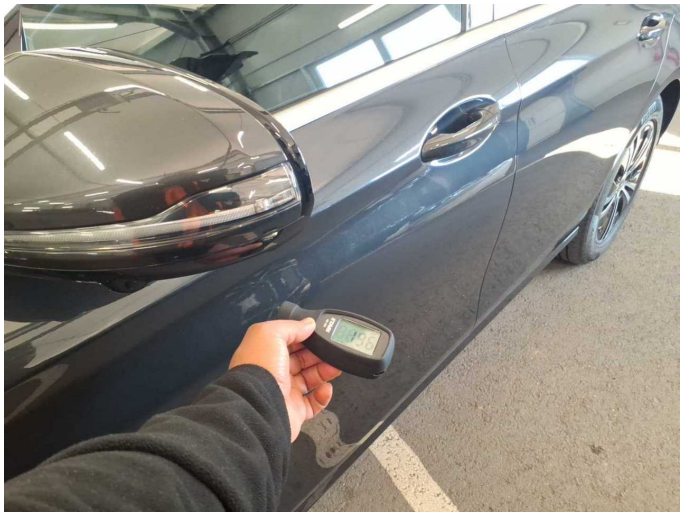
Repainting 1: Roof rail - left side, Side panel - rear left side, Door - front left side

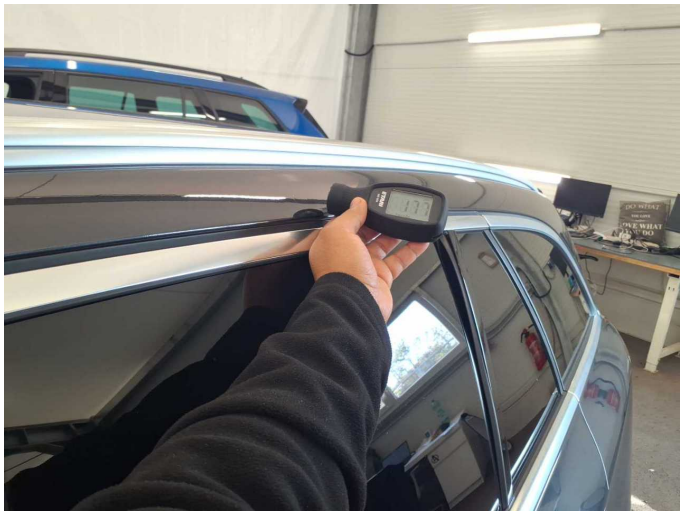
Repainting 1: Roof rail - left side, Side panel - rear left side, Door - front left side
