Expertise

Protocol number: 48048496
Order No. / Reference: 27060720
Inspection date: 9 Oct 2026

Manufacturer: Skoda	Model: Octavia Combi 2.0 TDI DSG RS
VIN: TMBJK0NX8RY030852

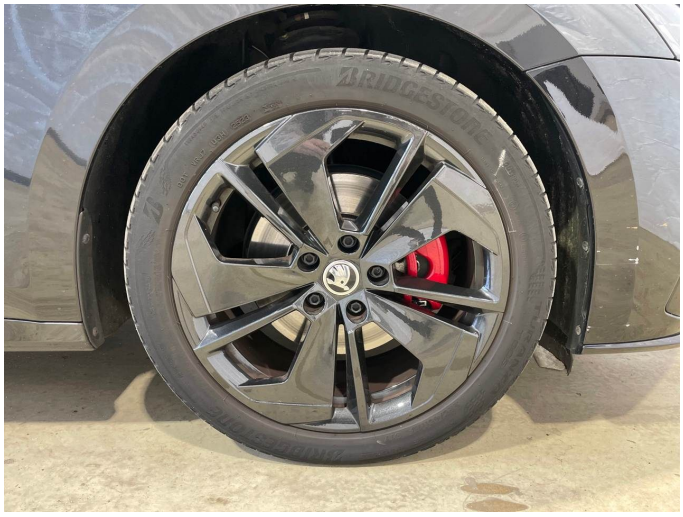
Figure 12: Mounted tyres

#	Tyre size	Type of tyre	Manufacturer	Tread depth
1)	225/45 R18 91Y	Summer tyres on Light alloy	Bridgestone	5mm / 5mm
2)	225/45 R18 91Y	Summer tyres on Light alloy	Bridgestone	6mm / 6mm

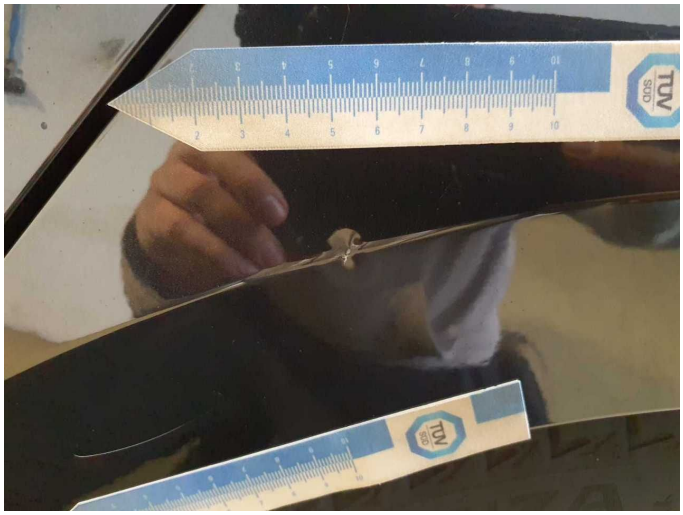
Damage 5: Side panel - rear left side: Side panel - Dent / paintcoat damage - Smart repair

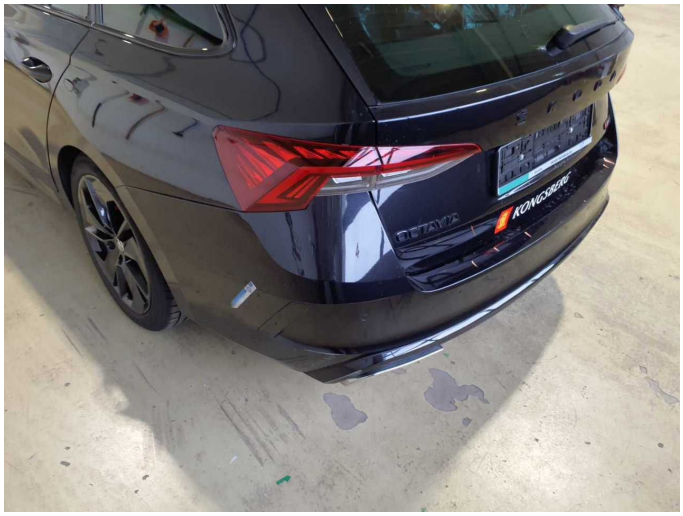
Damage 5: Side panel - rear left side: Side panel - Dent / paintcoat damage - Smart repair

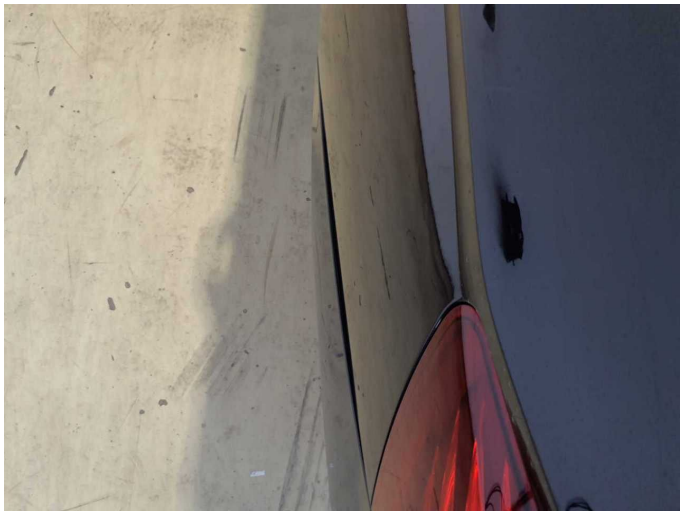
Damage 6: Rear bumper: Rear bumper (Zusätzlich Spaltmaß einstellen) - Scratch(es) - Paint

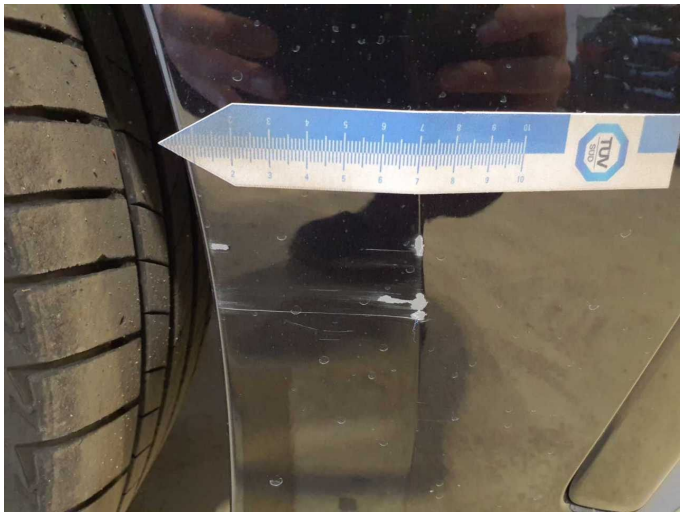
Damage 6: Rear bumper: Rear bumper (Zusätzlich Spaltmaß einstellen) - Scratch(es) - Paint

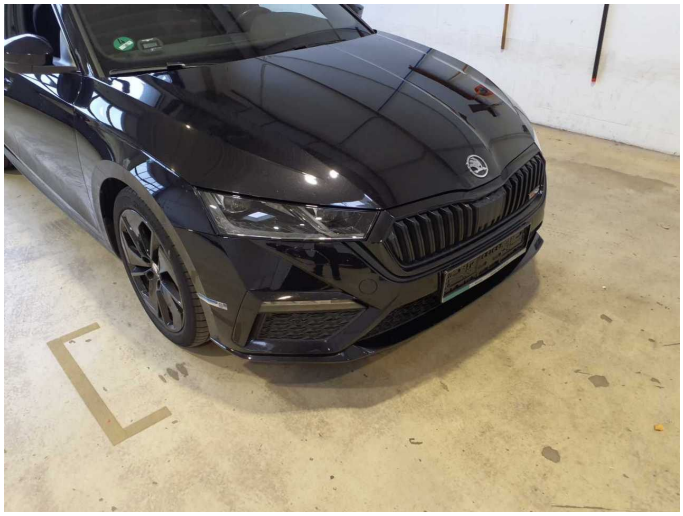
Damage 7: Front bumper: Front bumper - Scratch(es) - Paint
