Expertise

Protocol number: 47891209
Order No. / Reference: 27026954
Inspection date: 30 Sept 2026

Manufacturer: Audi	Model: A6 Avant 40 TDI quattro S tronic advanced
VIN: WAUZZZF23RN053492

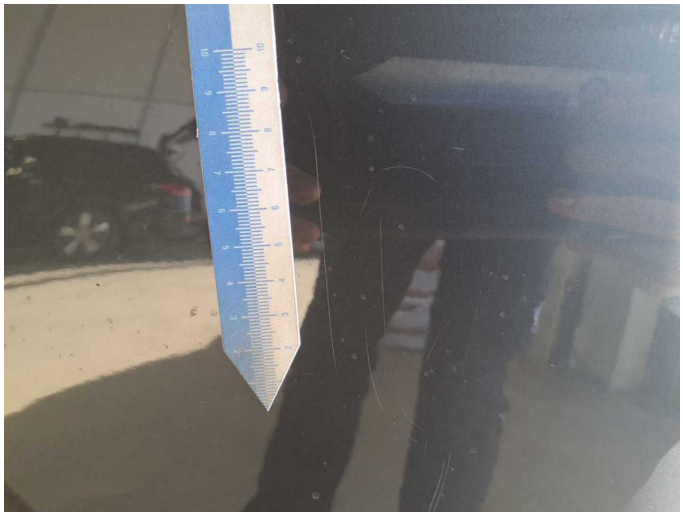
Damage 2: Rear bumper: Rear bumper - Scratch(es) - Smart repair
