Expertise

Protocol number: 48460063
Order No. / Reference: 27179472
Inspection date: 3 Nov 2026

Manufacturer: Audi	Model: A6 Avant 40 TDI S tronic
VIN: WAUZZZF29RN035868

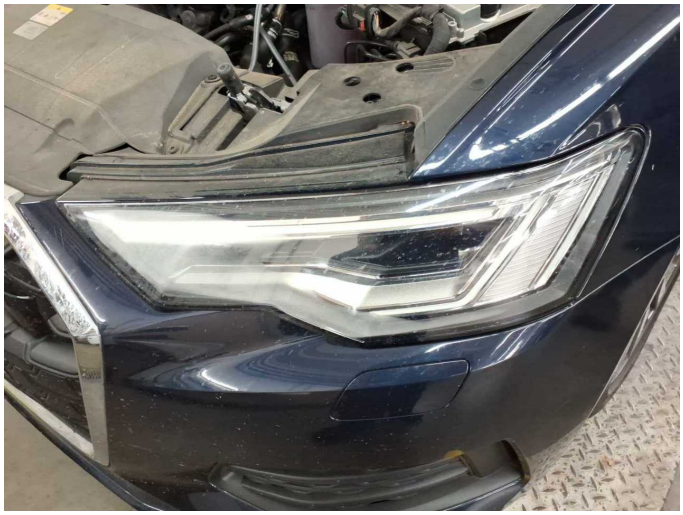
No.	Component group	Description
1	Wheel / tyres	Alloy rim - rear left side - Scratch(es) - Loss in value
2	Rear bumper	Spoiler - Scratch(es) - Loss in value
3	Headlight	Headlight - left side (beschlagen, reinigen, Mehrkosten möglich) - Soiled - Perform diagnosis
4	Headlight	Headlight - right side (beschlagen, reinigen, Mehrkosten möglich) - Soiled - Perform diagnosis
5	Roof	Roof - dent(s) - Smooth repair work
6	Side panel - rear left side	Side panel - Dent / paintcoat damage - Smart repair
7	Rear bumper	Rear bumper - Scratched - Paint
8	Front bumper	Front bumper - Scratched - Paint

Damage 2: Rear bumper: Spoiler - Scratch(es) - Loss in value

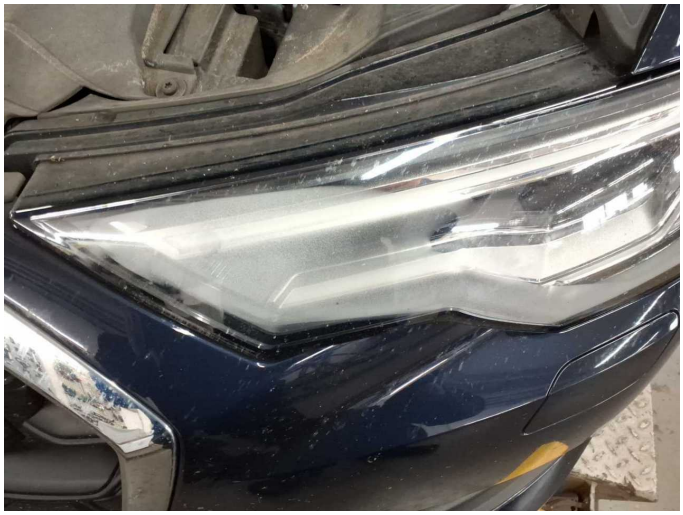
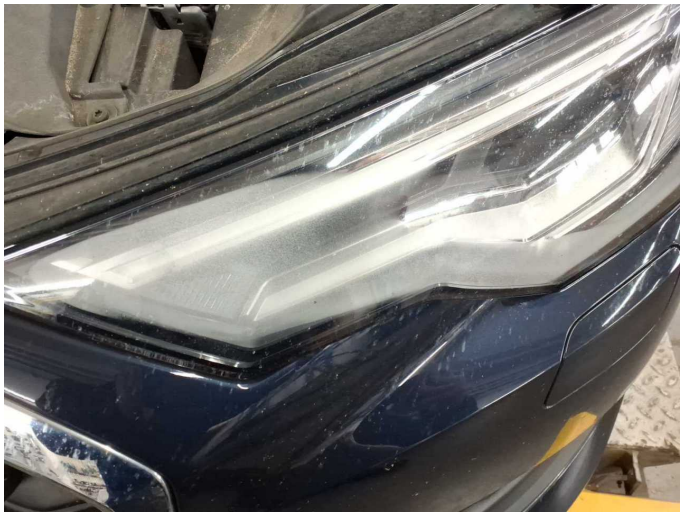
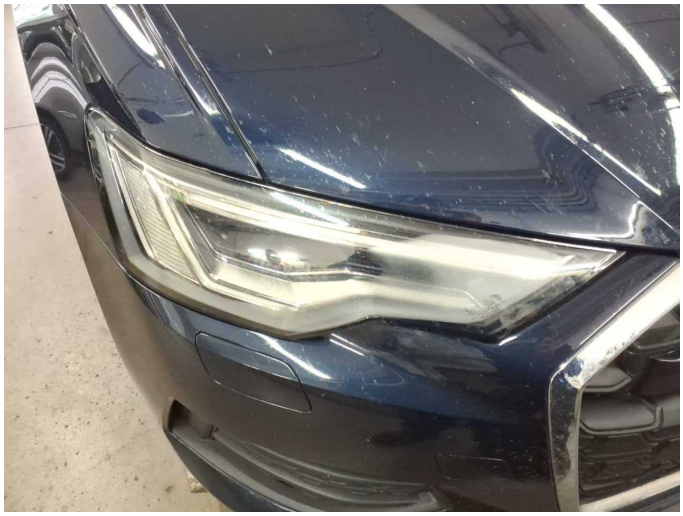
Damage 3: Headlight: Headlight - left side (beschlagen, reinigen, Mehrkosten möglich) - Soiled - Perform diagnosis

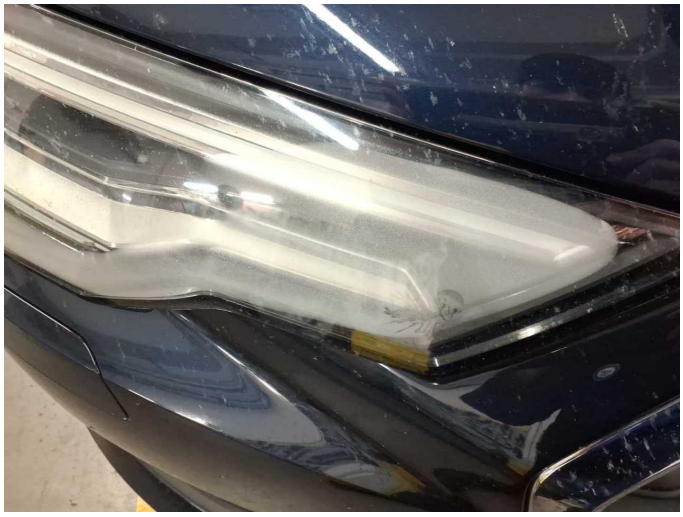
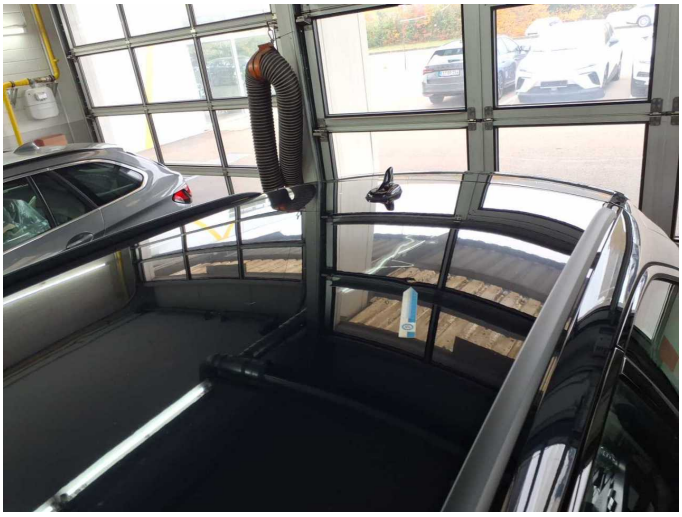
Damage 4: Headlight: Headlight - right side (beschlagen, reinigen, Mehrkosten möglich) - Soiled - Perform diagnosis

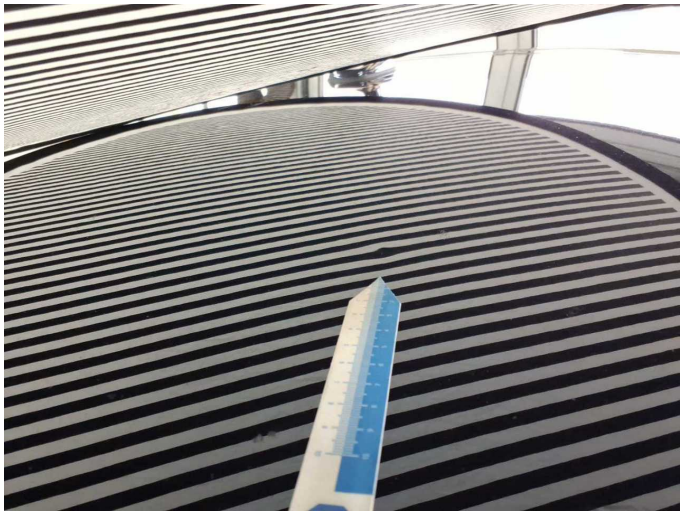
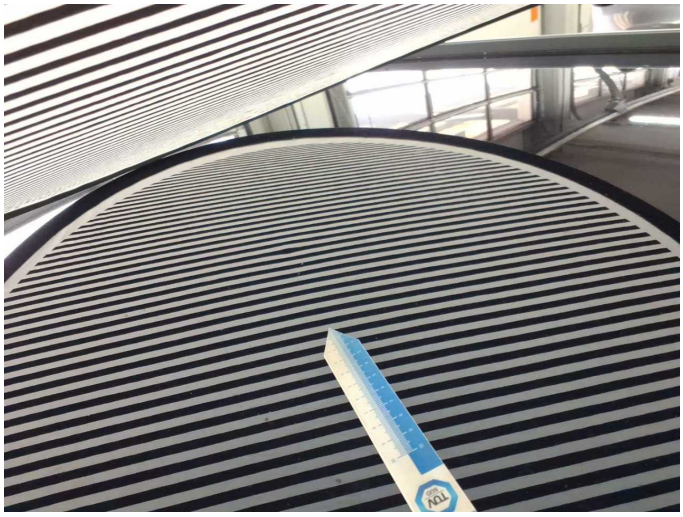
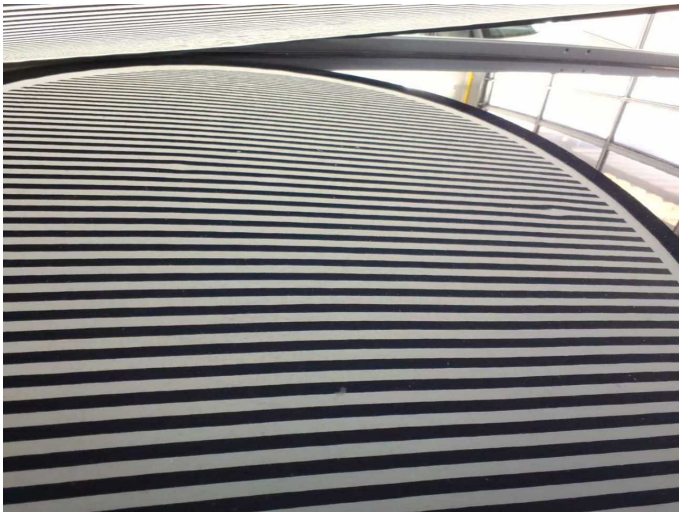
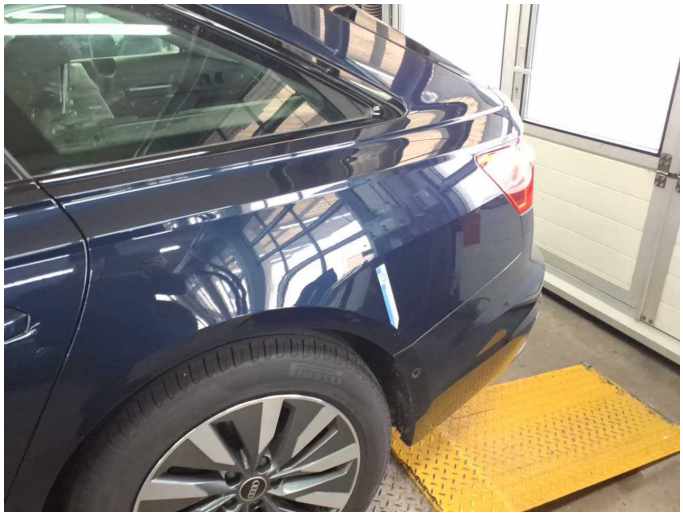
Damage 5: Roof: Roof - dent(s) - Smooth repair work

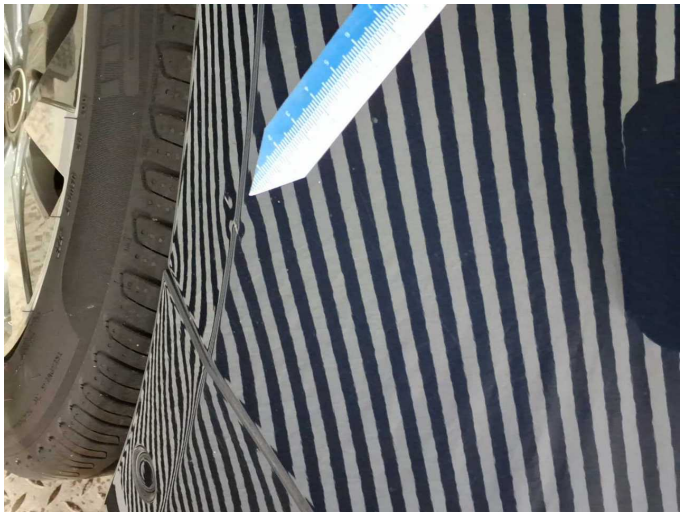
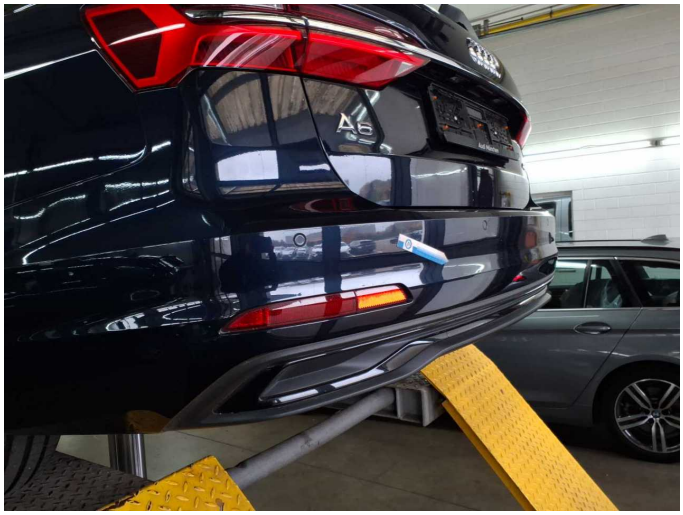
Damage 6: Side panel - rear left side: Side panel - Dent / paintcoat damage - Smart repair

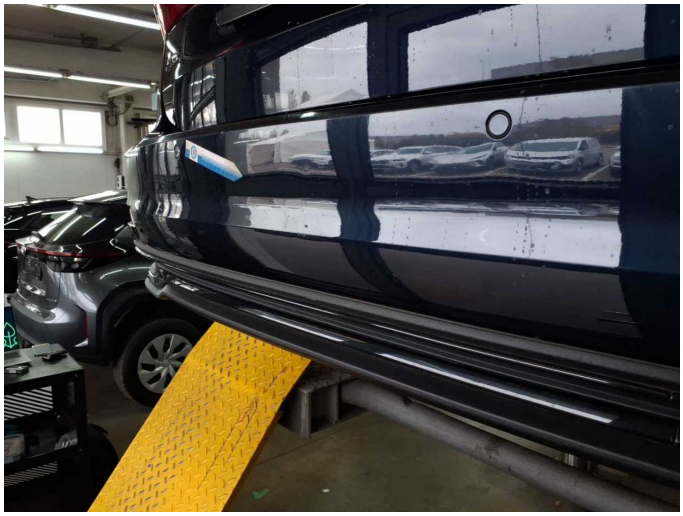
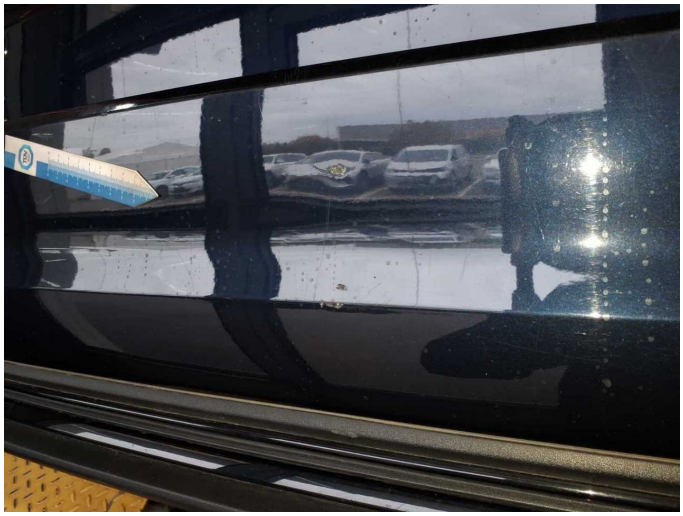
Damage 7: Rear bumper: Rear bumper - Scratched - Paint

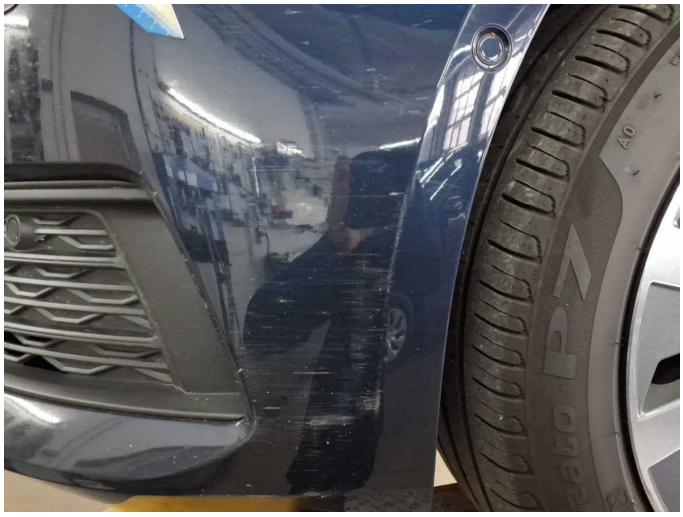
Damage 8: Front bumper: Front bumper - Scratched - Paint
