Expertise

Protocol number: 48368491
Order No. / Reference: 27099806
Inspection date: 27 Oct 2026

Manufacturer: Skoda	Model: Kodiaq 2.0 TDI DSG Ambition
VIN: TMBJJ9NSXP8050741

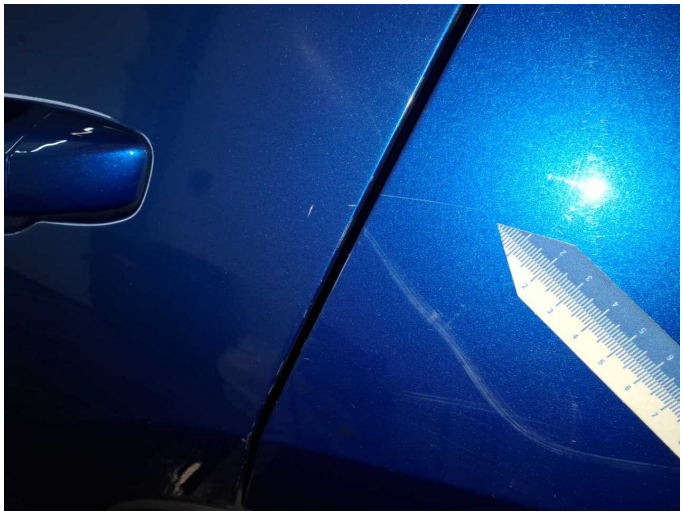
Damage 2: Side panel - rear left side: Side panel - Scratch(es) - Smart repair

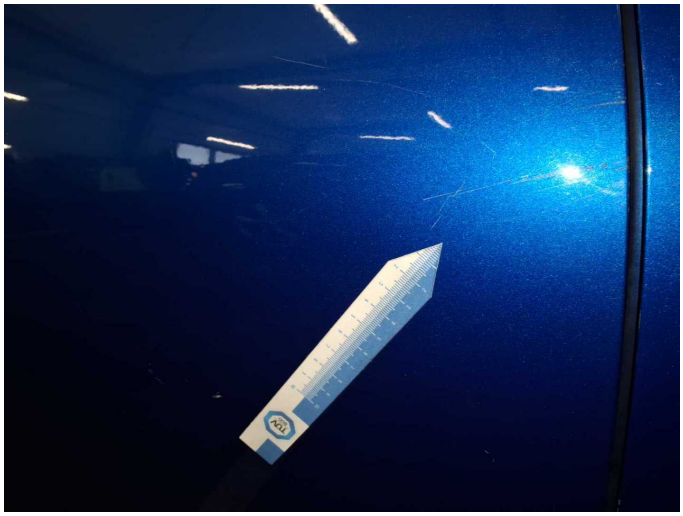
Damage 4: Door - rear left side: Door - Scratch(es) - Paint

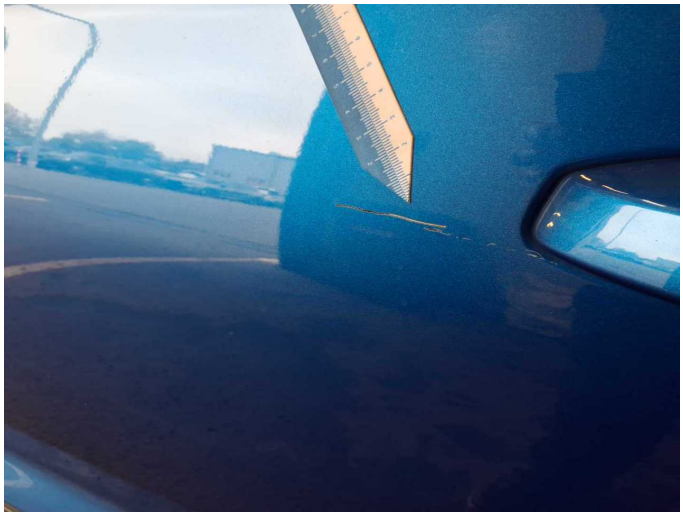
Damage 5: Door - rear right side: Door - Scratch(es) - Paint

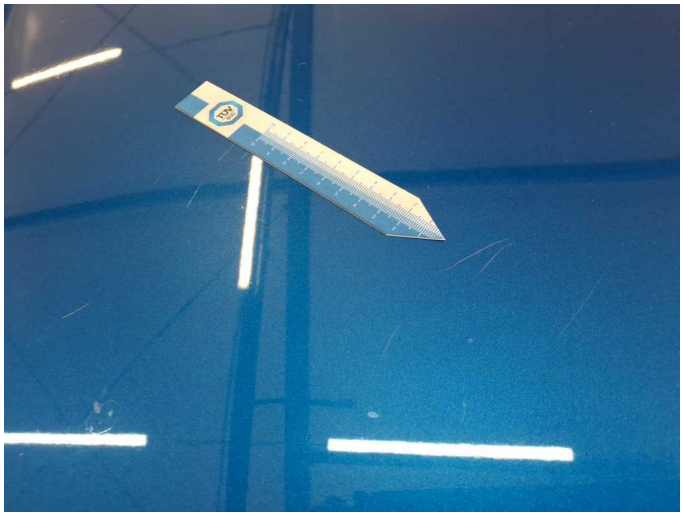
Damage 8: Bonnet: Bonnet - Scratch(es) - Paint

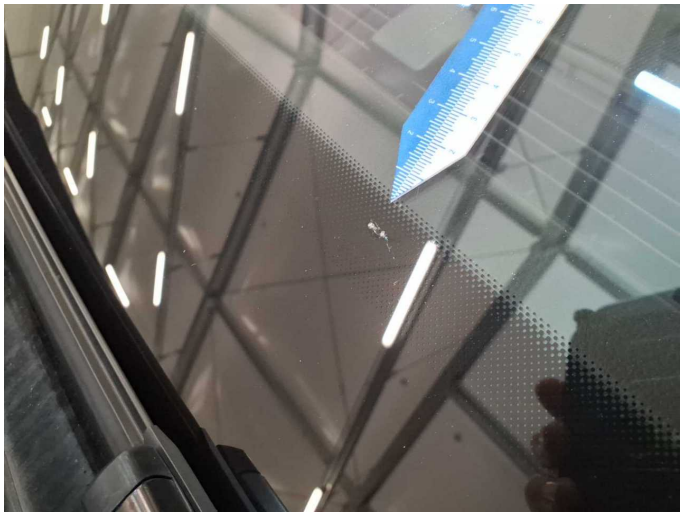
Damage 9: Vehicle glazing: Windscreen - Stone chips - Replace
