MACADAM

# BMW X5

## Vehicle information

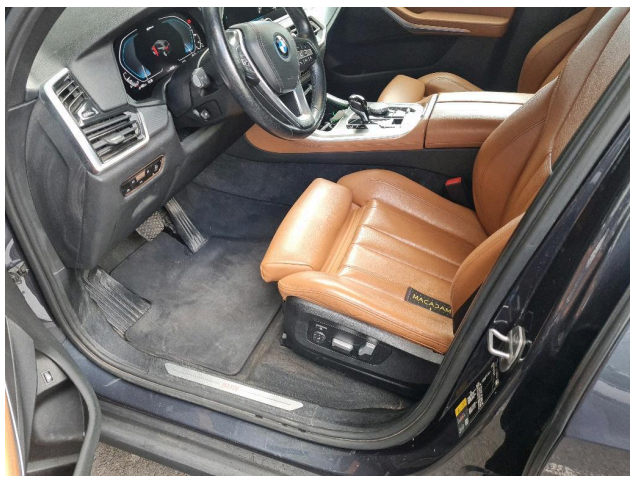
Dirty **Interior**

Damaged **Interior**
- Acceptable
Interior

- Clean

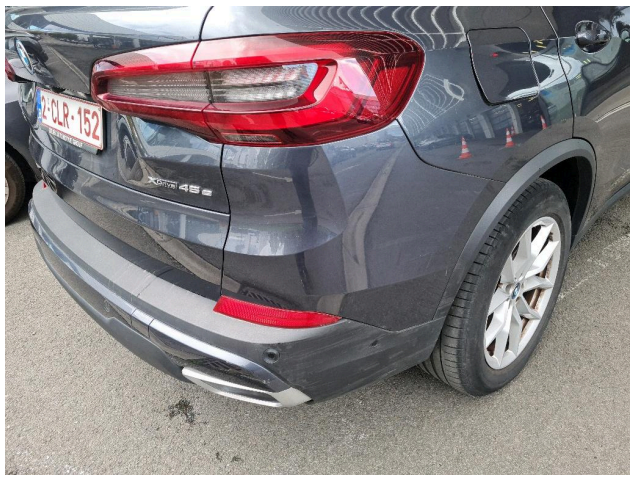
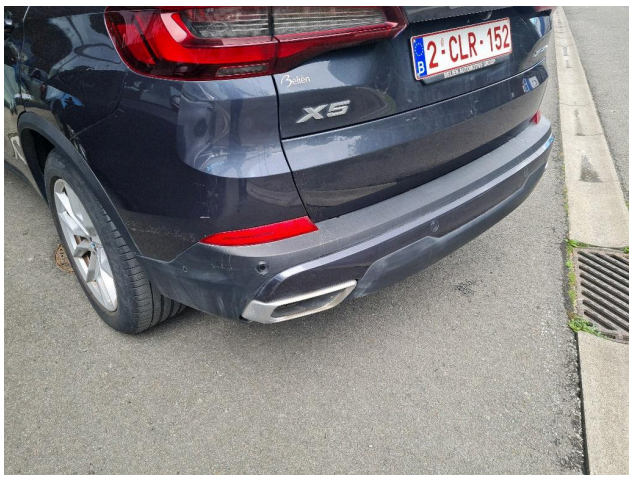
**Right Wing Molding**
Claw(s)
E - Replace
Right

**Rear bumper molding,**
claw(s)
, paint
rear

**Rear bumper,**
claw(s)
, paint
the rear

**Rear bumper,** Smart repair claw
(s)

Rear **right inner wheel arch.**
Dent(s) and scratch(es).
Smart repair.
