Audi

VIN: WAUZZZGY0PA114112

Estimated repair cost

Inspection loc
PARC LIZY

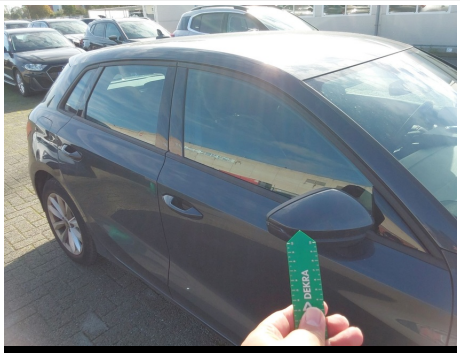
Wing / Back Right / Dent

012	Wing / Back Right	Dent	Repair	320.00 EUR

Bodywork time	Paint time	Part Price	Lumpsum
2.00 h	2.00 h	-	-
Bodywork cost	**Paint cost**	**MaterialCost**	
150.00 EUR	170.00 EUR	-
