Expertise

Protocol number: 48564930
Order No. / Reference: 27219158
Inspection date: 6 Nov 2026

Manufacturer: Volkswagen	Model: Golf Variant 2.0 TDI SCR DSG Life
VIN: WVWZZZCD2PW533023

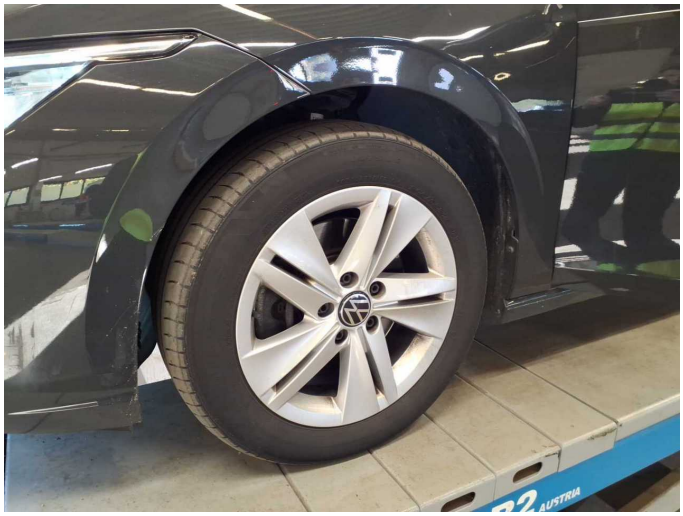
Damage 1: Wheel / tyres: Tyre - front (Außenflanke abgefahren) - Worn - Replace

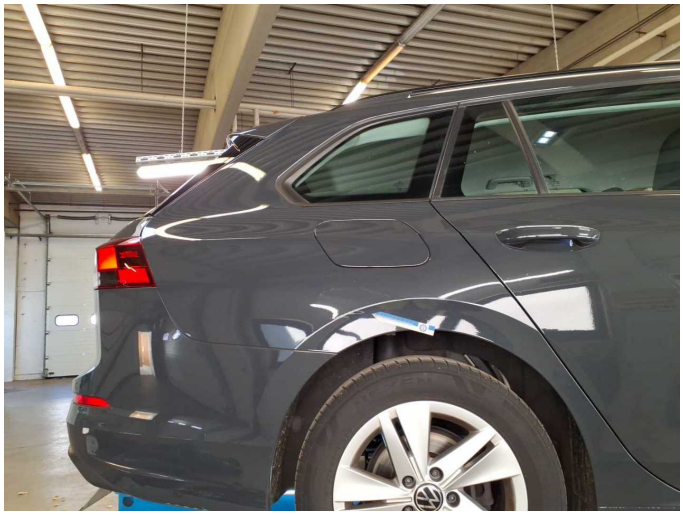
Damage 2: Door - rear left side: Door - Scratch(es) - Paint
