Expertise

Protocol number: 48469574
Order No. / Reference: 27154322-1
Inspection date: 23 Oct 2026

Manufacturer: Ford	Model: Puma 1.0 EcoBoost Hybrid Aut. TITANIUM
VIN: WF02XXERK2PL28635

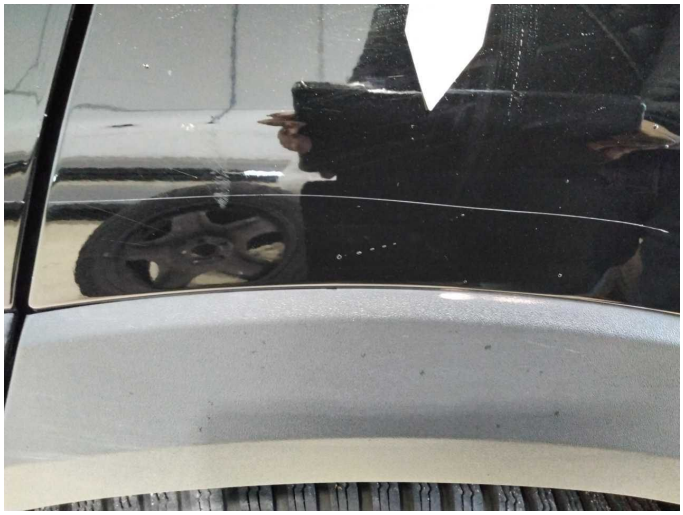
No.	Component group	Description
1	Body	C-pillar - right side - Dent / paintcoat damage - Smart repair
2	Boot lid / rear door	Boot lid - Scratch(es) - Smart repair
3	Side panel - rear left side	Side panel - Scratch(es) - Smart repair
4	Rear bumper	Rear bumper - Scratch(es) - Smart repair
5	Door - rear left side	Door (teilweise) - Dent / paintcoat damage - Repair and paint

Damage 3: Side panel - rear left side: Side panel - Scratch(es) - Smart repair

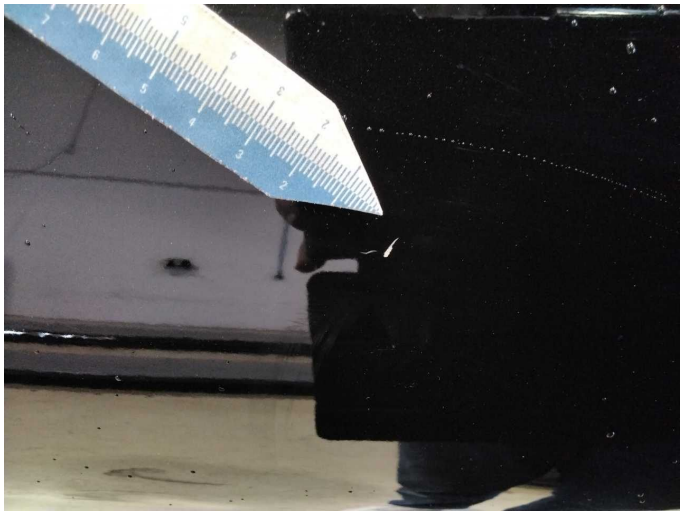
Damage 4: Rear bumper: Rear bumper - Scratch(es) - Smart repair
